## Item #12781131 - 2022 Screen Machine 50TJ Jaw Crusher

# Inspection Report

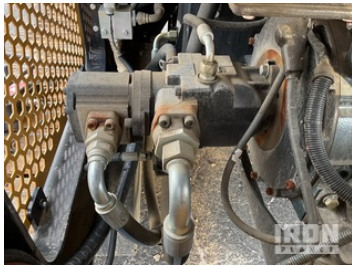
Hydraulics		
See photos for condition		
Item	Assessment	Photo
Hydraulics #18		
Hydraulics #17		
Hydraulics #16		
Hydraulics #15		
Pumps (Hydraulics)	★★★★

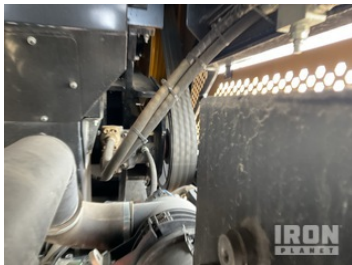
Hydraulic Motors	★★★★

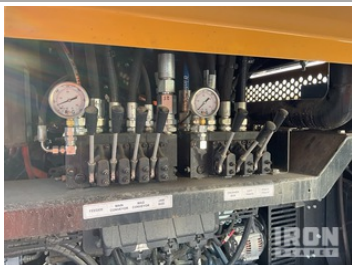
Valves	★★★★

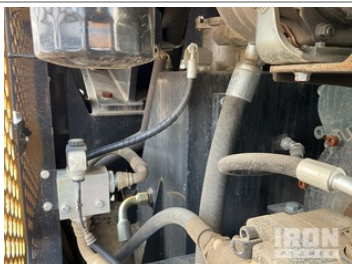
Hydraulic Tank	★★★★

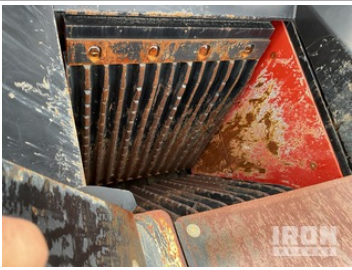
Crusher Door Cylinders	★★★★☆

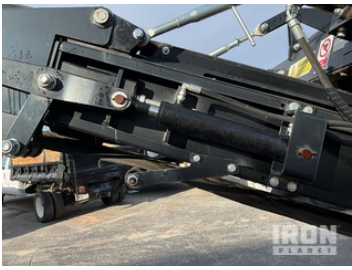
Conveyor Cylinders	★★★★☆

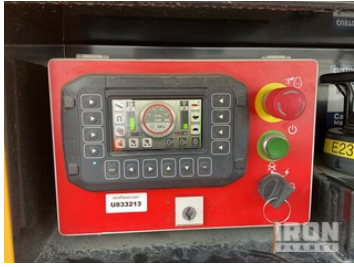
Engine Controls	★★★★☆

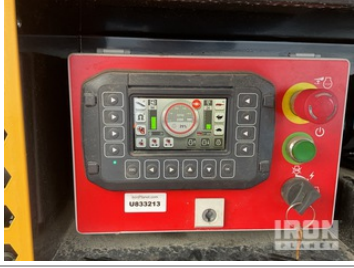
Crusher/Screen Controls	★★★★☆

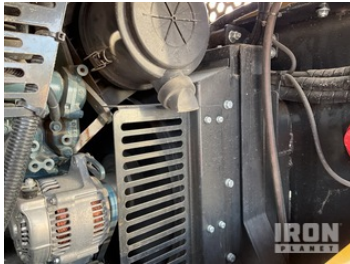
Radiator	★★★★☆

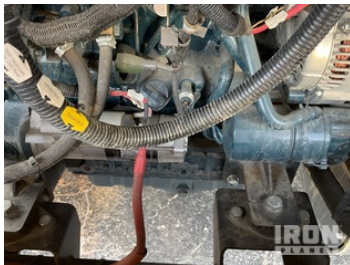
Oil Leaks	No dripping leaks

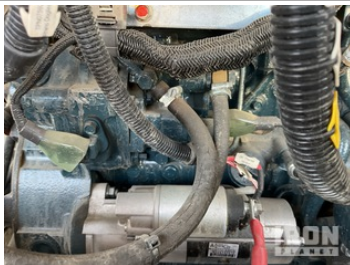
Fuel Leaks	No dripping leaks

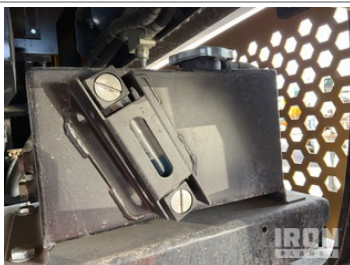
Cooling System Leaks	No dripping leaks

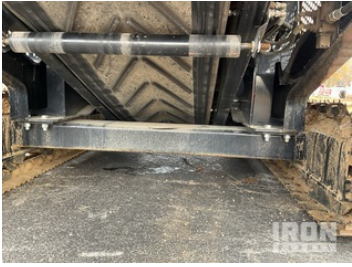
Chassis		
Item	Assessment	Photo
Crusher Base Frame	★★★★☆

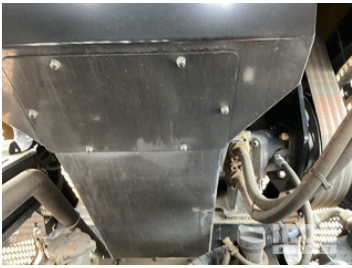
Crusher Chamber Frame	★★★★☆

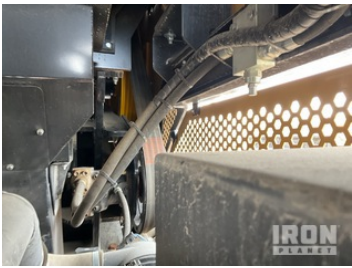
Crusher Drive System	★★★★☆

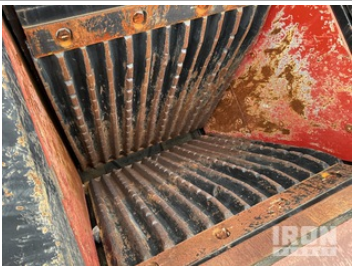
Crusher Roll Condition	★★★★☆

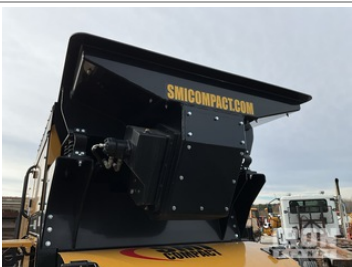
Feed Conveyor Condition	★★★★☆

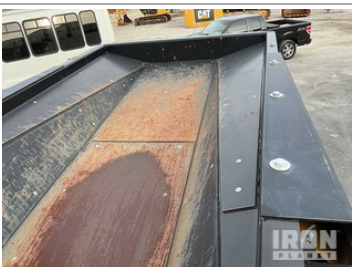
Feed Conveyor Frame	★★★★☆

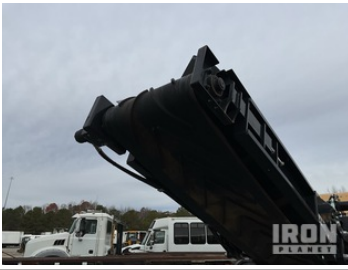
Feed Conveyor Head and Tail Pulley	★★★★☆

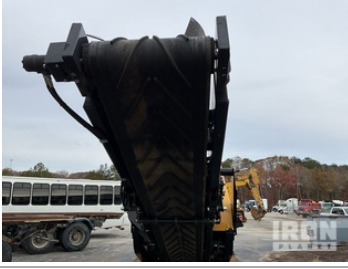
Discharge Conveyor Condition	★★★★☆

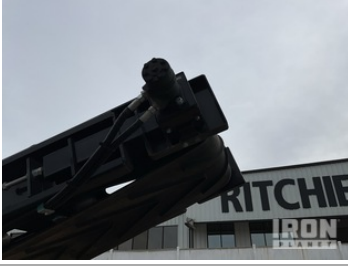
Discharge Conveyor Drive Motor	★★★★☆

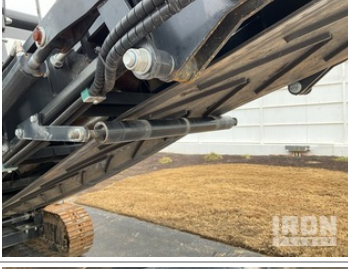
Discharge Conveyor Rollers	★★★★☆

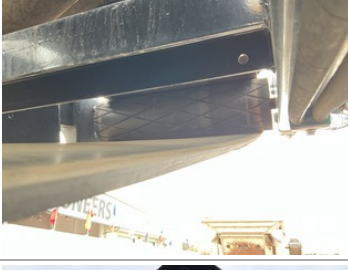
Discharge Conveyor Head and Tail Pulley	★★★★☆

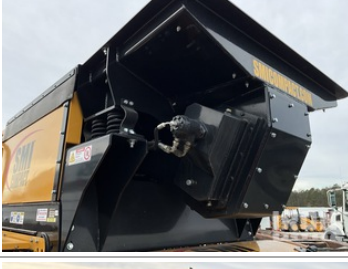
Deck Frames / Wear Bars	★★★★☆

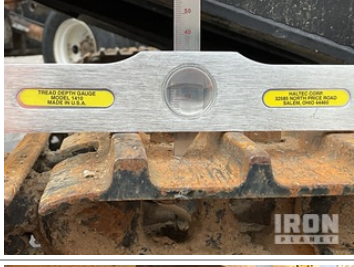
Left Grouser Height	12 mm

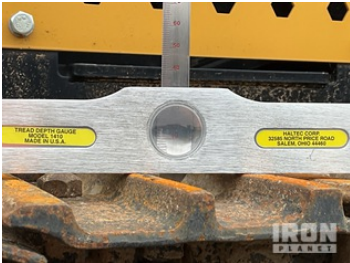
<p>Right Grouser Height</p>	<p>12 mm</p>

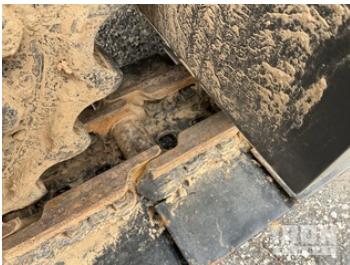
Right Track Bushings	Bushings have not been turned
