## Item #14159143 - 2022 Volvo A25G Articulated Dump Truck

# Inspection Report

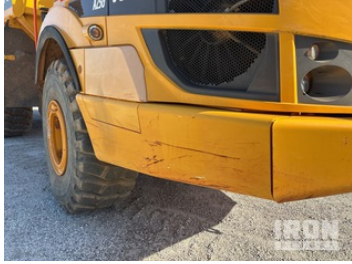
| Item | Assessment | Photo |
|---|---|---|
| Paint | Damage | |

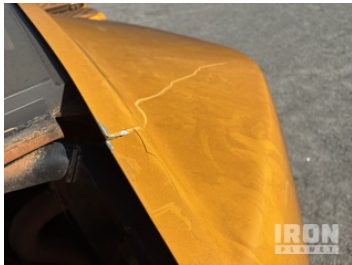
| Body Panels | Left side of hood damaged | |

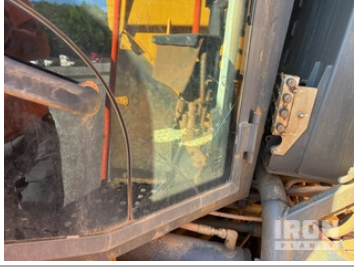
| Item | Assessment | Photo |
|---|---|---|
| Glass | Cab door cracked | |

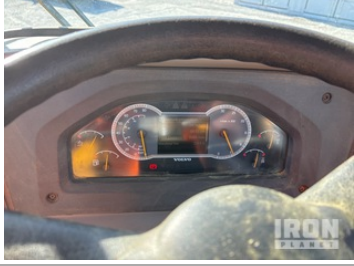
| Engine Oil Pressure | The fault indicator shuts off after the engine oil pressure rises. | |

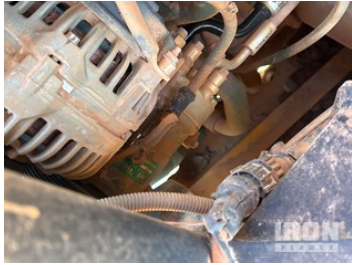
| Air Conditioner | Inoperable, Fans work but no cold air | |

| Engine | | |
|---|---|---|
| A/C Compressor | Compressor will not engage | |

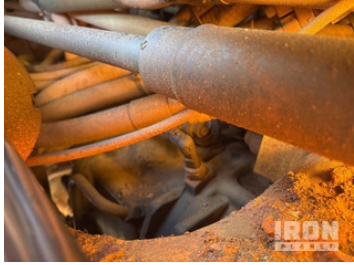
| Item | Assessment | Photo |
|---|---|---|
| Transmission | ★★☆☆<br>Operational | |

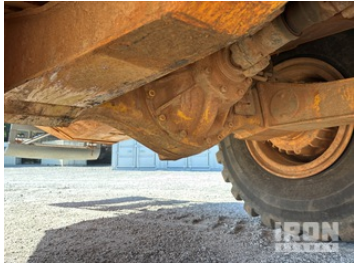
| Item | Assessment | Photo |
|---|---|---|
| Steer Axle | ★★☆☆ | |

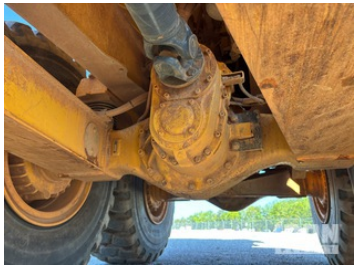
| Item | Assessment | Photo |
|---|---|---|
| Center Drive Axle | ★★☆☆ | |

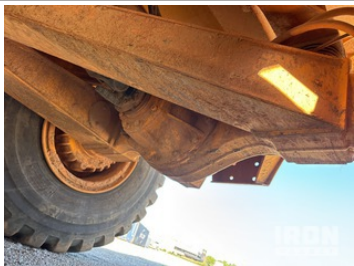
| Item | Assessment | Photo |
|---|---|---|
| Rear Drive Axle | ★★☆☆ | |

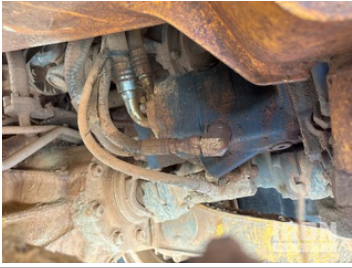
| Item | Assessment | Photo |
|---|---|---|
| Pumps (Hydraulics) | ★★★☆☆ | |

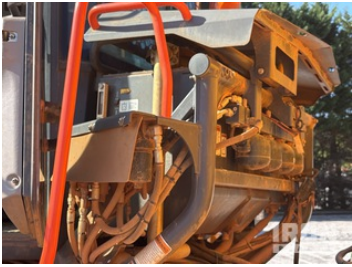
| Item | Assessment | Photo |
|---|---|---|
| Hydraulic Tank | ★★★☆☆ | |
