## Item #15746349 - 2022 Cat 150 Motor Grader

# Inspection Report

# 2022 CAT 150

UNIT: EB400550

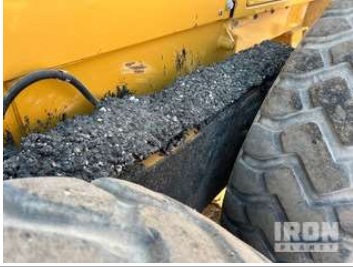
| Paint | Asphalt residue, Damage | |

| Cab Doors: Left side door seal damaged | \$300 | Paint: Asphalt residue, Damage | \$7,000 |

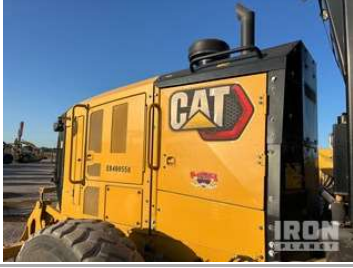
| Body Panels | No visible damage or missing components | |

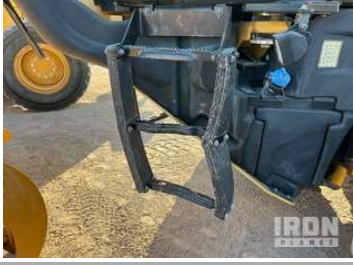
| Steps | Left cab damaged, Right cab bent | |

| Steps: Left cab damaged, Right cab bent | \$600 | Exterior Lights: 8 Inoperable / damaged / missing | \$2,400 |

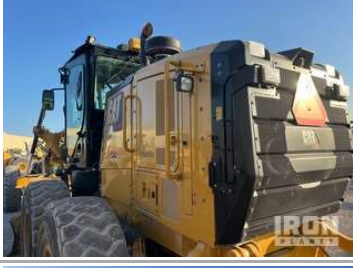
| Hand Rails | No visible damage or missing components | |

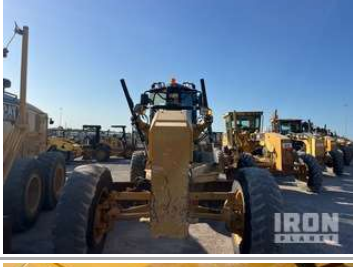
| Exterior Lights | 8 Inoperable / damaged / missing | |

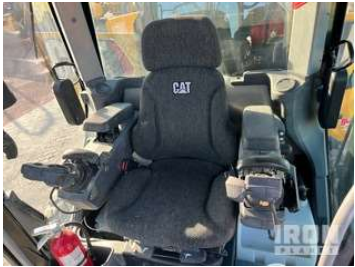
| Seat/Armrests | No visible damage or missing components | |

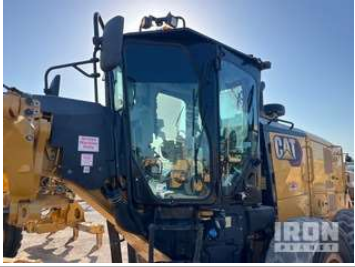
| Glass | No visible damage or missing components | |

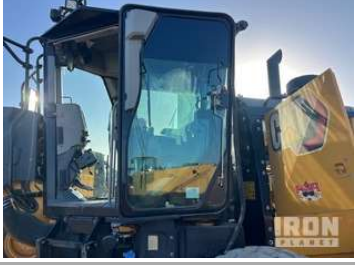
| Cab Doors | Left side door seal damaged | |

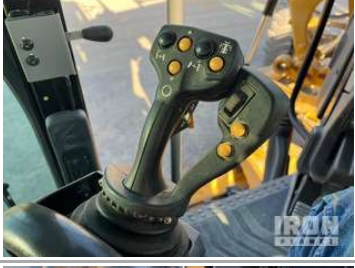
| Steering Controls | ★★★★☆ | |

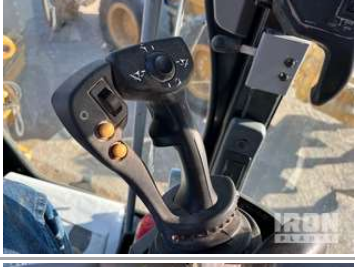
| Hydraulic Controls | ★★★★☆ | |

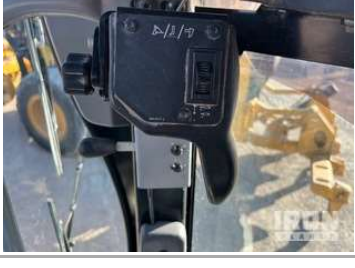
| Auxiliary Hydraulic Control | ★★★★☆ | |

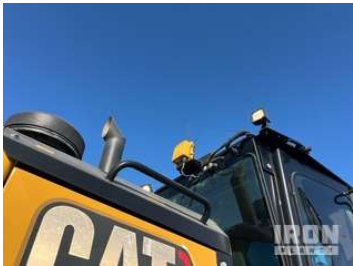
| Grade Control Antenna | Grade control Antenna intact | |

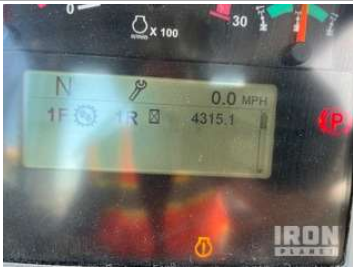
| Hour Meter / Odometer | 4315 hrs | |

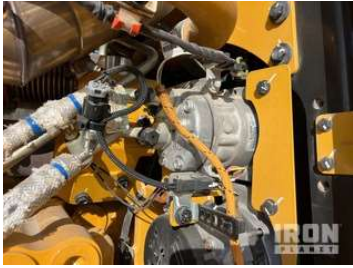
| Engine | | |
|---|---|---|
| A/C Compressor | Operational | |

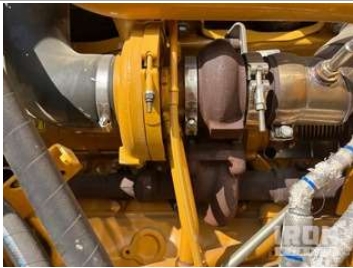
| Engine | | |
|---|---|---|
| Exhaust System | No visible damage or missing components | |

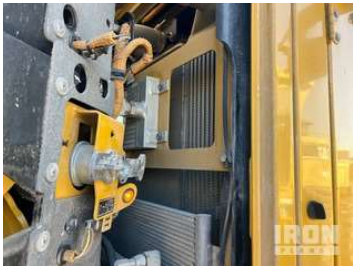
| Engine | | |
|---|---|---|
| Radiator | ★★★★☆ | |

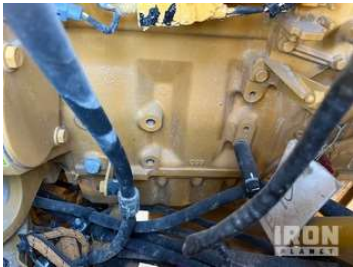
| Engine | | |
|---|---|---|
| Oil Leaks | No dripping leaks | |

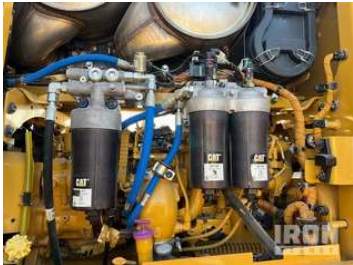
| Fuel Leaks | No dripping leaks | |

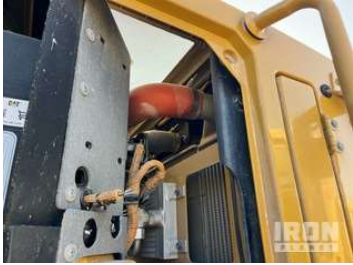
| Cooling System Leaks | No dripping leaks | |

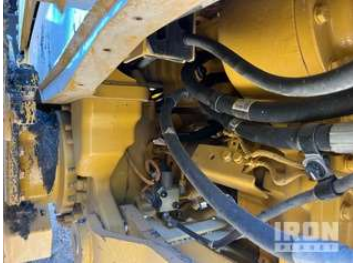
| Item | Assessment | Photo |
|---|---|---|
| Transmission | ★★★★☆<br>Operational | |

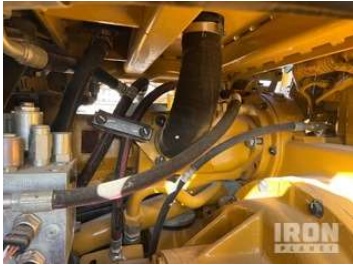
| Item | Assessment | Photo |
|---|---|---|
| Pumps (Hydraulics) | ★★★★☆ | |

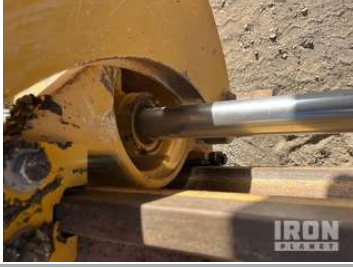
| Blade Side Shift Cylinders | ★★★★☆ | |

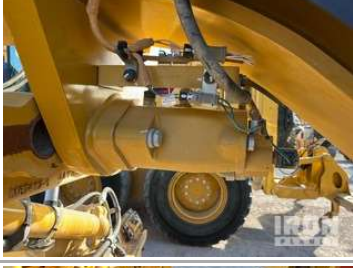
| Saddle Lock Pin | ★★★★☆ | |

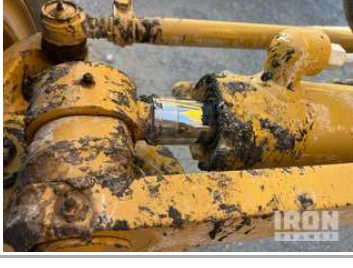
| Wheel Lean Cylinders | ★★★★☆ | |

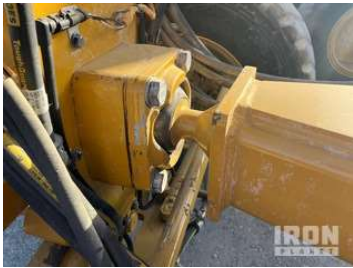
| Item | Assessment | Photo |
|---|---|---|
| Y-frame Pivot Trunnion | ★★★★☆<br>Shims remaining | |

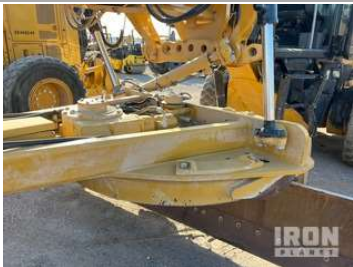
| Item | Assessment | Photo |
|---|---|---|
| Blade Tilt Frame (saddle) | ★★★★☆ | |

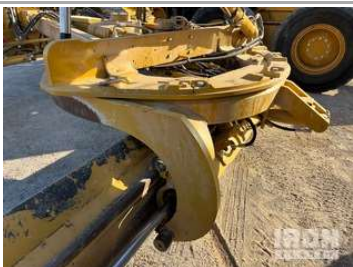
| Item | Assessment | Photo |
|---|---|---|
| Circle Frame and Brackets | ★★★★☆ | |

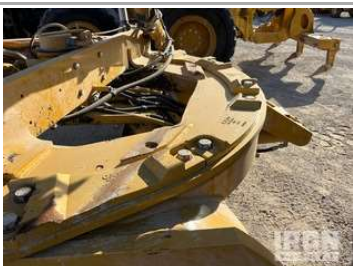
| Item | Assessment | Photo |
|---|---|---|
| Circle Wear Strips | ★★★★☆ | |

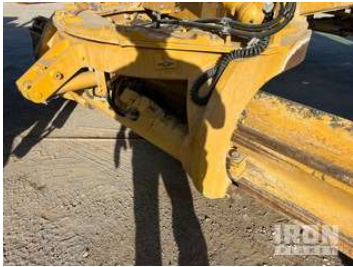
| Circle Support Brackets | ★★★★☆ | |

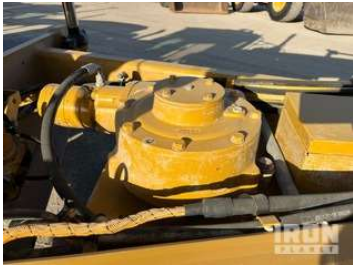
| Circle Gear Box | ★★★★☆ | |

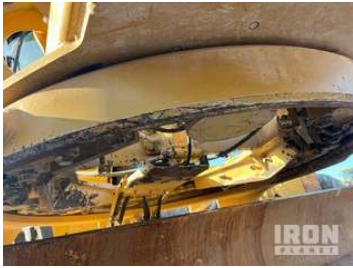
| Circle Gear | ★★★★☆ | |

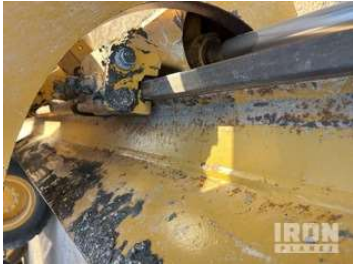
| Mold Board Slide Wear Strips | ★★★★☆ | |

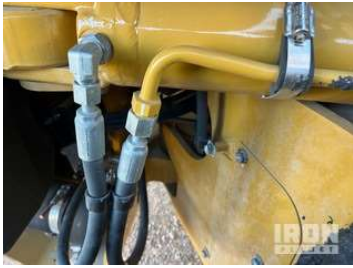
| Articulating Center Pins | ★★★★☆ | |

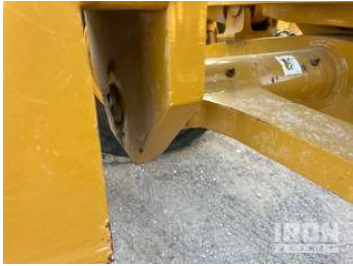
| Front Axle Oscillating Pin | ★★★★☆ | |

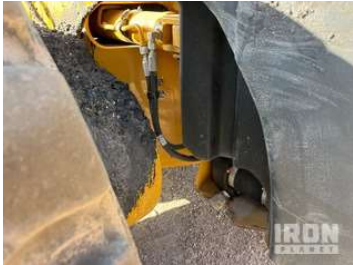
| Frame Condition | ★★★★☆ | |

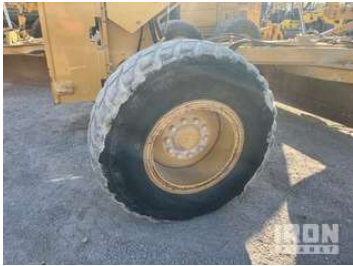
| Left Front Tire | Size: 17.5R25 Brand: Bridgestone Model: K Traction Tread Depth: 16/32 | |

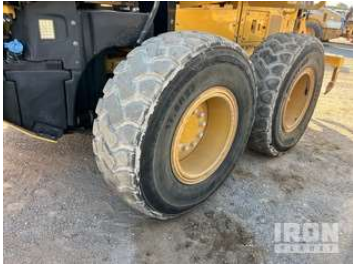
| Left Middle Tire | Size: 17.5R25 Brand: West Lake Model: WR03 Tread Depth: 18/32 | |

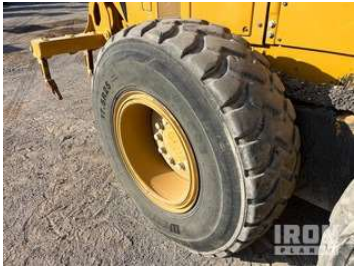
| Right Rear Tire | Size: 17.5R25 Brand: West Lake Model: WR03 Tread Depth: 17/32 | |

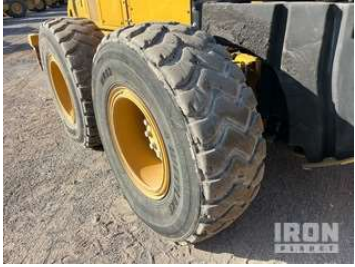
| Right Middle Tire | Size: 17.5R25 Brand: West Lake Model: WR03 Tread Depth: 17 /32 | |

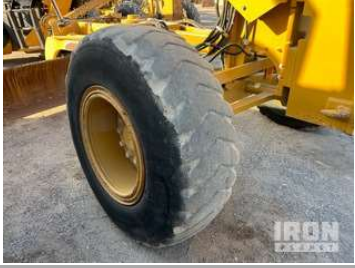
| Right Front Tire | Size: 17.5R25 Brand: Bridgestone Model: K Traction Tread Depth: 8/32 | |

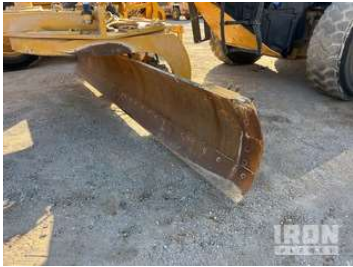
| Specialty | | |
|---|---|---|
| Blade Condition | ★★★★☆ | |

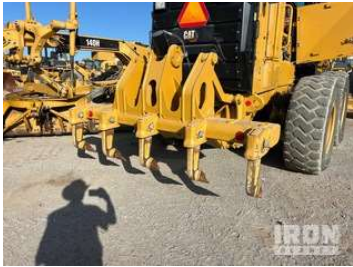
| Specialty | | |
|---|---|---|
| Rear Combination Ripper Scarifier | ★★★★☆ | |
