Item #15092790 - 2019 Hyundai HD 160D-9 36000 lb Forklift

Inspection Report

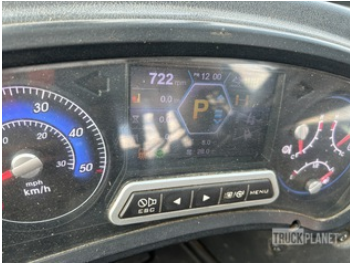
<p>Hour Meter</p>	<p>0 hrs, Inoperable hour meter</p>

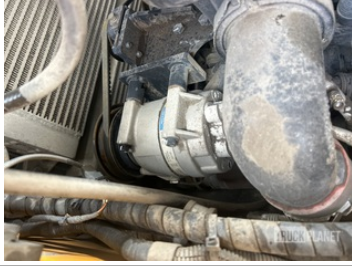
A/C Compressor	In place; ambient temperature too cold to check operation

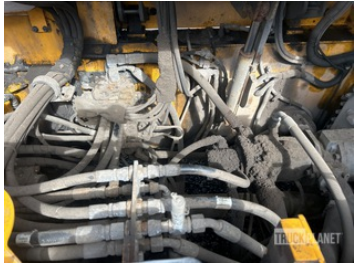
Hoses (Hydraulics)	★ ★ ☆ ☆ Right side shift hose broken

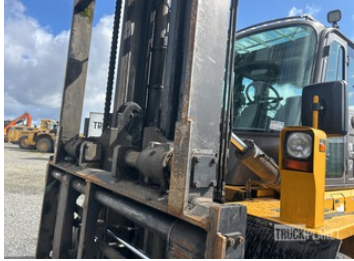
Chassis		
IronPlanet pin connection pivot point wear inspections are limited to sound, sight and feel observations. Dial indicator testing is not performed.		
Item	Assessment	Photo
Mast/Boom Condition	★★☆☆ Heavy wear

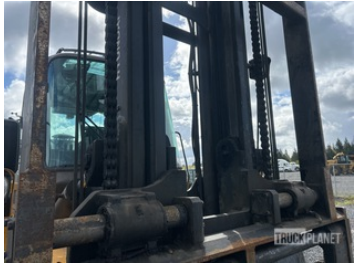
Chain / Tensioners	★★☆☆ Heavy wear

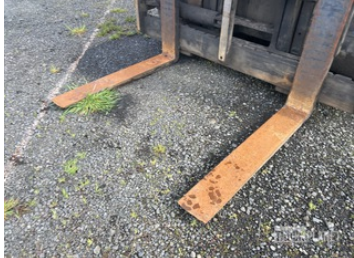
Forks	★★☆☆ Broken tip
