Item #12781137 - 2023 Astec Ranger i32 Tracked Impact Crusher Plant

Inspection Report

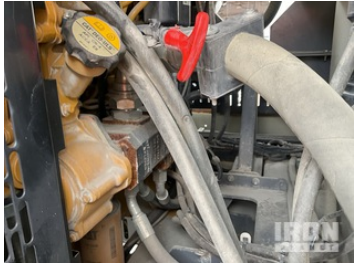
<h2>Hydraulics</h2>		
See photos for condition		
Item	Assessment	Photo
Hydraulics #18		
Pumps (Hydraulics)	★★★★☆

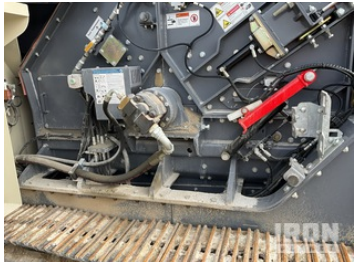
Hydraulic Motors	★★★★☆

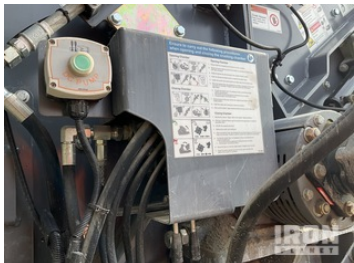
Valves	★★★★☆

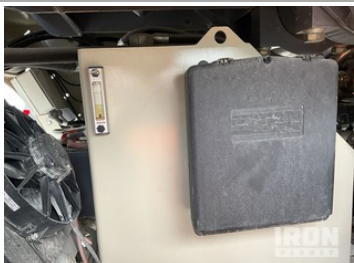
Hydraulic Tank	★★★★☆

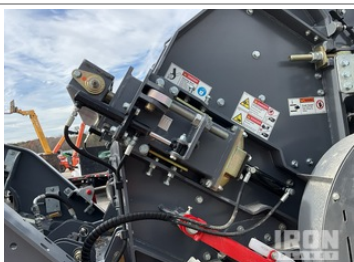
Crusher Door Cylinders	★★★★☆

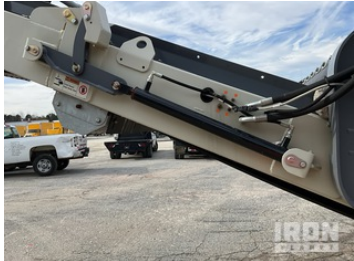
Conveyor Cylinders	★★★★☆

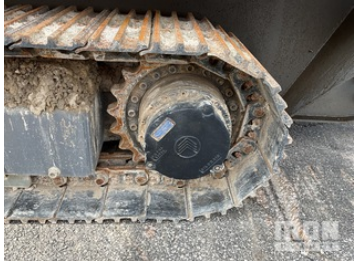
Power Travel Drive System	★★★★☆ 1 Travel Speed

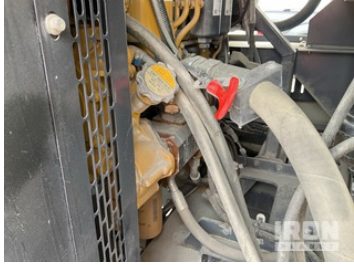
Radiator	★★★☆☆	 
Oil Leaks	No dripping leaks

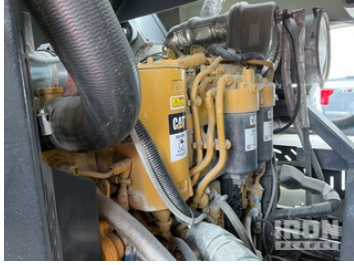
Fuel Leaks	No dripping leaks

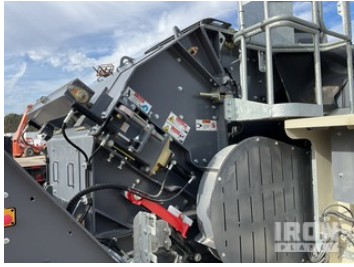
Chassis		
Item	Assessment	Photo
Crusher Base Frame	★★★★☆

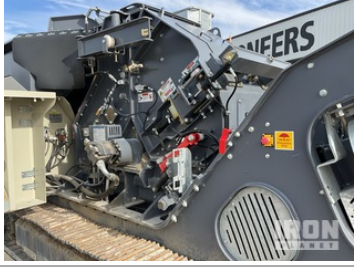
Crusher Chamber Frame	★★★★☆

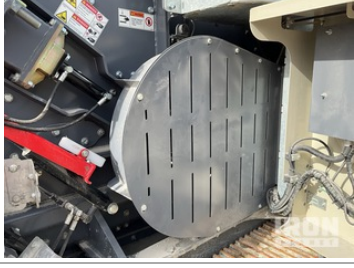
Crusher Drive System	★★★★☆

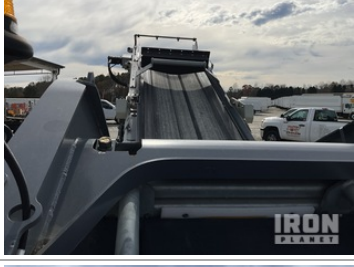
Discharge Conveyor Condition	★★★★☆

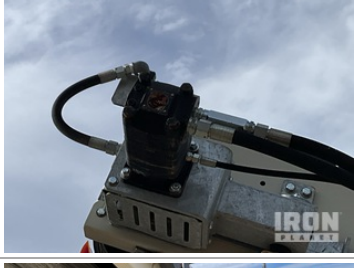
Discharge Conveyor Drive Motor	★★★★☆ Operational

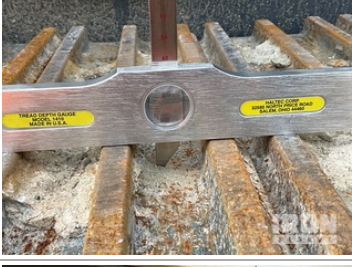
Left Grouser Height	19 mm

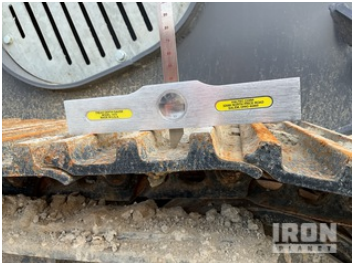
Right Grouser Height	19 mm

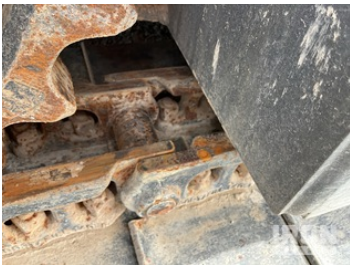
Right Track Bushings	Bushings have not been turned
