## Item #14159141 - 2019 Volvo A25G Articulated Dump Truck

- Features: Air Conditioner, Rear View Camera, 2018 US EPA Label, Requires Diesel Exhaust Fluid, Steel Body Liner
- Meter Reading: 5,608 Hours
- Serial #: VCE0A25GJ00742299
- Inspection Completed: 4/14/25

# Inspection Report

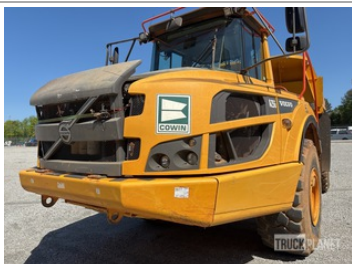
| Item | Assessment | Photo |
|---|---|---|
| Paint | Damage | |

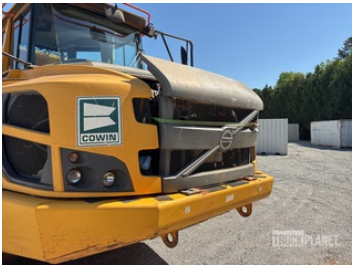
| Body Panels | Grille damaged | |

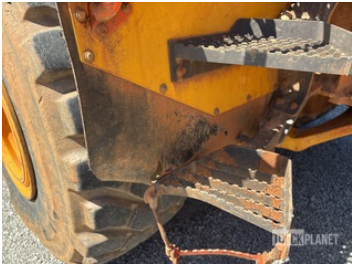
| Mud Flaps | Left damaged | |

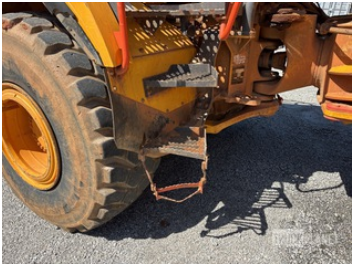
| Steps | Left cab steps bent, Right cab steps bent | |

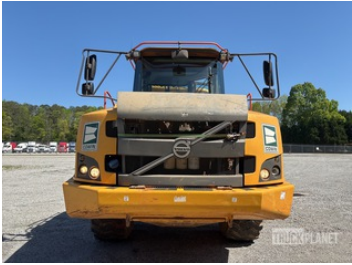
| Exterior Lights | 2 Inoperable / damaged / missing | |

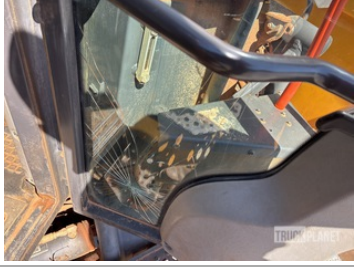
| Item | Assessment | Photo |
|---|---|---|
| Glass | Cab door cracked | |

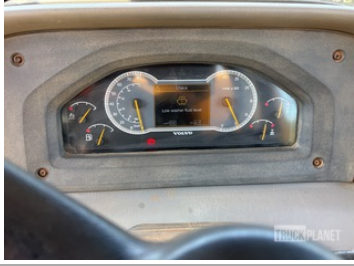
| Engine Oil Pressure | The fault indicator shuts off after the engine oil pressure rises. | |

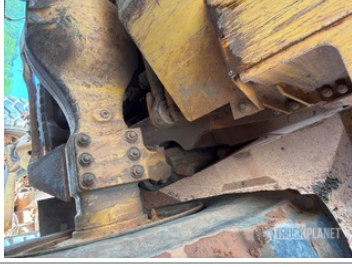
| Item | Assessment | Photo |
|---|---|---|
| Suspension Cylinders | ★★★★☆<br>Not visible | |

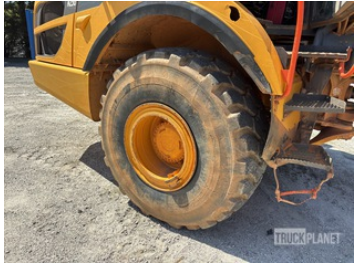
| Left Front Tire | ★★★★☆<br>Michelin XADN+ 23.5R25 29/32" Tread Depth Has cuts in the side wall | A close-up photograph of the left front tire of a yellow machine. The tire is a Michelin XADN+ 23.5R25 29/32" model. It shows significant wear, including cuts in the side wall and a visible tread pattern. |

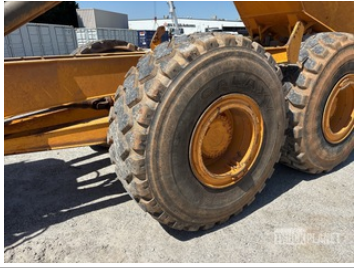
| Left Middle Tire | ★★★★☆<br>Galaxy LDSR 300 23.5R25 29/32" Tread Depth Has cuts in the side wall, tread has missing chunks | A photograph showing the left middle tire of a yellow machine. The tire is a Galaxy LDSR 300 23.5R25 29/32" model. It shows significant wear, including cuts in the side wall and missing chunks of tread. |

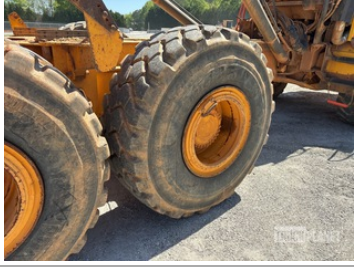
| Right Middle Tire | ★★★★☆<br>Michelin XADN+ 23.5R25 31/32" Tread Depth Has a repair patch | A photograph showing the right middle tire of a yellow machine. The tire is a Michelin XADN+ 23.5R25 31/32" model. It shows significant wear, including cuts in the side wall and a visible tread pattern. |
