## Item #12781133 - 2023 Screen Machine 107T Tracked Screen Plant

# Inspection Report

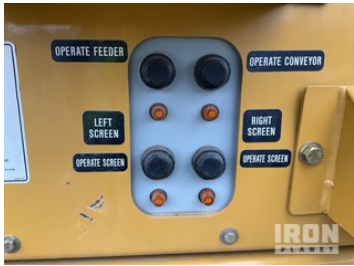
Crusher/Screen Controls	☆☆☆☆

Limited Function Check	The main components are in place and operational as noted. Control panel is loose

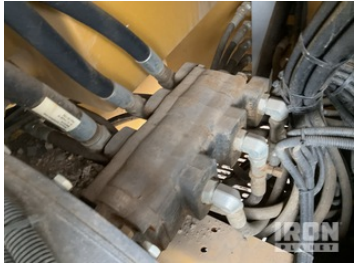
Hydraulics		
See photos for condition		
Item	Assessment	Photo
Pumps (Hydraulics)	★★★★☆

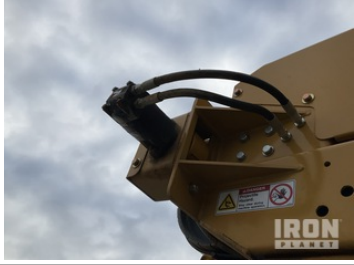
Hydraulic Motors	★★★★☆

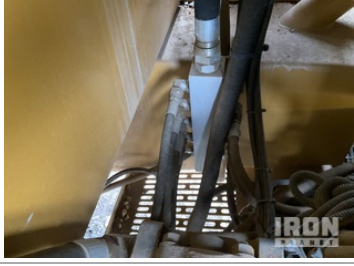
Valves	★★★★☆

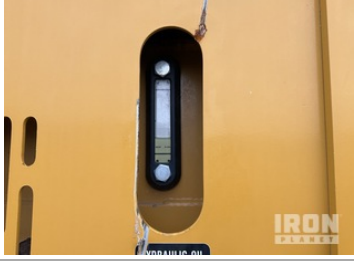
Hydraulic Tank	★★★★☆

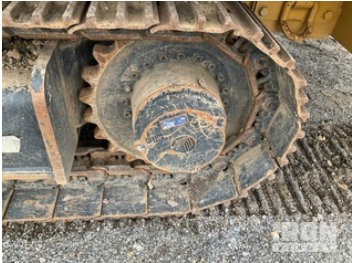
Power Travel Drive System	★★★★☆ 1 Travel Speed, Travels properly

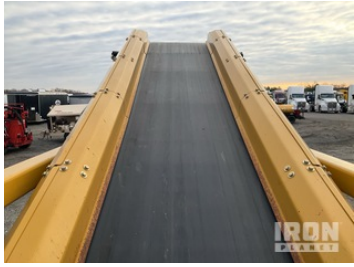
<b>Chassis</b>		
<b>Item</b>	<b>Assessment</b>	<b>Photo</b>
Discharge Conveyor Condition	★★★★☆

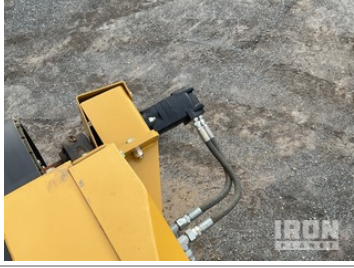
Discharge Conveyor Drive Motor	★★★★☆ Operational

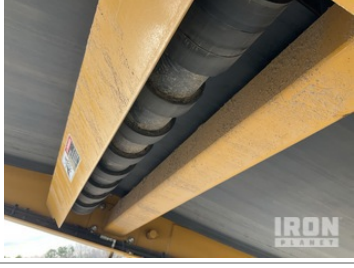
Discharge Conveyor Rollers	★★★★☆

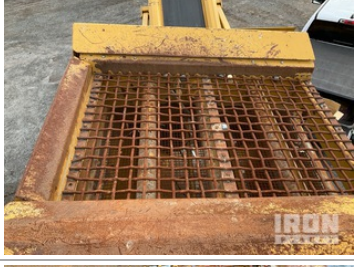
Screen Deck	★★★★☆ Incline screen, Number of decks: 2

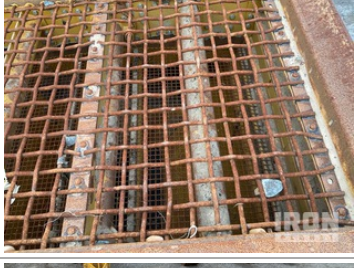
Deck Frames / Wear Bars	★★★★☆

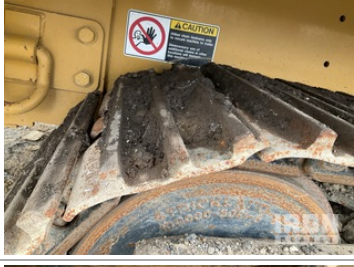
Left Grouser Height	18 mm

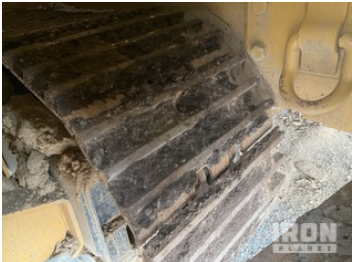
Right Grouser Height	18 mm
