Item #7251498 - 2014 Apache AS720 90 ft 4x2 High Clearance Self-Propelled Sprayer

Inspection Report

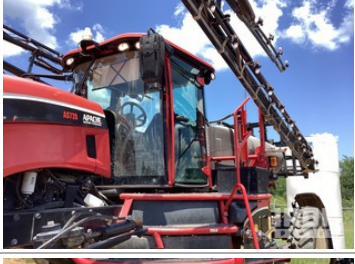
<p>Exterior Lights</p>	<p>Some not operational, headlights fault code lights are not operational</p>

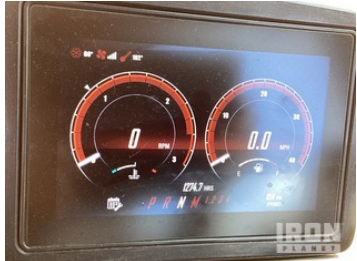
Warning Lights	Operational, head light fault when on light stays on

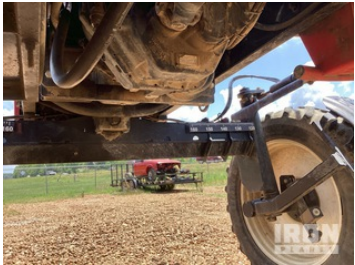
Front Drive Axle	★★☆☆ Axle track width slides worn out will not slide or retract non driven axle is 4x2. Center pivot pin bushing wear.

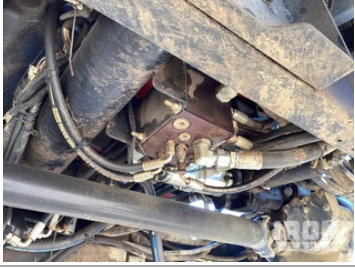
Valves	★★★★☆ Dripping leak, From hose fittings

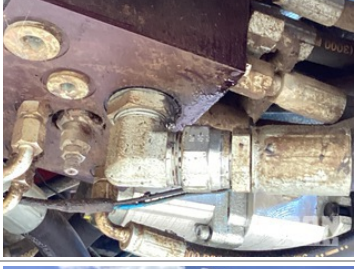
Hoses	Minor leaking

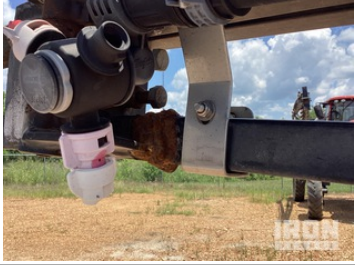
Chassis		
IronPlanet pin connection pivot point wear inspections are limited to sound, sight and feel observations. Dial indicator testing is not performed.		
Item	Assessment	Photo
Booms and Boom Tree	★★☆☆ Boom tips welding repair and cracking evident
