### Item #15307646 - 2024 Komatsu PC210LC-11 Tracked Excavator

- Features: Air Conditioner, 2023 US EPA Label, 10 ft Stick, Auxiliary Hydraulic Plumbing, 48 in Digging Bucket
- Meter Reading: 1,447 Hours
- Serial # : KMTPC257LPTC82469
- Inspection Completed: 7/8/26

# Inspection Report

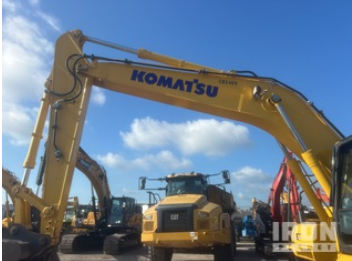
Paint	I just chipped and scratched all over

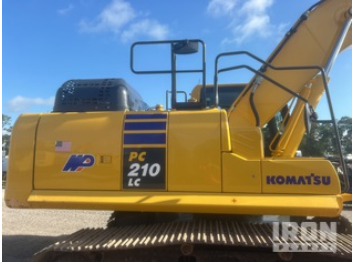
Body Panels	Left rear door damaged

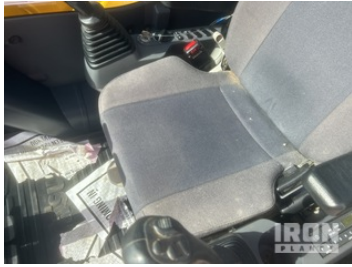
<b>Control Station</b>		
<b>Item</b>	<b>Assessment</b>	<b>Photo</b>
Seat/Armrests	Has a switch pulled out of the back of the seat

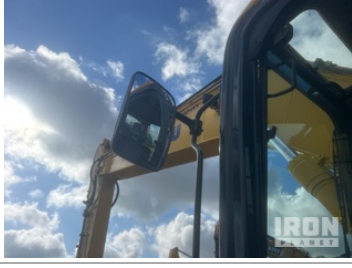
Mirrors	Mirror on the right side front damaged

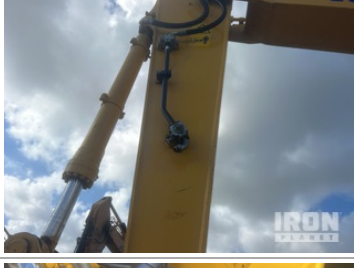
Auxiliary Hydraulic Plumbing	Not operationally checked, End of stick, No fittings and not capped off

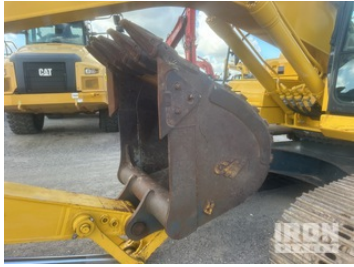
Specialty		
Item	Assessment	Photo
Excavator Bucket Condition	★★☆☆ Bent on the bottom
