## Item #15396135 - 2024 Tigercat 620H 4x4 Skidder

# Inspection Report

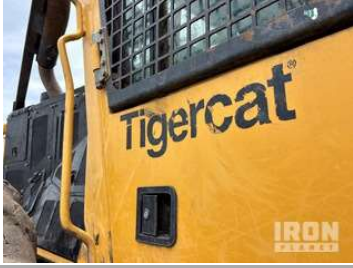
| Exterior Lights | Some not operational, Rear lights lights are not operational | |

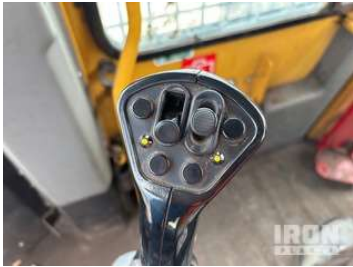
| Drivetrain Controls | <p>★★☆☆</p> <p>Loose switch</p> | |

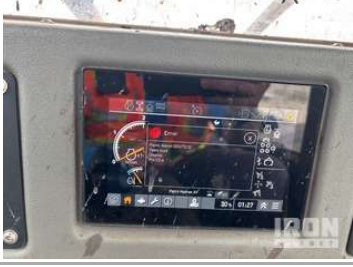
| Warning Lights | <p>Operational, Multiple alarms on the screen light stays on</p> | |

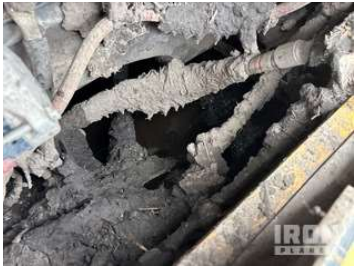
| Oil Leaks | Cannot verify oil leaks, engine bay is full of water | |

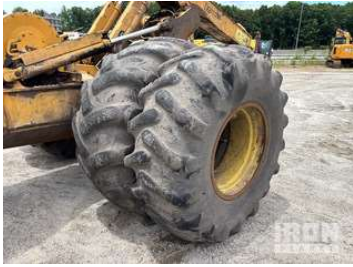
| Item | Assessment | Photo |
|---|---|---|
| Left Rear Tire | All tires have damage | |

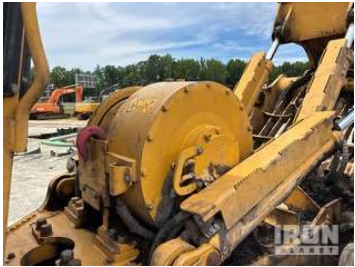
| Specialty | | |
|---|---|---|
| Winch | ★★☆☆<br>Not operationally checked | |

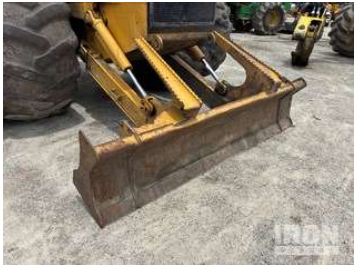
| Specialty | | |
|---|---|---|
| Blade Condition | ★★☆☆<br>Damaged blade | |
