## Item #13748190 - 2021 Volvo EC750EL Tracked Excavator

# Inspection Report

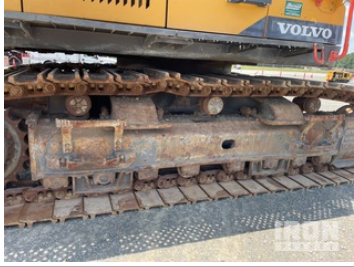
| Paint | Damage | A close-up photograph showing significant rust and paint damage on the lower chassis and track area of the excavator. The metal is heavily corroded, and the original paint is missing in several places. |

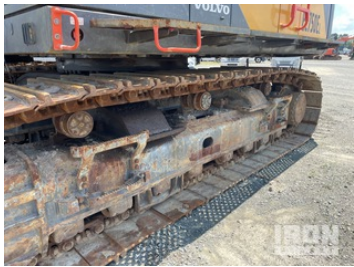
| Steps | No visible damage or missing components | A photograph showing the side profile of the excavator's tracks and lower body. The tracks appear to be in good condition, and there is no visible damage to the body panels or steps. |

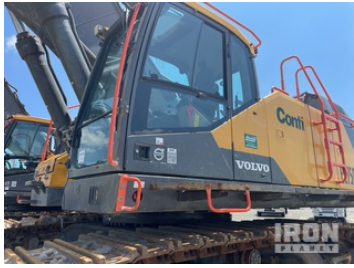
| Hand Rails | No visible damage or missing components | A photograph of the excavator's cab and upper body. Red hand rails are visible on the side of the cab, and they appear to be in good condition with no visible damage. |

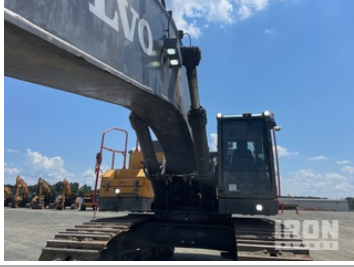
| Exterior Lights | All lights operational | A photograph of the excavator from a front-three-quarter view. The headlights and other exterior lights are visible and appear to be operational. |

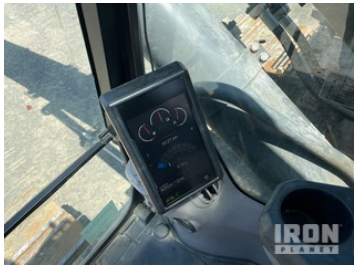
| Engine Oil Pressure | The fault indicator shuts off after the engine oil pressure rises. | |

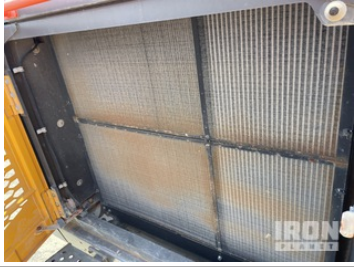
| Engine | | |
|---|---|---|
| Radiator | ★★★★☆ | |

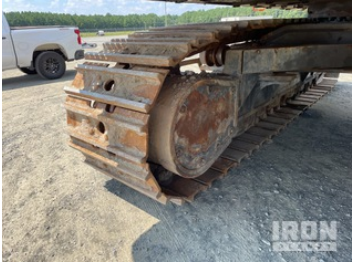
| Item | Assessment | Photo |
|---|---|---|
| Left Drive Motor | ★★★★☆ | A photograph showing the left drive motor of a tracked vehicle, which is a large, cylindrical component with a rusty, weathered appearance. It is mounted on a metal frame, and the surrounding area is a gravel lot. A white pickup truck is partially visible in the background. |

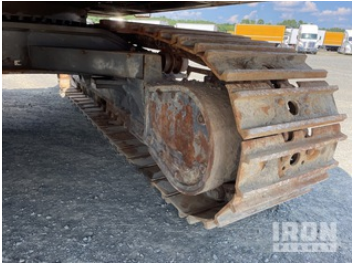
| Item | Assessment | Photo |
|---|---|---|
| Right Drive Motor | ★★★★☆ | A photograph showing the right drive motor of a tracked vehicle, similar to the left one, with a rusty, weathered appearance. It is mounted on a metal frame, and the surrounding area is a gravel lot. A white pickup truck is partially visible in the background. |

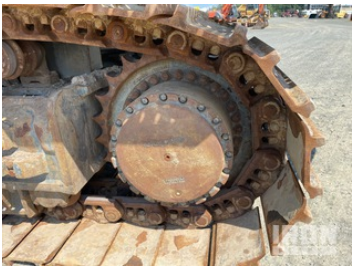
| Item | Assessment | Photo |
|---|---|---|
| Left Final Drive | ★★★★☆ | A close-up photograph of the left final drive, showing a large, circular gear with a rusty, weathered appearance. It is mounted on a metal frame, and the surrounding area is a gravel lot. |

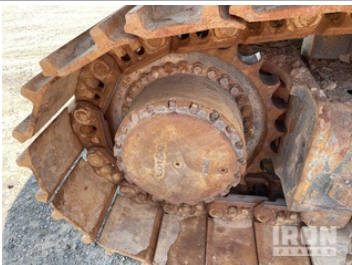
| Item | Assessment | Photo |
|---|---|---|
| Right Final Drive | ★★★★☆ | A close-up photograph of the right final drive, showing a large, circular gear with a rusty, weathered appearance. It is mounted on a metal frame, and the surrounding area is a gravel lot. |

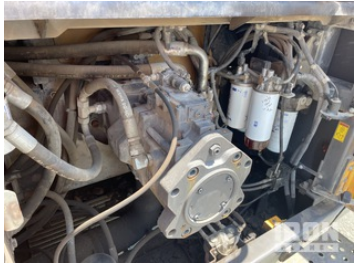
| Item | Assessment | Photo |
|---|---|---|
| Pumps (Hydraulics) | <p>★ ★ ☆ ☆</p> <p>Machine has weak hydraulic functions.<br/>Will not pick itself up.</p> | |

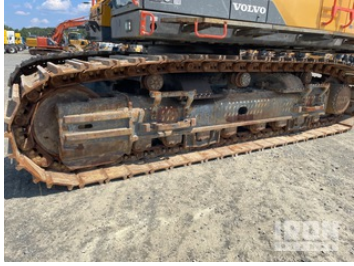
| Item | Assessment | Photo |
|---|---|---|
| Left Roller Frame | ★★★☆☆ | |

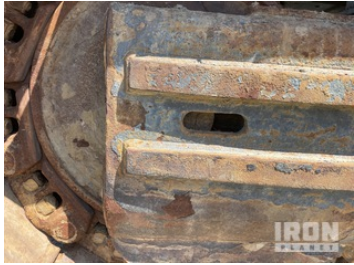
| Item | Assessment | Photo |
|---|---|---|
| Left Track Tensioner | ★★★☆☆ | |

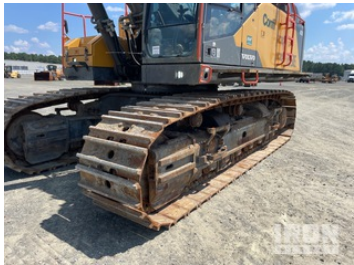
| Item | Assessment | Photo |
|---|---|---|
| Left Track Pads | ★★★☆☆<br>36 in Wide Double Grouser | |

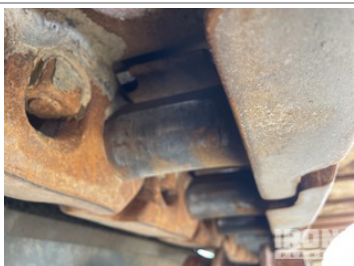
| Item | Assessment | Photo |
|---|---|---|
| Left Track Bushings | 81 mm | |

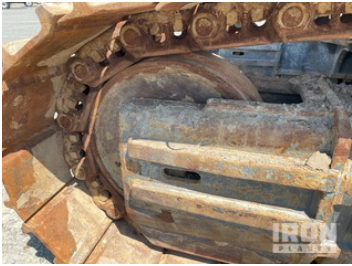
| Left Idler | 29 mm | |

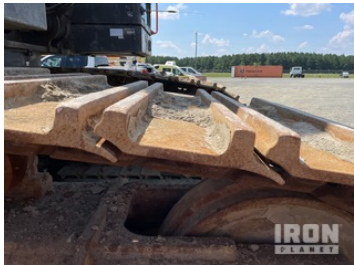
| Right Grouser Height | 47 mm | |

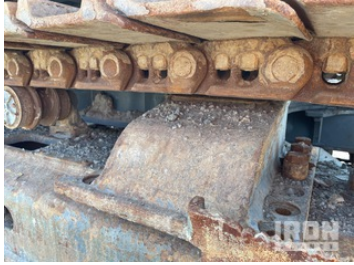
| Right Track Links | 30 mm One link seized | |

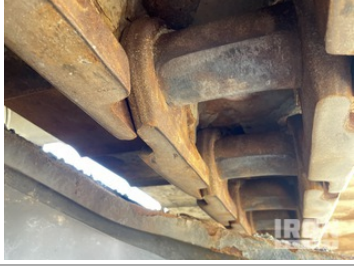
| Right Track Bushings | 84 mm | |

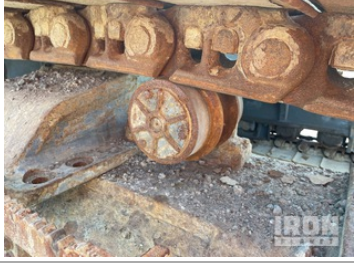
| Right Carrier Rollers | 3 Carrier Rollers #1 196 mm #2 197 mm #3 196 mm | |

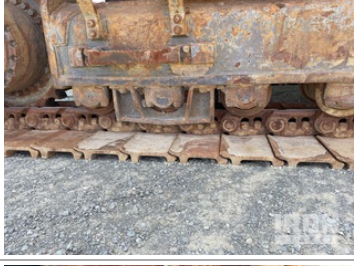
| Right Bottom Rollers | 8 Bottom Rollers: #5 235 mm Can only measure roller 5 | |

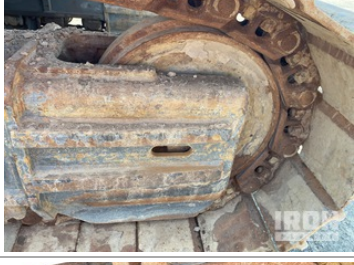
| Right Idler | 25 mm | |
