Item #12781172 - 2023 KPI-JCI FT2650 Tracked Jaw Crushing Plant

Inspection Report

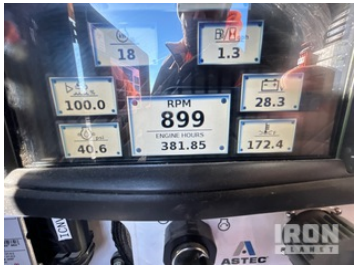
Hour Meter / Odometer	381 hrs

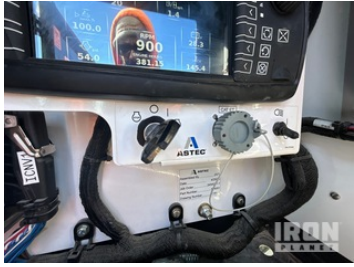
Engine Controls	★★★★☆

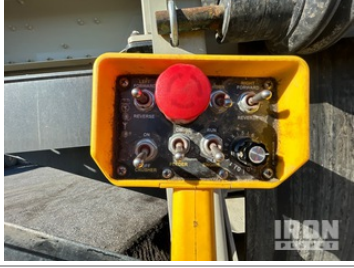
Crusher/Screen Controls	★★★★☆

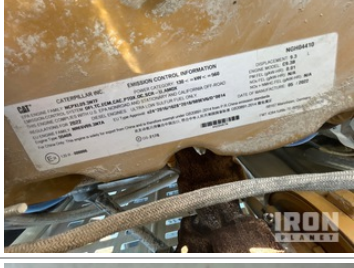
Emission Certification Label	US EPA certification label

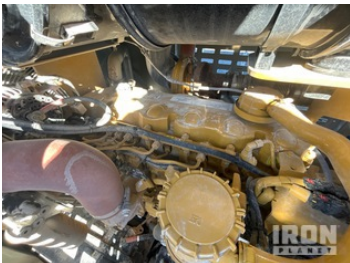
Exhaust System		 
Radiator	★★★★☆	 
Oil Leaks	No dripping leaks

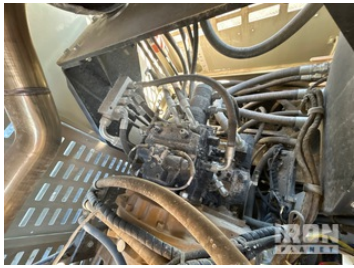
Hydraulics		
See photos for condition		
Item	Assessment	Photo
Pumps (Hydraulics)	★★★★☆

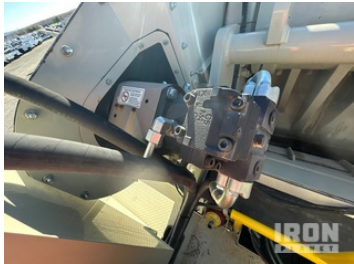
Hydraulic Motors	★★★★☆

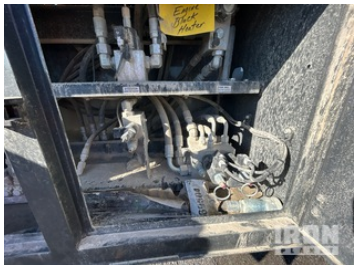
Valves	★★★★☆

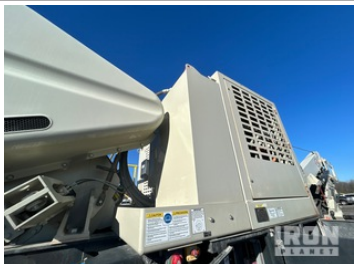
Hydraulic Tank	★★★★☆

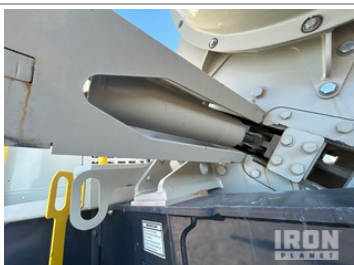
Crusher Door Cylinders	★★★★☆

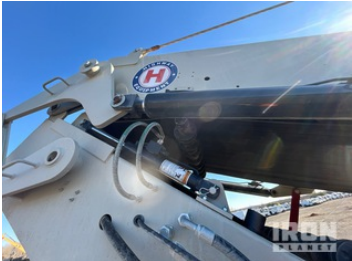
Conveyor Cylinders	★★★★☆

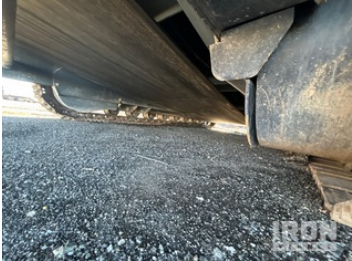
Power Travel Drive System	★★★★☆ 1 Travel Speed, Travels properly

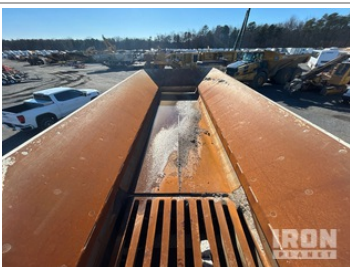
Feed Hopper	★★★★☆ Length @ top: 18 ft 10 in, Width @ top: 7 ft 8 in

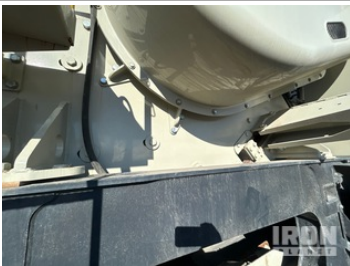
Crusher Base Frame	★★★★☆

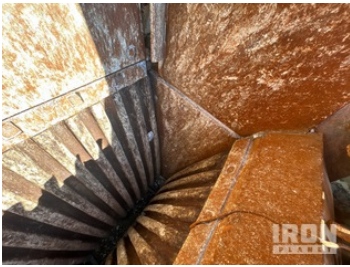
Crusher Chamber Frame	★★★★☆

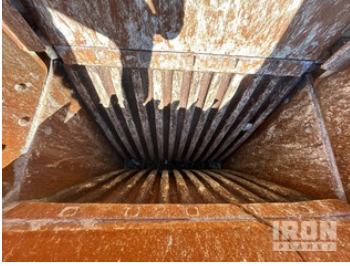
Jaw, Blow Bar and Anvil Wear Surface	★★★★☆

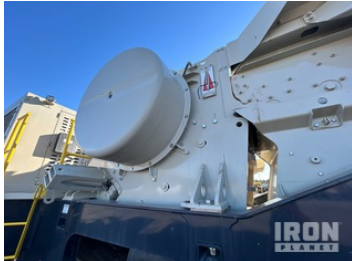
VSI / HSI Crusher Chamber	★★★★☆

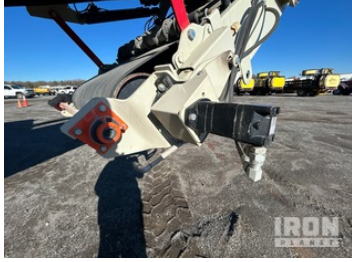
A photograph showing the interior of the discharge conveyor, with a large, curved metal structure and a red conveyor belt. The IronPlanet logo is visible in the bottom right corner.
Discharge Conveyor Drive Motor	Not operationally checked, Unable to test, discharge conveyor bolted for transport

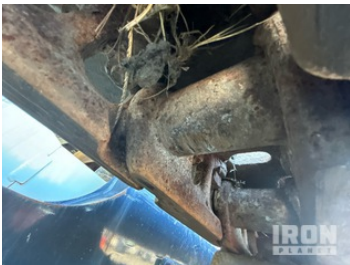
Left Track Bushings	Bushings have not been turned

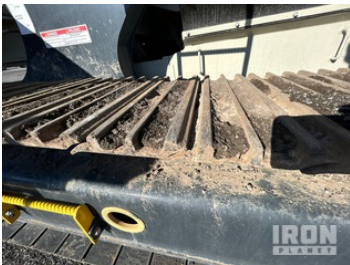
Right Grouser Height	25 mm

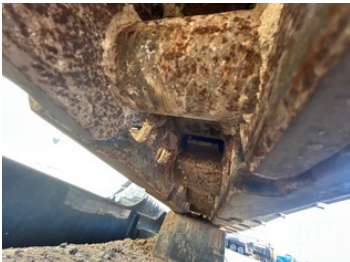
Right Track Bushings	Bushings have not been turned
