## Item #15681455 - 2022 CMI C-175 TwisterII Tracked Mulcher Tractor

- Features: Enclosed Cab, Air Conditioner, Joystick Steering, Rear View Camera, 2022 US EPA Label, Requires Diesel Exhaust Fluid, 22 in Track Belts, Denis Cimaf 6 ft 3 in, Forestry mower, Winch
- Meter Reading: 1,928 Hours
- Serial # : CMI175CUD204504
- Inspection Completed: 8/3/26

# Inspection Report

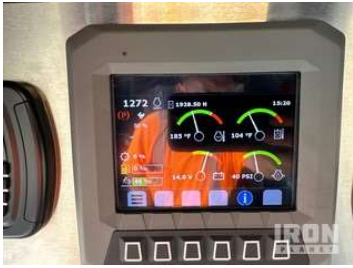
| Engine Oil Pressure | The fault indicator shuts off after the engine oil pressure rises. | |

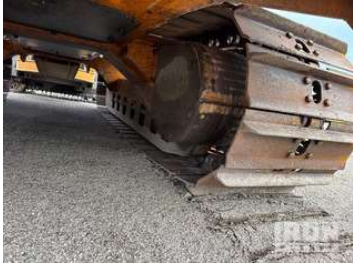
| Item | Assessment | Photo |
|---|---|---|
| Drive Motors | ★★★☆☆ | |

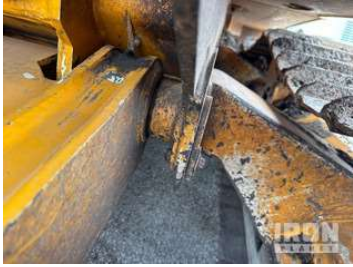
| Item | Assessment | Photo |
|---|---|---|
| Chassis to Arm Pins | ★★★★☆<br>Heavy movement | |

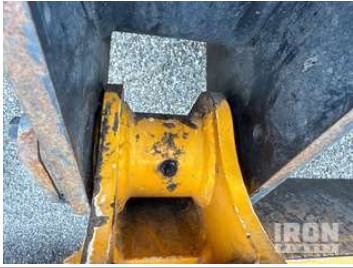
| Item | Assessment | Photo |
|---|---|---|
| Quick Coupler to Arms Pins | ★★★★☆<br>Heavy movement | |

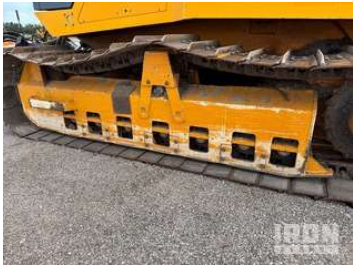
| Item | Assessment | Photo |
|---|---|---|
| Roller Frames | ☆☆☆☆ | |

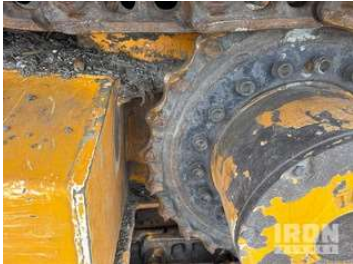
| Item | Assessment | Photo |
|---|---|---|
| Sprockets | Left sprocket has major damage Track bushing have extreme wear | |
