## Item #15943684 - 2023 Tigercat 720G Wheel Feller Buncher

# Inspection Report

# 2023 TIGERCAT 720G

UNIT: 7207692

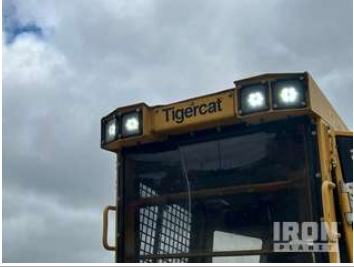
| Exterior Lights | Operational | |

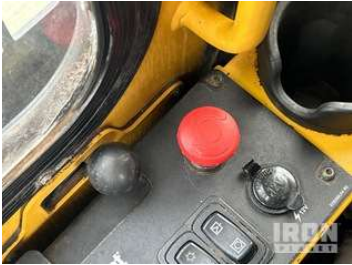
| Safety | | |
|---|---|---|
| Safety Lock Out/Stop | Operational | |

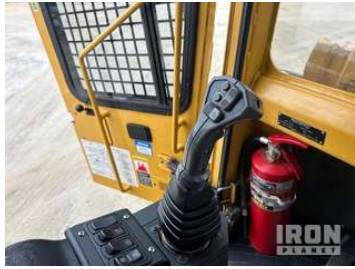
| Steering Controls | ★★★★☆ | |

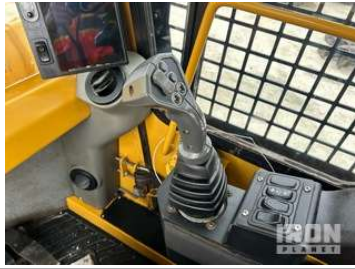
| Auxiliary Hydraulic Control | ★★★★☆ | |

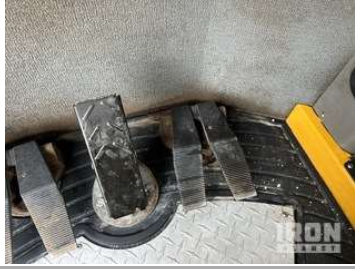
| Drivetrain Controls | ★★★★☆ | |

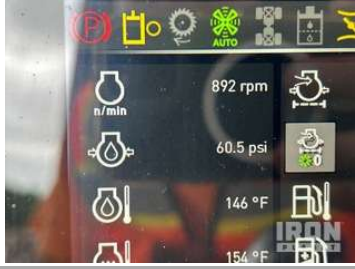
| Engine Oil Pressure | The gauge registers in the operating range. | |

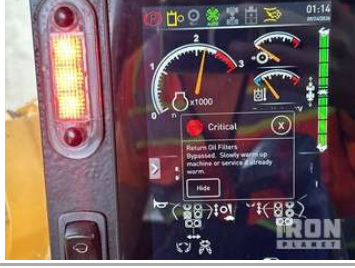
| Warning Lights | Operational, Return oil filters bypassed light stays on | |

| Return oil filters bypassed light on | \$750 | | |

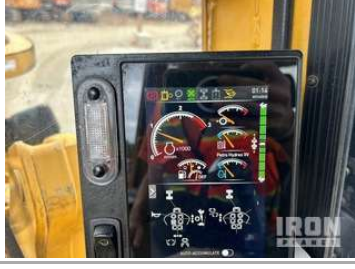
| Gauges | Operational | |

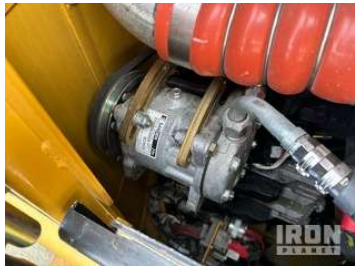
| Engine | | |
|---|---|---|
| A/C Compressor | Operational | |

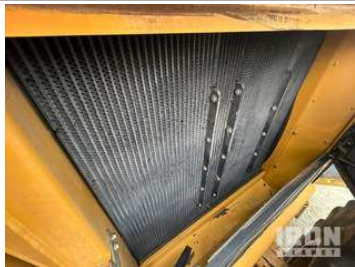
| Engine | | |
|---|---|---|
| Radiator | ★★★★☆ | |

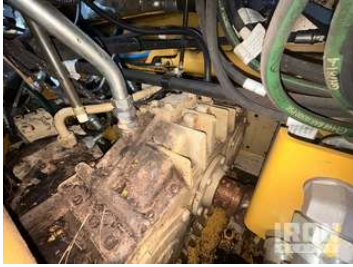
| Drivetrain | | |
|---|---|---|
| Transmission | ★★★★☆<br>Operational | |

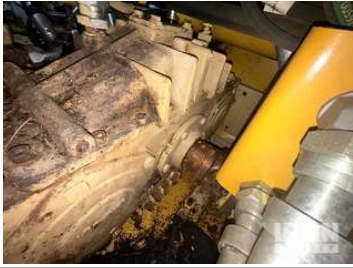
| Drivetrain | | |
|---|---|---|
| Transfer Case / Drop Box | ★★★★☆<br>Operational | |

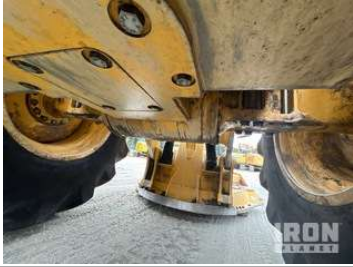
| Drivetrain | | |
|---|---|---|
| Front Drive Axle | ★★★★☆ | |

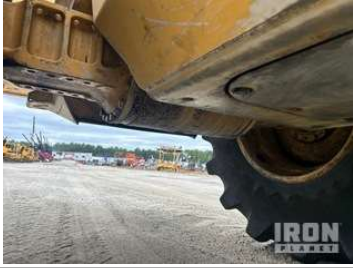
| Drivetrain | | |
|---|---|---|
| Rear Drive Axle | ★★★★☆ | |

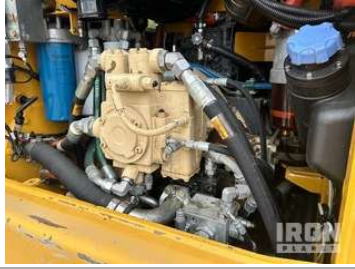
| Hydraulics | | |
|---|---|---|
| Pumps (Hydraulics) | ★★☆☆☆<br>Dripping leak | |

| Rear camera screen - inop | \$1,500 | Hydraulic Pumps - Leak | \$5,500 |

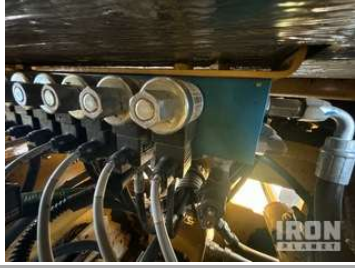
| Hydraulics | | |
|---|---|---|
| Valves | ★★★☆☆ | |

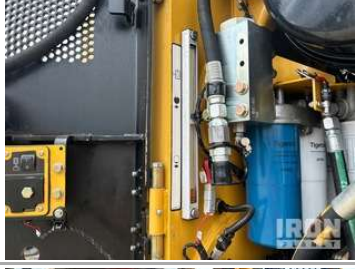
| Hydraulics | | |
|---|---|---|
| Hydraulic Tank | ★★★☆☆ | |

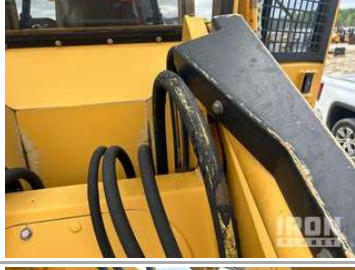
| Hydraulics | | |
|---|---|---|
| Hoses (Hydraulics) | ★★☆☆☆<br>Damaged hose. | |

| Hydraulic Hose - Damaged | \$1,000 | Horn - Inop | \$200 |

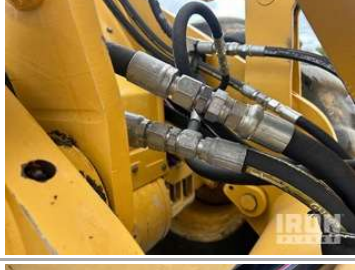
| Hydraulics | | |
|---|---|---|
| Auxiliary Hydraulic Plumbing | Operational | |

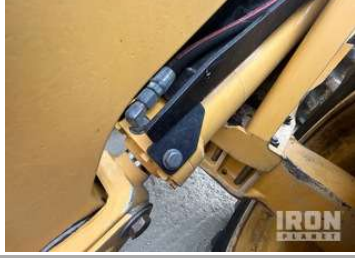
| Hydraulics | | |
|---|---|---|
| Boom Lift Cylinder(s) | ★★★☆☆ | |

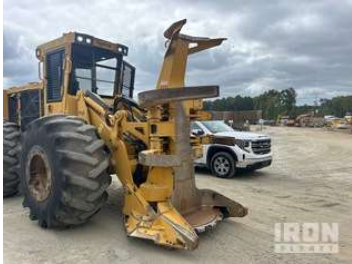
| Item | Assessment | Photo |
|---|---|---|
| Bunching Head Frame | ★★★★☆ | |

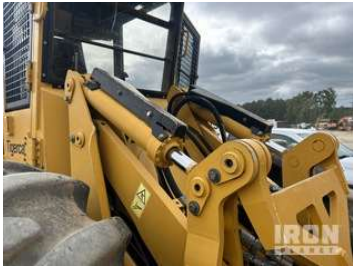
| Tilt Cylinders | ★★★★☆ | |

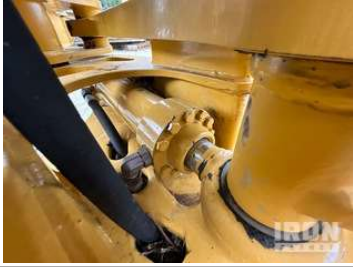
| Arm Cylinders | ★★★★☆ | |

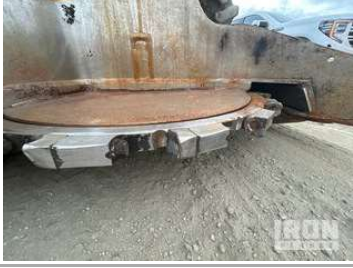
| Cutting Blade | ★★★★☆ | |

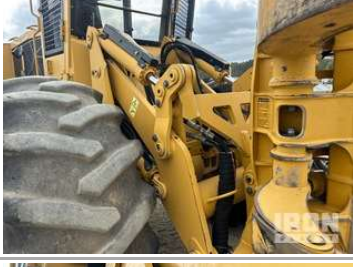
| Boom Condition | ★★★★☆ | |

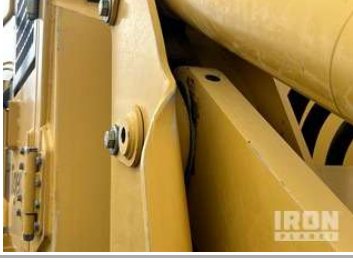
| Boom Base Pin and Bushings | ★★★★☆ | |

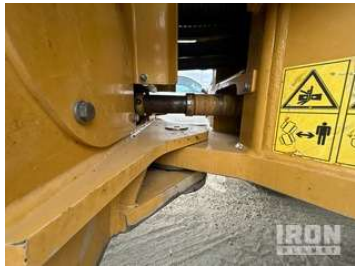
| Articulating Center Pins | ★★★★☆ | |

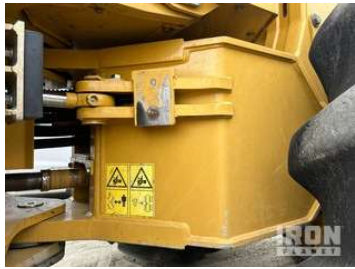
| Frame Condition | ★★★★☆ | |
