## Item #12984395 - 2021 Hamm H10i Smooth Drum Compactor

## Inspection Report

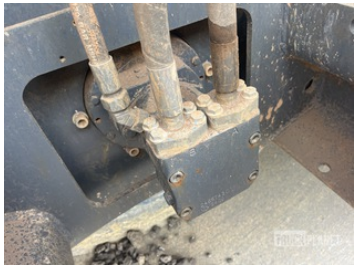
| Drum Vibration Motors | ★★★★☆ | |

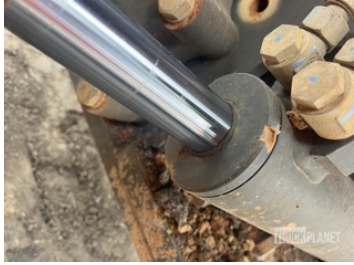
| Steering Cylinders | ★★★★☆ | |

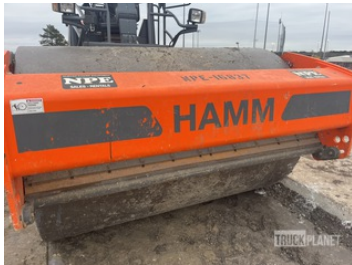
| Paint | Limestone residue, Damage | |

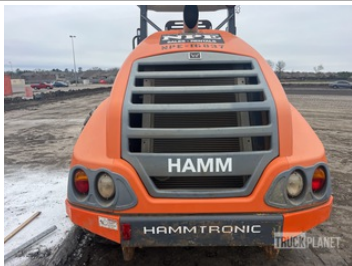
| Body Panels | No visible damage or missing components | |

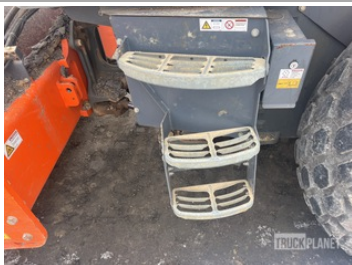
| Steps | No visible damage or missing components. | |

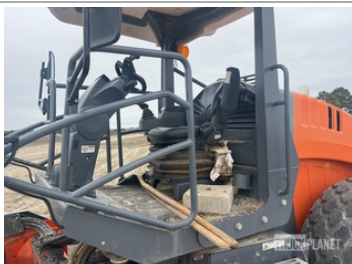
| Hand Rails | No visible damage or missing components | |

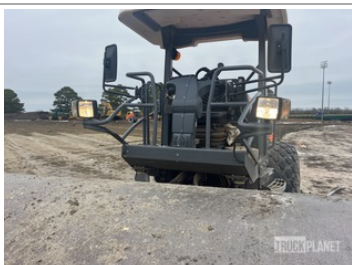
| Exterior Lights | 1 Inoperable / damaged / missing | |

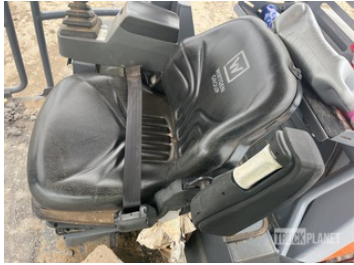
| Control Station | | |
|---|---|---|
| Seat/Armrests | No visible damage or missing components | |

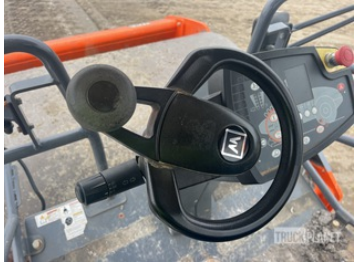
| Control Station | | |
|---|---|---|
| Steering Controls | ★★★★☆ | |

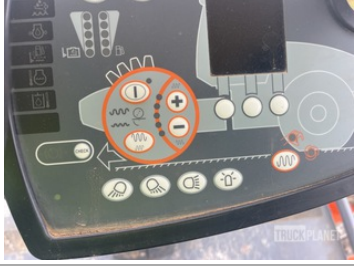
| Control Station | | |
|---|---|---|
| Hydraulic Controls | ★★★★☆ | |

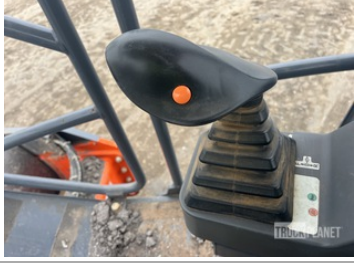
| Control Station | | |
|---|---|---|
| Drivetrain Controls | ★★★★☆ | |

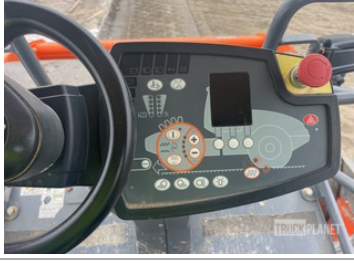
| Control Station | | |
|---|---|---|
| Dash Console | ★★★★☆ | |

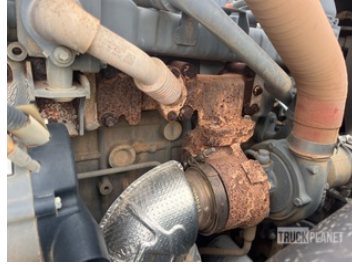
| Engine | | |
|---|---|---|
| Exhaust System | No visible damage or missing components | |

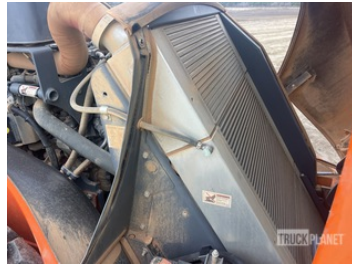
| Engine | | |
|---|---|---|
| Radiator | ★★★★☆ | |

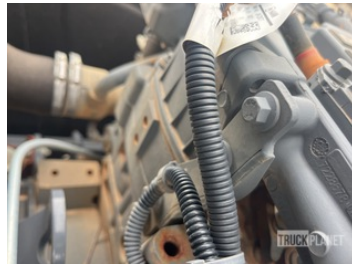
| Engine | | |
|---|---|---|
| Oil Leaks | No dripping leaks | |

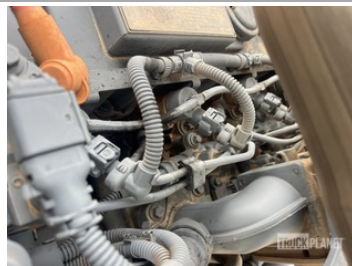
| Engine | | |
|---|---|---|
| Fuel Leaks | No dripping leaks | |

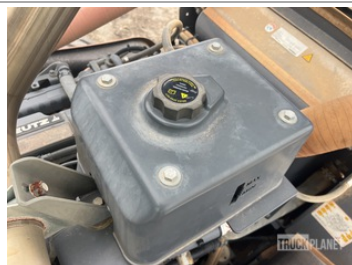
| Engine | | |
|---|---|---|
| Cooling System Leaks | No dripping leaks | |

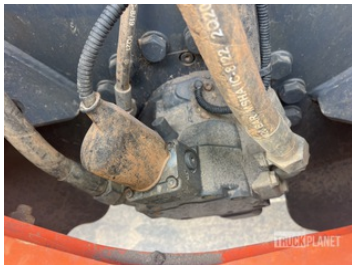
| Item | Assessment | Photo |
|---|---|---|
| Right Front Drive Motor | ★★★★☆ | |

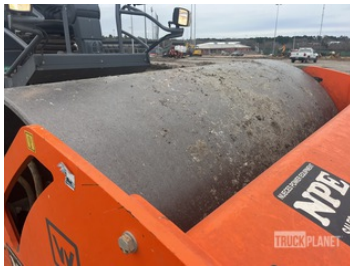
| Item | Assessment | Photo |
|---|---|---|
| Drum Condition | ★★★★☆ | |

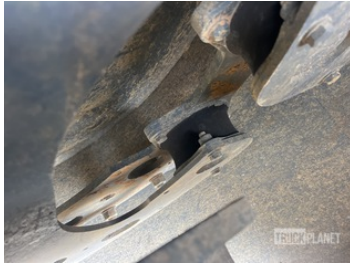
| Item | Assessment | Photo |
|---|---|---|
| Rubber Drum Isolators | ★★★★☆ | |

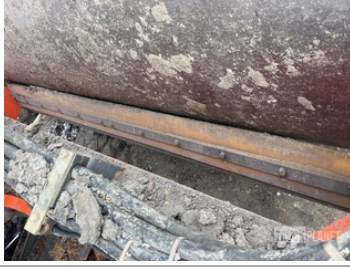
| Item | Assessment | Photo |
|---|---|---|
| Drum Scraper | ★★★★☆ | |

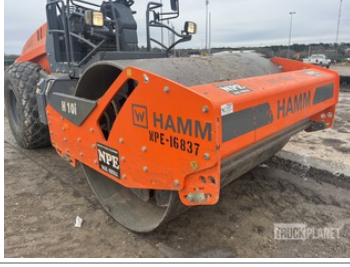
| Item | Assessment | Photo |
|---|---|---|
| Frame Condition | ★★★★☆ | |

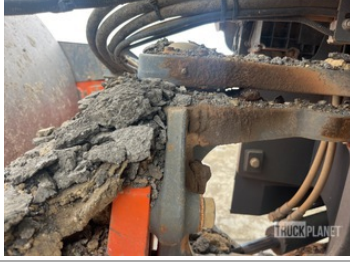
| Item | Assessment | Photo |
|---|---|---|
| Articulating Center Pins | ★★★★☆ | |

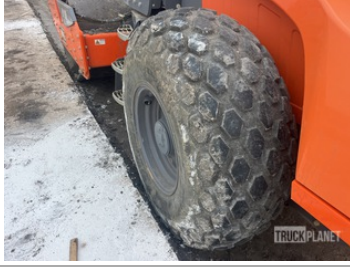
| Item | Assessment | Photo |
|---|---|---|
| Left Rear Tire | Size: 23.1-26 Brand: mitas Model: Ind uk10 Tread Depth: 20/32 | |

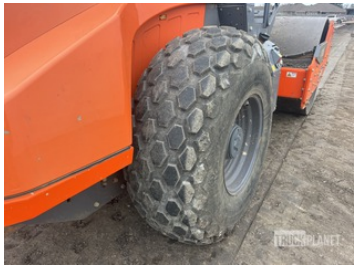
| Right Rear Tire | Size: 23.1-26 Brand: mitas Model: Ind uk10 Tread Depth: 20/32 | |

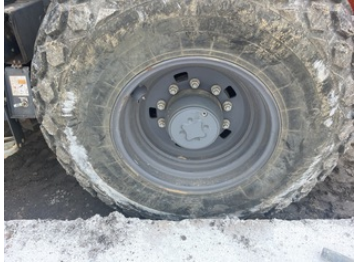
| Wheel Condition | No visible damage or missing components | |
