**Item #15936905 - 2024 Kobelco SK210LC Tracked Excavator**

# Inspection Report

# 2024 KOBELCO SK210LC-11

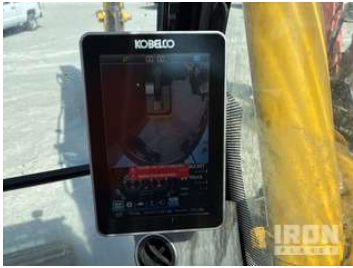
| Engine Oil Pressure | The fault indicator shuts off after the engine oil pressure rises. | |
| Warning Lights | Operational, Check engine light stays on | |

| Check engine light on | \$4,500 | Hydraulic Fluid Level Low | \$350 |

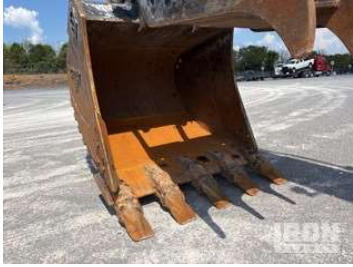
| Item | Assessment | Photo |
|---|---|---|
| Excavator Bucket Condition | ★★☆☆☆<br>Coupler | |

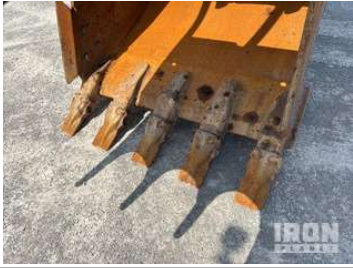
| Item | Assessment | Photo |
|---|---|---|
| Bucket Cutting Edge/Shanks/Teeth | ★★☆☆☆<br>No visible damage or missing components | |

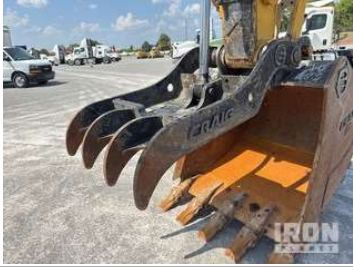
| Item | Assessment | Photo |
|---|---|---|
| Thumb | ★★☆☆☆<br>Hydraulic thumb | |
