## Item #15092789 - 2021 Hyundai 110D-9 25000 lb Forklift

# Inspection Report

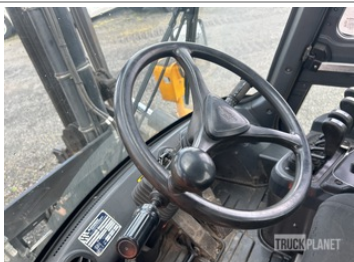
Steering Control	★★★★☆ Heavy steering wheel play

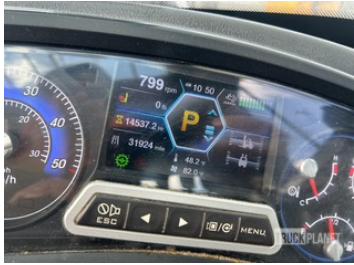
Hour Meter	14537 hrs, Operational hour meter

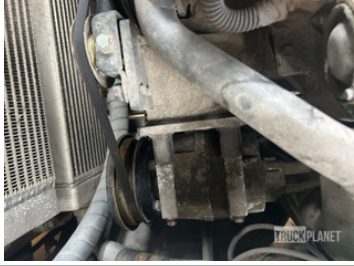
A/C Compressor	In place; ambient temperature too cold to check operation

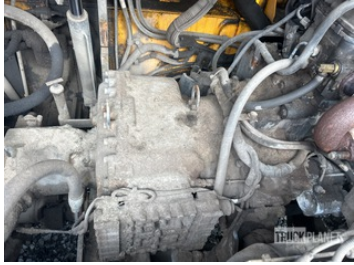
<b>Drivetrain</b>		
Operational test is limited to low speed in a confined flat area without load. Differential interlocks, full transmission shifting and functionality of all drive axles cannot be fully verified. Inspector listens for abnormal noises, observes leaks and notes physical damage.		
<b>Item</b>	<b>Assessment</b>	<b>Photo</b>
Transmission	★★☆☆ Operational

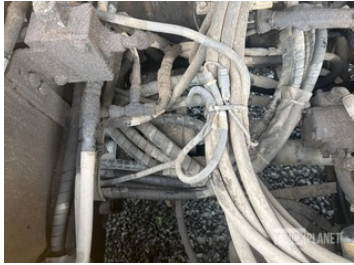
Front Drive Axle	★★☆☆

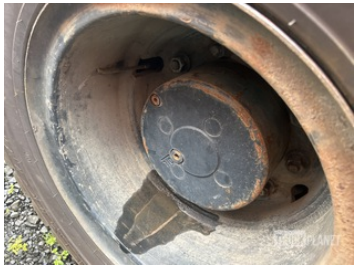
Final Drives	★★☆☆

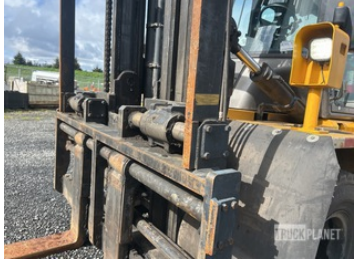
Chassis		
IronPlanet pin connection pivot point wear inspections are limited to sound, sight and feel observations. Dial indicator testing is not performed.		
Item	Assessment	Photo
Mast/Boom Condition	★★☆☆ Heavy wear

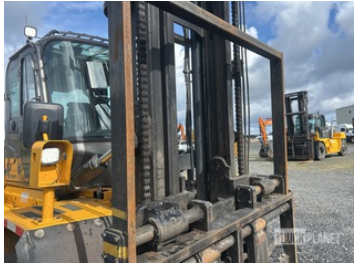
Chain / Tensioners	★★☆☆ Heavy wear

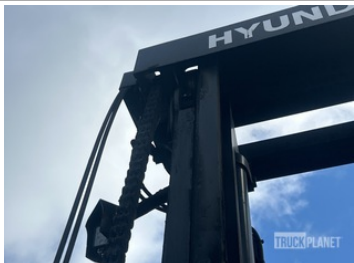
Carriage Rollers and Guides	★★☆☆

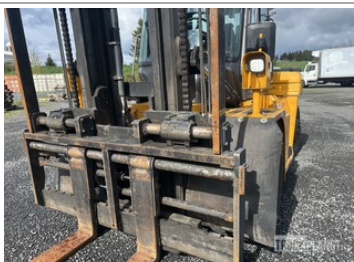
Load Back Rest	★★☆☆

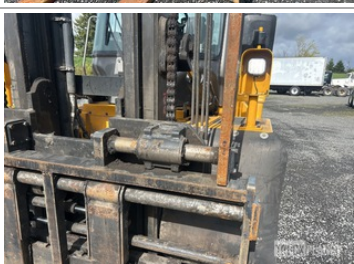
Side Shift	★★☆☆

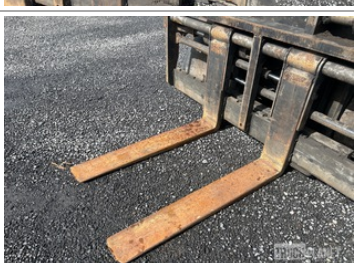
Forks	★★☆☆
