## Item #5657204 - RBR Vector 300 Fertilizer Spreader

- Features: 2016 US EPA Label, Cummins 6 Cylinder 305 hp 8.3 L Diesel Engine,
- Meter Reading: 2,576 Hours
- Serial # : M1700633
- Inspection Completed: 11/19/21

# Inspection Report

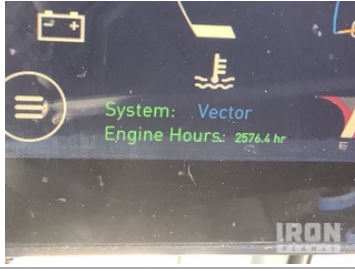
| Hour Meter / Odometer | 2576.4 hrs, Not operationally checked | |

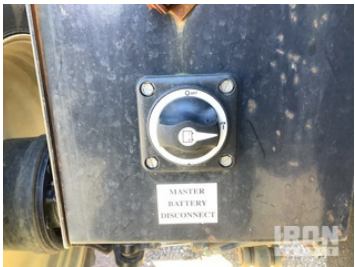
Engine #7

| Engine | The engine would crank with a jump but would not run. |
