Detailed Equipment Information

2021 HITACHI ZW330-6 / WLR

SERIAL NUMBER / VIN	BANNGE60C92C25019

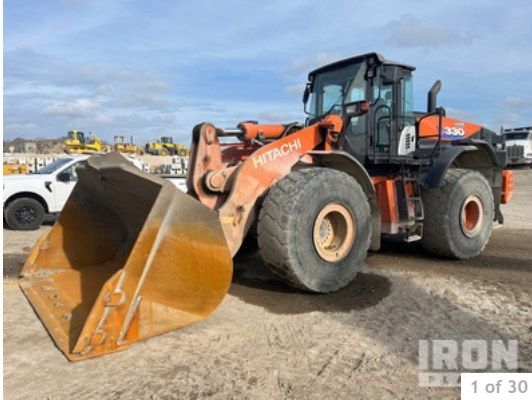
Photo 1 Photo 2 Photo 3

PRE-OPERATIONAL CHECKS	<p>Confirm Fluids Checked: Engine Coolant.</p> <p>Confirm Fluids Checked: Engine(s) Oil.</p> <p>Confirm Fluids Checked: Transmission Fluid.</p> <p>Confirm Fluids Checked: Hydraulic Fluid.</p> <p>Confirm Fluids Checked: Fuel Level</p>	
PAINT	Damage

BODY PANELS	Grille damaged	
FENDERS	No visible damage or missing components.

STEPS	Left cab steps bent

EXTERIOR LIGHTS	2 Inoperable / damaged / missing

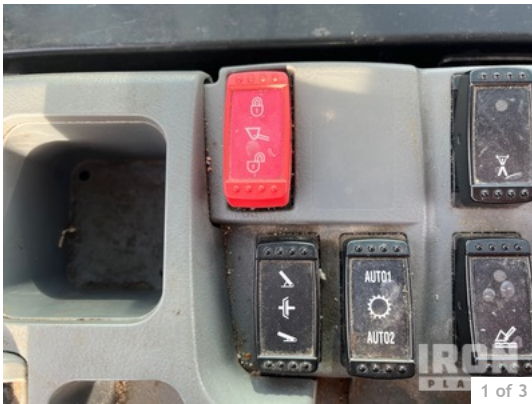
Photo 1 Photo 2 Photo 3

TRAVEL ALARM	Operational	
HORN	Operational	
SEAT BELTS	Operational	
SAFETY LOCK OUT/STOP	Operational

CURRENT SAFETY MANUAL	No	
CURRENT OPERATOR/MAINTENANCE MANUAL	No

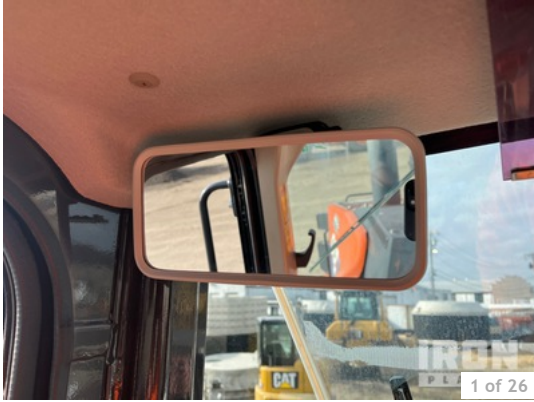
ENGINE OIL PRESSURE	The fault indicator shuts off after the engine oil pressure rises.

HOUR METER /ODOMETER USAGE READING (START)	6195.4 hrs

AIR CONDITIONER	Operational
HEATER	Operational
LIMITED FUNCTION CHECK	The main components are in place and operational as noted.

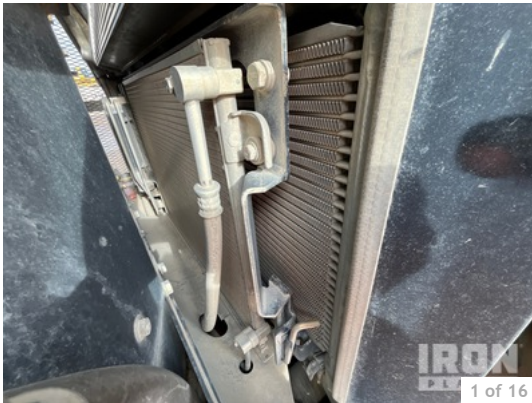
OIL LEAKS	Oil Pan

FUEL LEAKS	No dripping leaks

No dripping leaks

The engine started and ran.

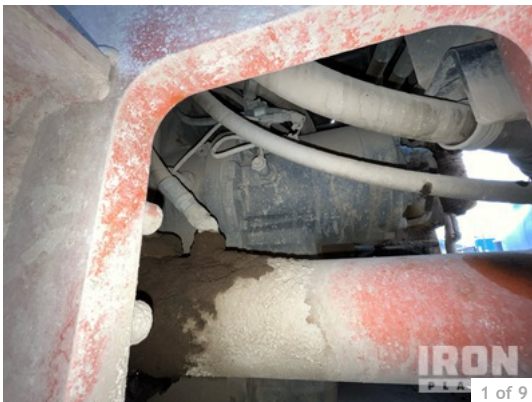
The drivetrain was operational.

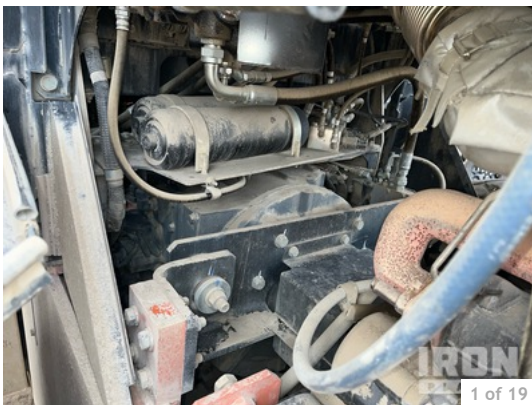
LIMITED FUNCTION CHECK	The hydraulic system was operational.

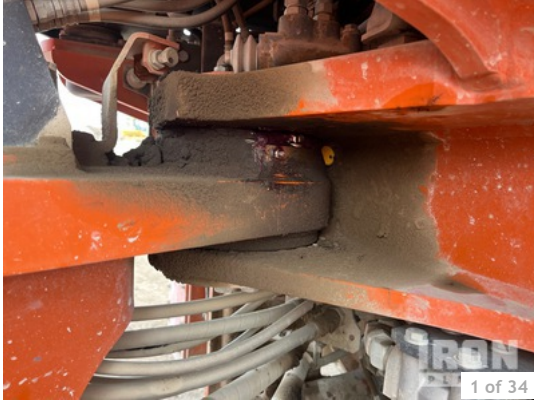
PARK BRAKE	GOOD	
LIMITED FUNCTION CHECK - BRAKES	The brake system functioned, stopping and holding the machine.	
FRAME CONDITION	GOOD

LEFT FRONT TIRE	Bridgestone V-Steel M-Traction 26.5R25 11/32" Tread Depth

LEFT REAR TIRE	Bridgestone V-Steel M-Traction 26.5R25 10/32" Tread Depth

RIGHT REAR TIRE	Bridgestone V-Steel M-Traction 26.5R25 9/32" Tread Depth

RIGHT FRONT TIRE	Bridgestone V-Steel M-Traction 26.5R25 12/32" Tread Depth

The main chassis components were operational in a limited check.

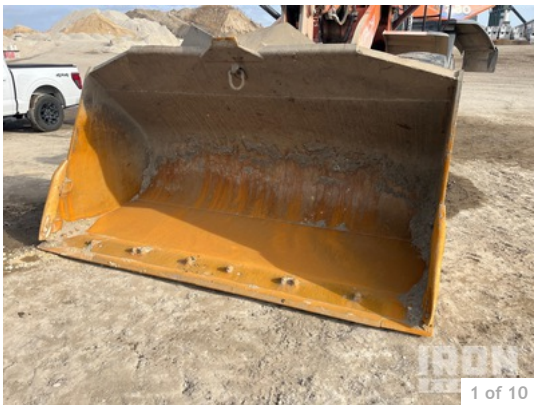
GOOD

No visible damage or missing components

Worn
