Item #14978244 - 2023 John Deere 544 P-Tier Wheel Loader

Inspection Report

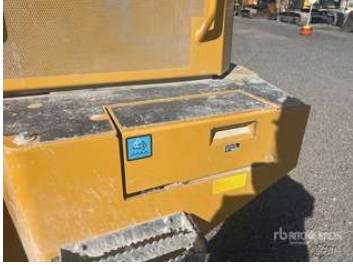
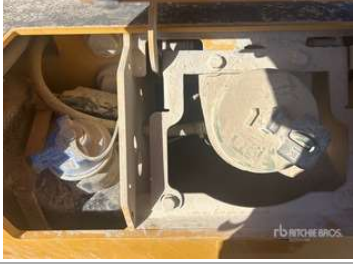
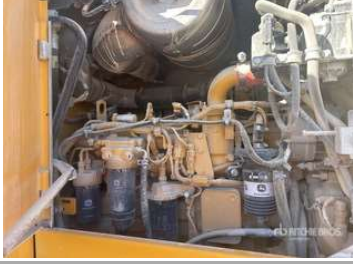
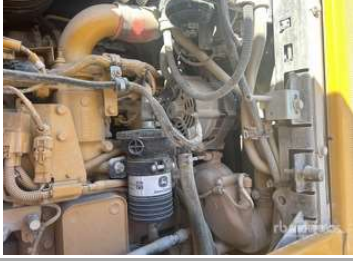
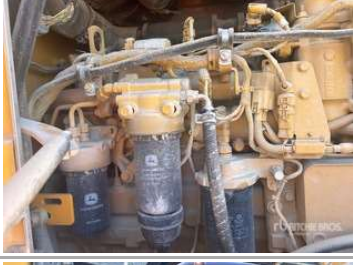
v2 Engine # 7		 
Limited Function Check	The engine started and ran.

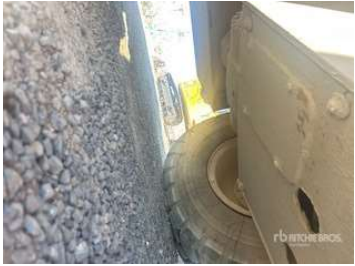
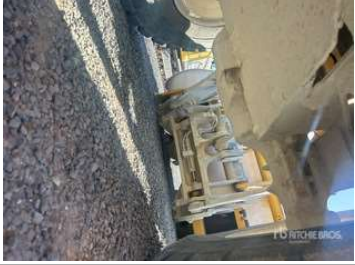
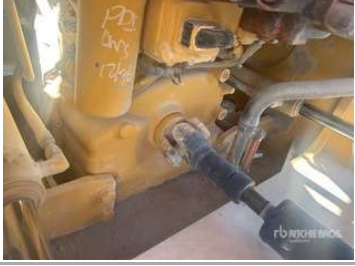
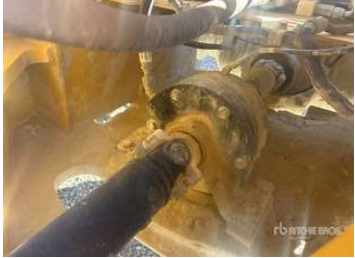
Drivetrain		
Item	Assessment	Photo
Limited Function Check	The drivetrain was operational.	
Drivetrain #1

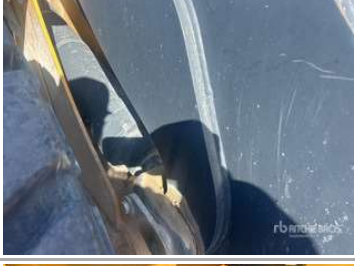
Hydraulics		
Item	Assessment	Photo
Limited Function Check	The hydraulic system was operational.	
Hydraulics #1		 
Hydraulics #2		 
Hydraulics #3		 
Hydraulics #4		 
Hydraulics #5
