DEKRA Services Inc.
Customer Service 770-257-0107

362 - Wells Fargo Equipment Management

Complete VIN:	3CET2V925J5189192	Request ID:	2015273441
Unit number:		Year:	2018
Make:	VOLVO	Model:	9700

CONDITION REPORT

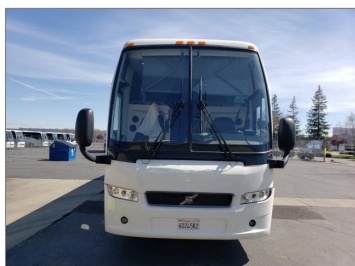
FRONT OF BUS

THE COACH WAS INSPECTED AT THE INSURED'S YARD. THE COACH WAS IN GOOD RUNNING CONDITION. THERE WAS DAMAGE TO THE FRONT BUMPER, RIGHT SIDE, LEFT SIDE, DRIVER'S SEAT ARMREST, RIGHT MIRROR COVER AND FOUR BAD TIRES.

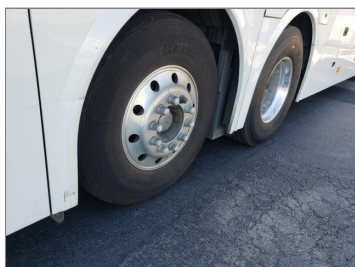
RIGHT REAR TIRES

Engine Compartment Area			COMMENTS	
Operational Test			COMMENTS	
X	In Cab Inspection	COMMENTS		
	Interior Condition/ Seats, Panels, Etc.	DRIVER'S SEAT ARMREST		
X	Outside Inspection	COMMENTS		
	Paint Condition & Physical Damage	BODY DAMAGE		
Under Vehicle Inspection			COMMENTS	
X	Tires/Wheels/Brakes	COMMENTS		
	Tires/Wheels	4 BAD TIRES		
Additional Services		Requested	Status	Comments

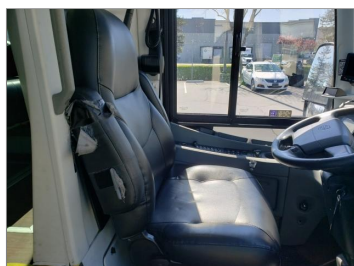
COMPLETE DRIVERS SEAT

ITEM	DESCRIPTION / COMMENTS	PART COST (\$)	LABOR
Interior Condition/ Seats, Panels, Etc.	X DRIVER'S SEAT ARMREST	150	50
Paint Condition & Physical Damage	X BODY DAMAGE	0	0
Tires/Wheels	X 4 BAD TIRES	1200	400
FRONT BUMPER	DAMAGED	100	500
RIGHT SIDE PANEL	DAMAGED	0	300
RIGHT MIRROR COVER	DAMAGED	150	50
RIGHT REAR DOOR	DAMAGED	50	200
RIGHT REAR WHEELHOUSE	DAMAGED	100	300
RIGHT REAR UPPER DOOR	DAMAGED	50	200
RIGHT SIDE ENGINE DOOR	DAMAGED	50	300
LEFT SIDE BATTERY DOOR	DAMAGED	50	200
REAR BUMPER	DAMAGED	50	300
TOTAL ESTIMATE		1950	2800
TOTAL (PARTS + LABOR)			4750
