Jacobsen GP400

Year/Make/Model: Jacobsen GP400

EQUIPMENT INSPECTION

Inspection Date: 2021-02-12

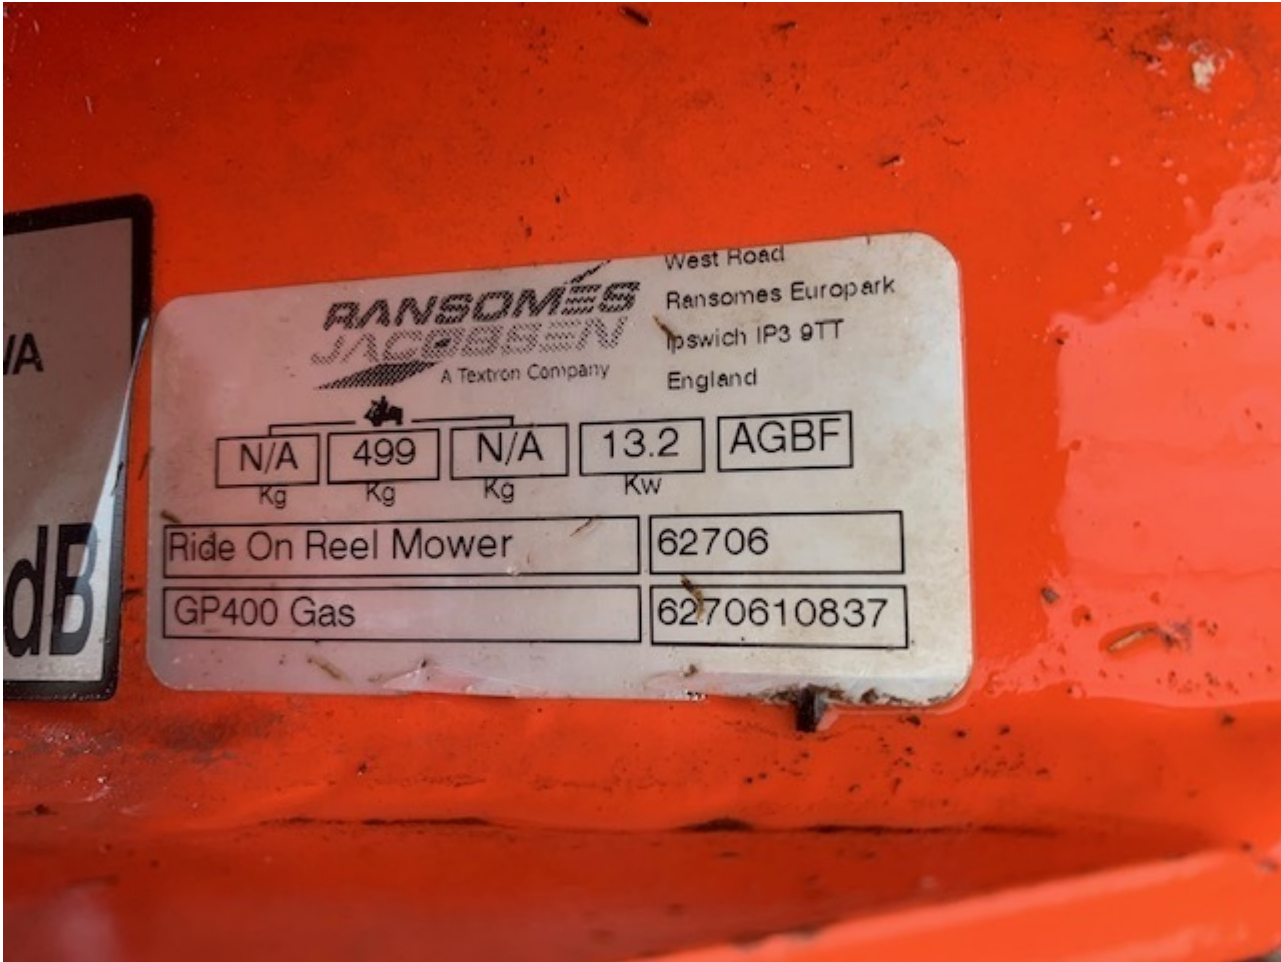
Screws for instrument panel are missing. Seat is cracked on left hand side. Heavy rust on reels and rollers. Reels will raise and lower but will not engage. Low on hydraulic fluid. Radiator is rusty on bottom edge.
