# Jacobsen GP400

**Year/Make/Model:** Jacobsen GP400

**Inspection Date:** 2021-02-12

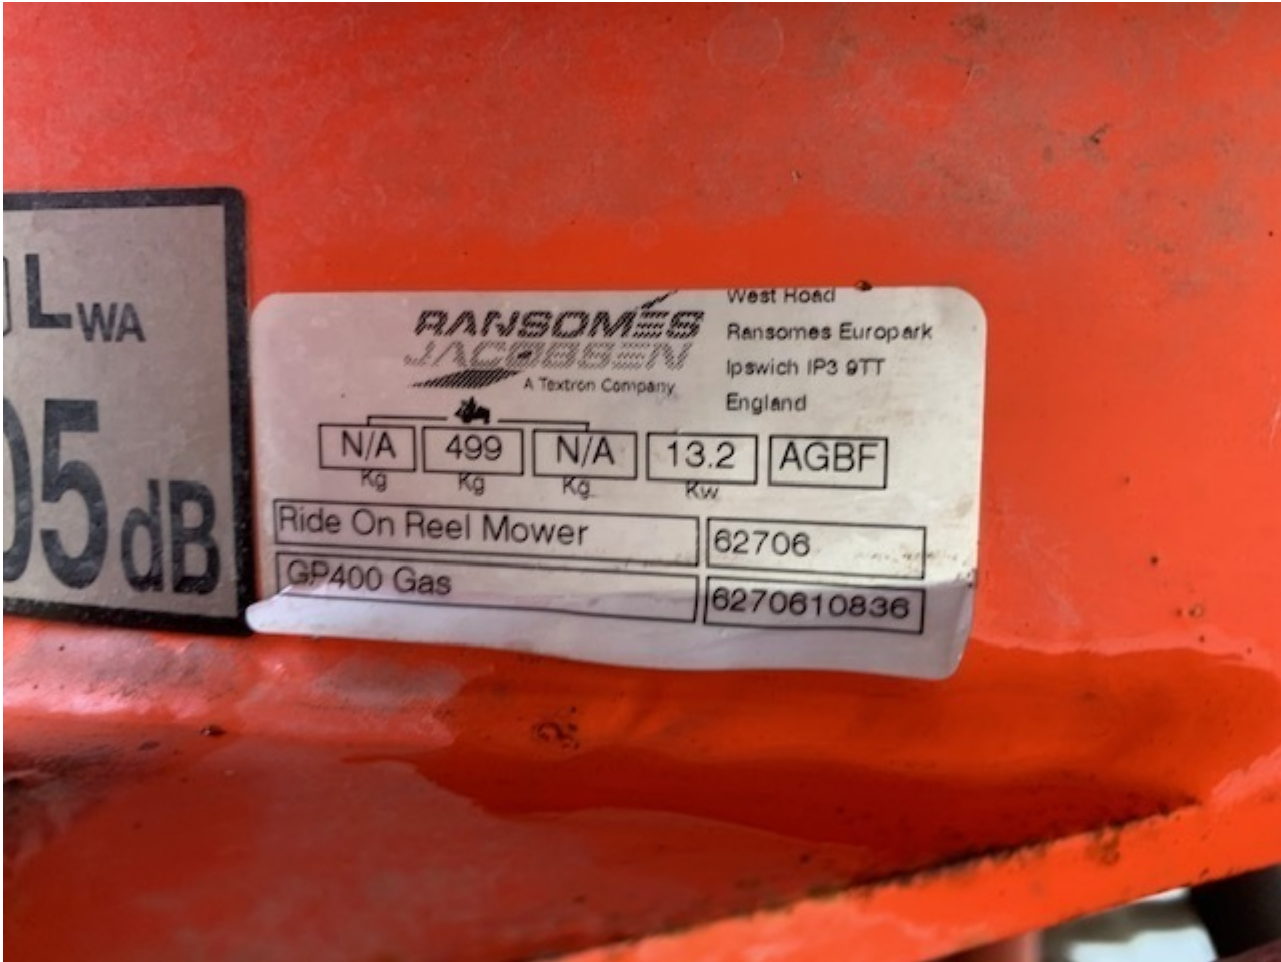
Unit will crank and run after being jumped. Needs new battery. Front right tire does not match other tires. Front left rim is bent. Heavy rust on reels and rollers. Reels will not lift, lower, or engage. Hydraulic warning light was on, added hydraulic fluid but still had the same results.

**Wheels / Tires / Tracks:** Poor Condition {No Tread}

**Rollers / Reels / Decks Attachments:** Poor Condition (Rusty)

**Machine Controls:** Not Working

**Engine Condition:** Bad Battery
