Item #12781172 - 2023 KPI-JCI FT2650 Tracked Jaw Crushing Plant

Inspection Report

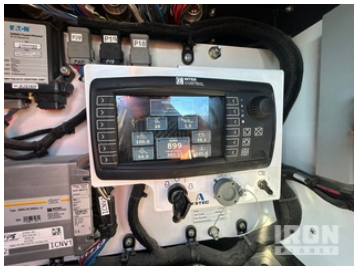
Control Station		
Pin connection pivot point wear inspections are limited to sound, sight and feel observations. Dial indicator testing is not performed.		
Item	Assessment	Photo
Gauges	Operational

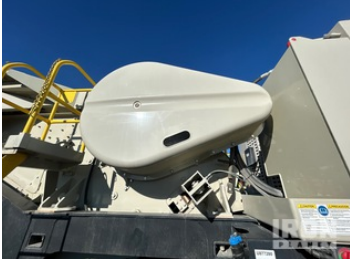
Crusher Drive System	★★★★☆

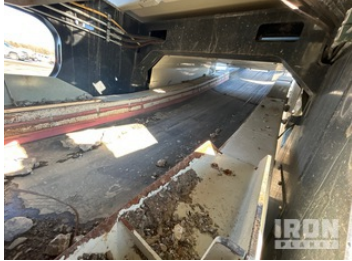
A close-up photograph of the VSI/HSI crusher chamber, showing a large, circular, metallic component with a textured surface. The IronPlanet logo is visible in the bottom right corner.
Discharge Conveyor Condition	★★★★☆

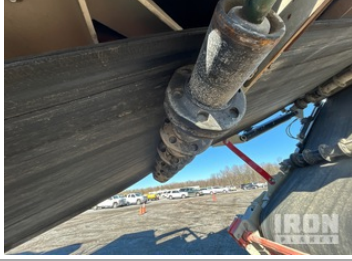
A photograph of the discharge conveyor drive motor, showing a large, white, cylindrical component with a red and black electrical connection. The IronPlanet logo is visible in the bottom right corner.
Discharge Conveyor Rollers	★★★★☆

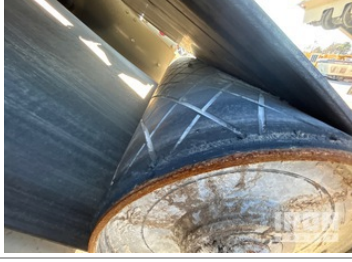
Discharge Conveyor Head and Tail Pulley	★★★★☆
