DEKRA Services Inc.
Customer Service 770-257-0107

362 - Wells Fargo Equipment Management

Complete VIN:	3CET2V925J5189192	Request ID:	2015273441
Unit number:		Year:	2018
Make:	VOLVO	Model:	9700

CONDITION REPORT

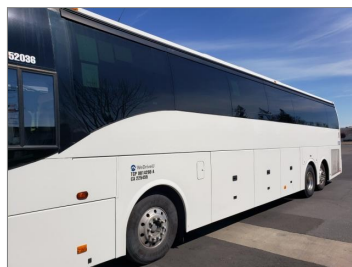
LEFT SIDE

THE COACH WAS INSPECTED AT THE INSURED'S YARD. THE COACH WAS IN GOOD RUNNING CONDITION. THERE WAS DAMAGE TO THE FRONT BUMPER, RIGHT SIDE, LEFT SIDE, DRIVER'S SEAT ARMREST, RIGHT MIRROR COVER AND FOUR BAD TIRES.
