# Aspen Field Services

Job #: 28468 /

Serial #: H2350108

## HAMM H 10I ROLLER

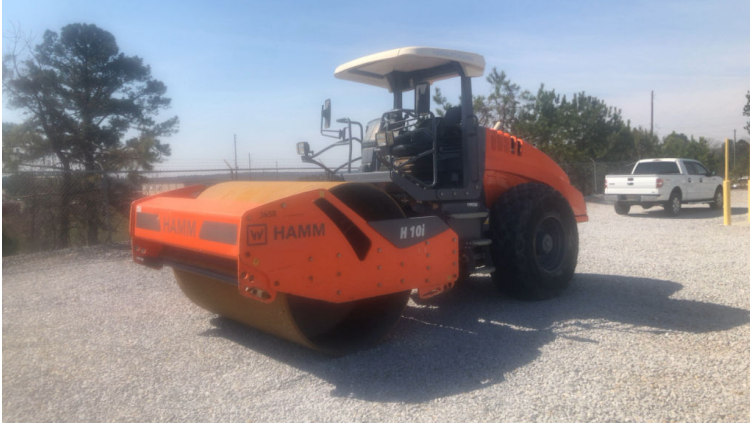
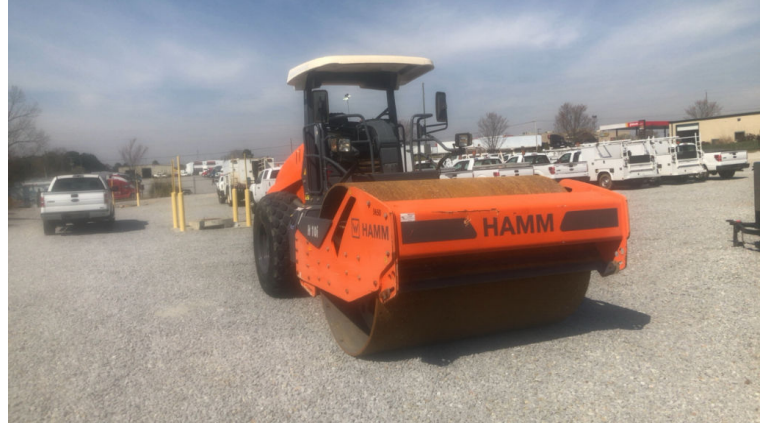
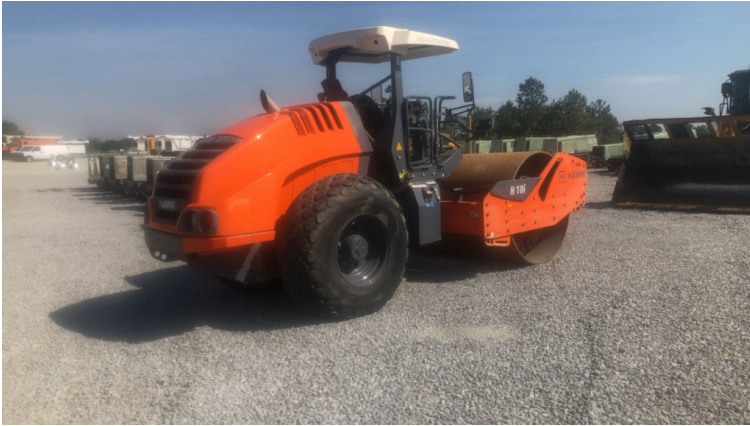
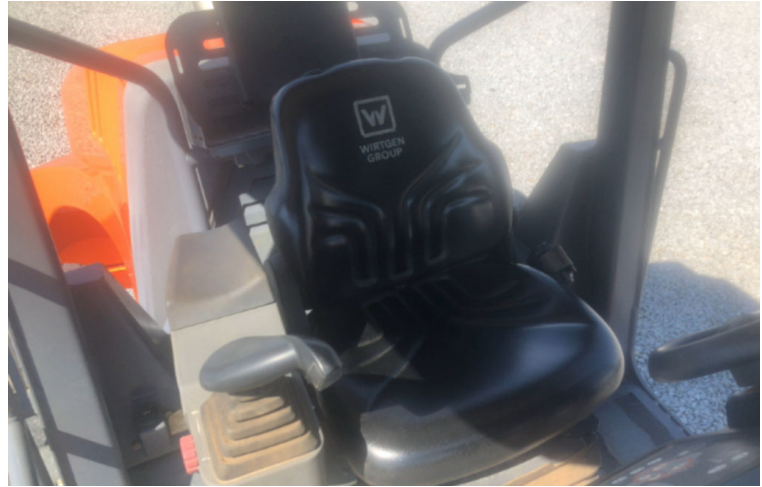
Inspection Details	
Year	2017
Make	Hamm
Model	H 10i
Serial Number	H2350108
Type	Roller
Date Of Inspection	3/9/2021
Location of Business	JJ Kane Auctioneers- 100 Liberty Rd, Villa Rica, GA 30180
Attachment(s)/ Accessory(s)	Roller Serial Number Not Visible and Roller Serial Number Not Visible
Enclosed Cab	No
Engine MFR	Deutz
Engine Serial Number	11962807
Hours	1002
Active Warnings	None
Cab A-C	No
Cab A-C Condition	N/A

Hydraulic Lines	Good Condition - No Leaks
Roller Thickness	1"
Roller Diameter	52"
Roller Width	88"
Comments	The working lights are non operational. The site contact was unable to open up the engine door during the time of inspection.
