PECHANGA  
RESORT CASINO.

### Vehicle Issues

2016 Van Hool Vehicle

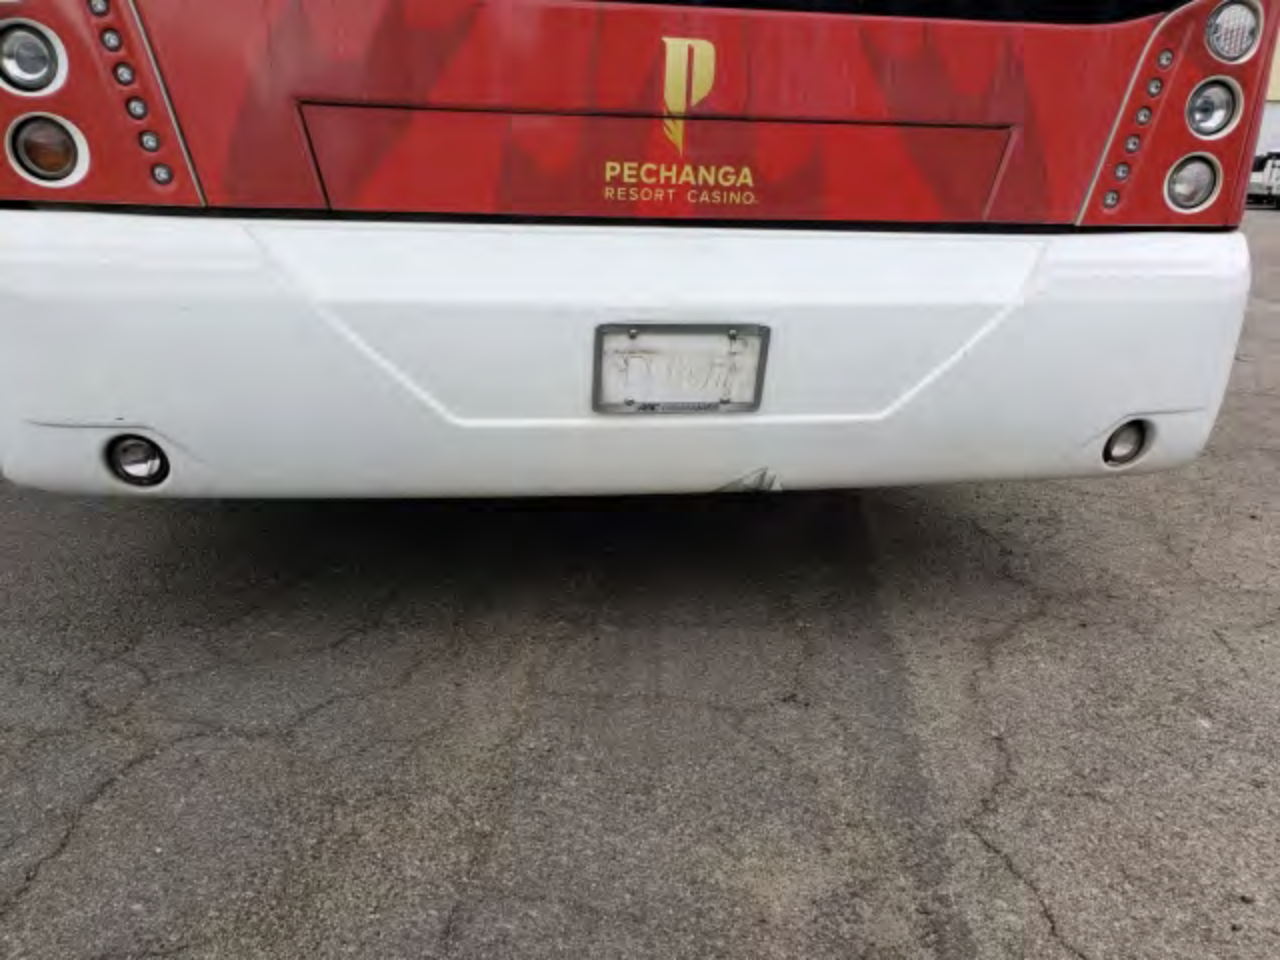
The image shows the rear of a red vehicle, likely a bus or shuttle, with a white bumper. The vehicle features a large gold 'P' logo on the red background. Below the logo, the text 'PECHANGA' is written in a bold, sans-serif font, and 'RESORT CASINO' is written in a smaller font below it. The license plate is white with black text, and the number '37 14670' is visible. The vehicle is parked on a dark, cracked asphalt surface.

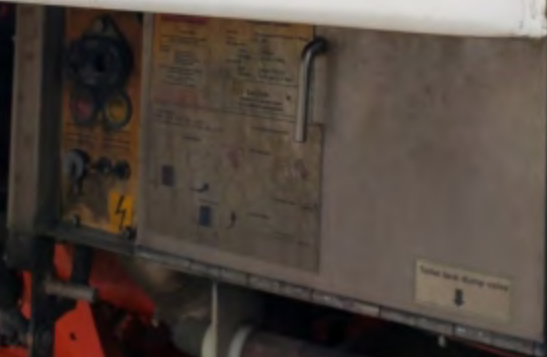
Under Hood Battery Control

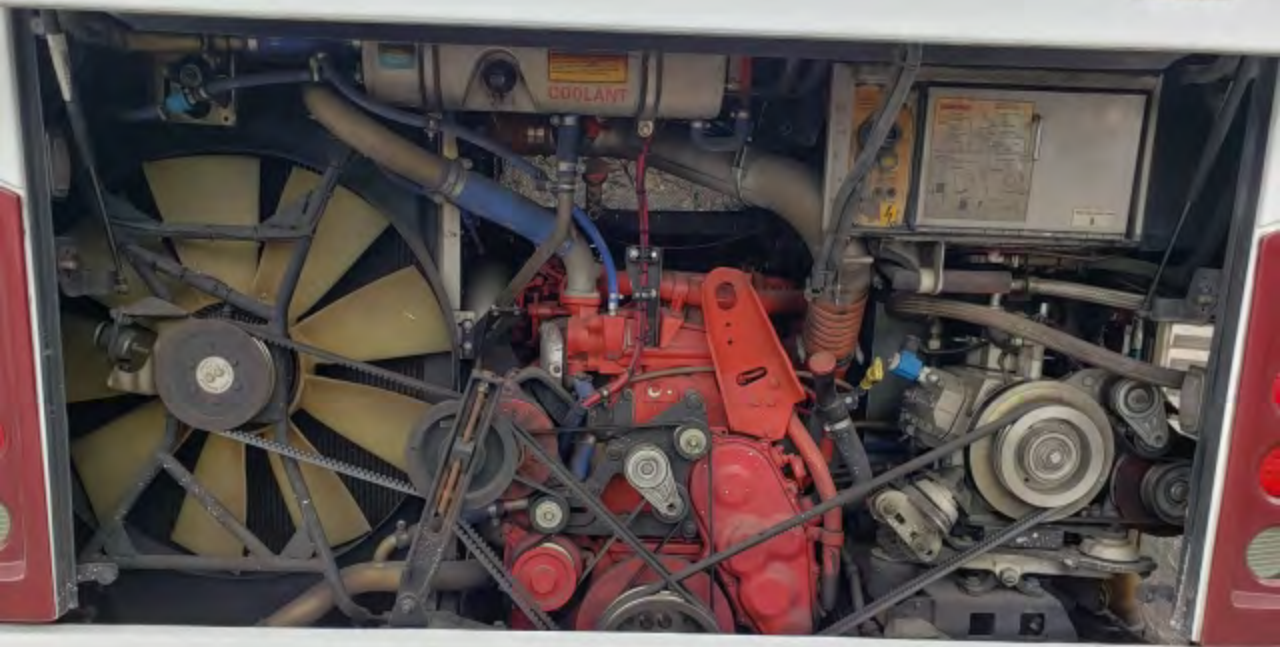
Engine No. 75048673  
Fluxivity FCEXH0729XAE  
Model ISX12 425MC  
Date of Mfg. 12/15  
Idle Speed RPM 600-800  
Mat. No. 11438416

Adapt. No. 425

Peak Torque (PS-12) 7650

Peak HP at Altitude 235

Idle Fuel Cons. (PS-12) 20.4 GPH
