## Item #12781131 - 2022 Screen Machine 50TJ Jaw Crusher

# Inspection Report

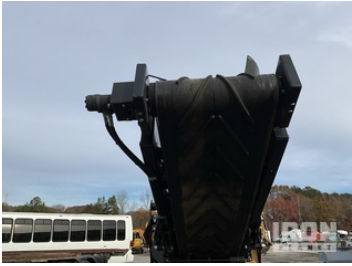
Limited Function Check	The hydraulic system was operational.	
Hydraulics #1

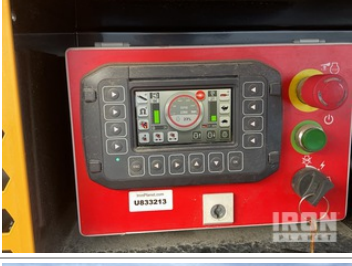
Hour Meter / Odometer	26 hrs

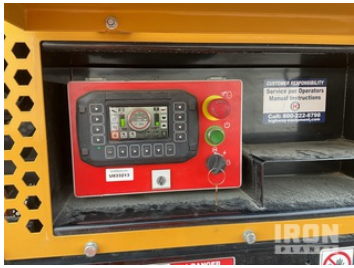
Limited Function Check	The main components are in place and operational as noted.	
Control Station #1

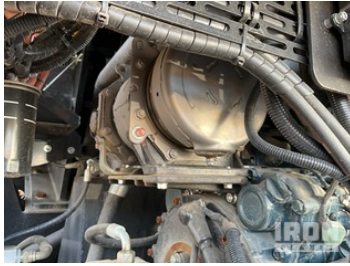
Blow by @ idle (subjective visual observation)	No noticeable vapor or pressure	
Starter	Operational	
Exhaust System

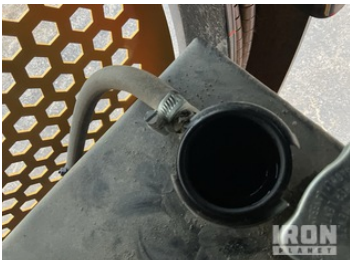
<p>Limited Function Check (Engine)</p>	<p>The engine started and ran.</p>	
<p>Engine #1</p>
