## Item #14159143 - 2022 Volvo A25G Articulated Dump Truck

# Inspection Report

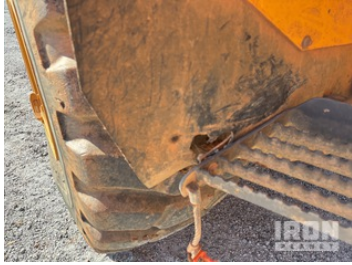
| Mud Flaps | No visible damage or missing components | |

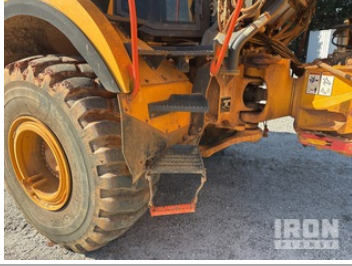
| Steps | No visible damage or missing components. | |

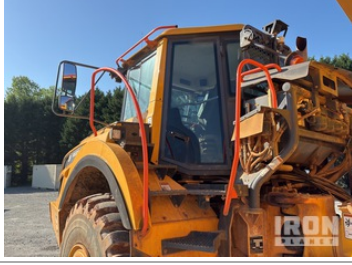
| Hand Rails | No visible damage or missing components | |

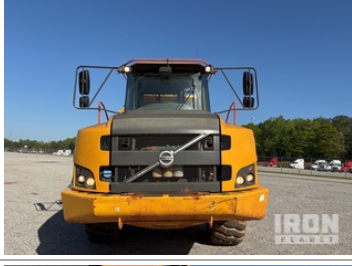
| Exterior Lights | All lights operational | |

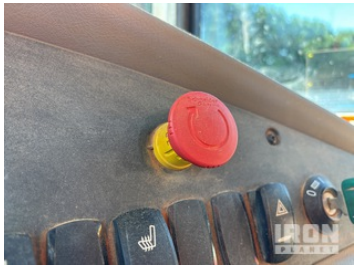
| Item | Assessment | Photo |
|---|---|---|
| Safety Lock Out/Stop | Operational | |

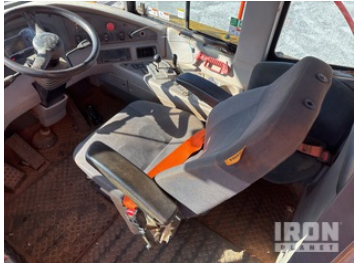
| Item | Assessment | Photo |
|---|---|---|
| Seat/Armrests | No visible damage or missing components | |

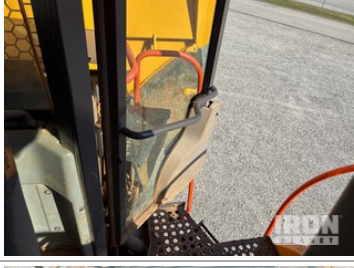
| Item | Assessment | Photo |
|---|---|---|
| Cab Doors | No visible damage or missing components | |

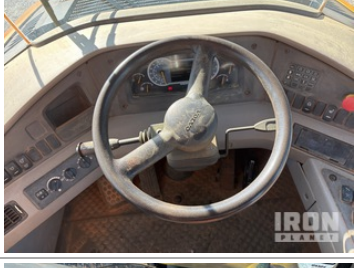
| Item | Assessment | Photo |
|---|---|---|
| Steering Controls | ★★★★☆ | |

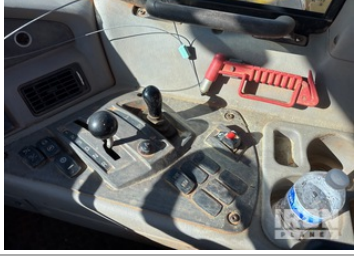
| Item | Assessment | Photo |
|---|---|---|
| Hydraulic Controls | ★★★★☆ | |

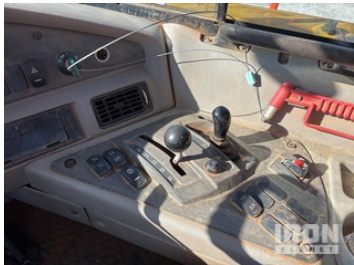
| Drivetrain Controls | ★★★★☆ | |

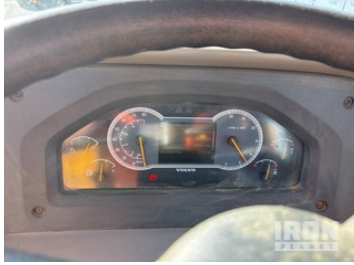
| Dash Console | ★★★★☆ | |

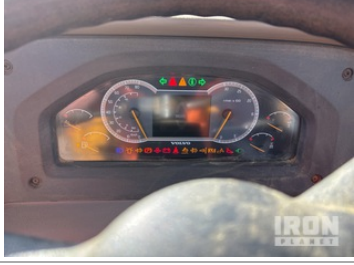
| Warning Lights | Operational | |

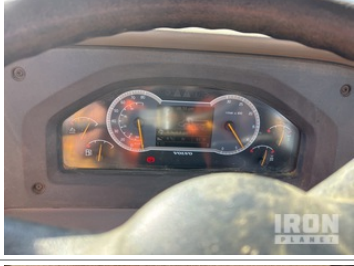
| Gauges | Operational | |

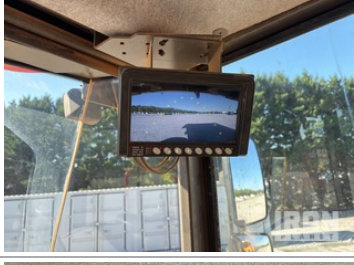
| Rear View Camera | Camera operates as intended | |

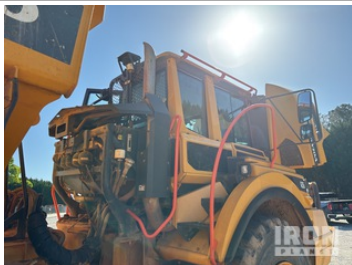
| Engine | | |
|---|---|---|
| Exhaust System | No visible damage or missing components | |

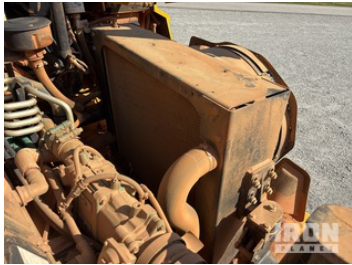
| Engine | | |
|---|---|---|
| Radiator | ★★★★☆ | |

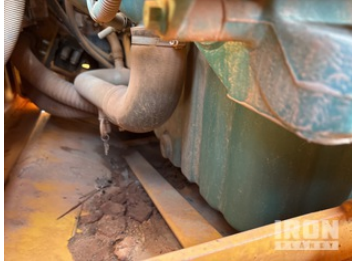
| Engine | | |
|---|---|---|
| Oil Leaks | No dripping leaks | |

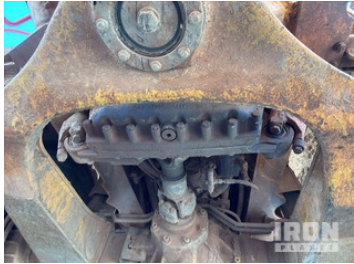
| Item | Assessment | Photo |
|---|---|---|
| Transfer Case / Drop Box | ★★☆☆<br>Operational | |

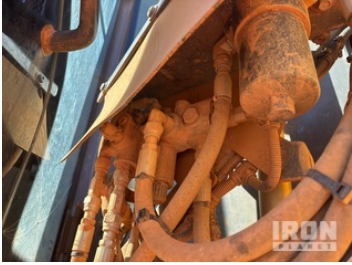
| Item | Assessment | Photo |
|---|---|---|
| Valves | ★★★☆☆ | |

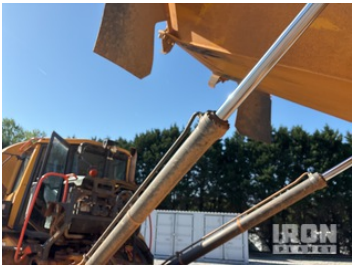
| Item | Assessment | Photo |
|---|---|---|
| Cylinders | ★★★☆☆ | |

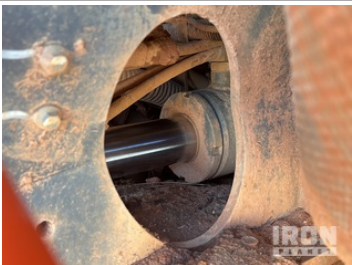
| Item | Assessment | Photo |
|---|---|---|
| Steering Cylinders | ★★★☆☆ | |

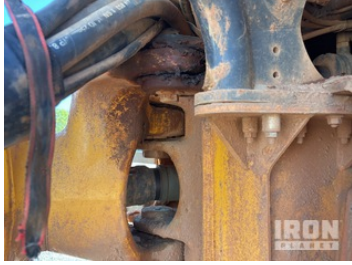
| Item | Assessment | Photo |
|---|---|---|
| Articulating Center Pins | ★★★★☆ | |

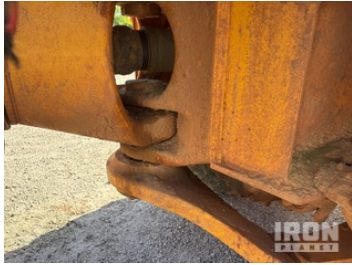
| Item | Assessment | Photo |
|---|---|---|
| Oscillating Hitch | ★★★★☆ | |

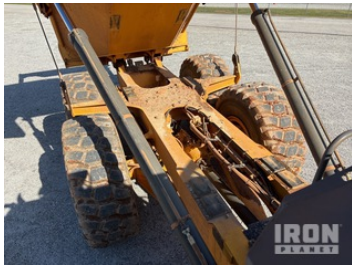
| Item | Assessment | Photo |
|---|---|---|
| Frame Condition | ★★★★☆ | |

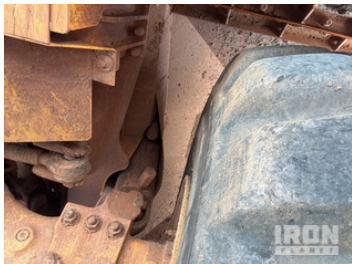
| Item | Assessment | Photo |
|---|---|---|
| Suspension Cylinders | ★★★★☆ | |

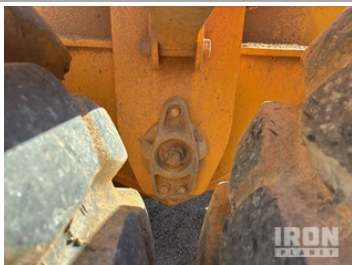
| Item | Assessment | Photo |
|---|---|---|
| Suspension Pivot Points | ★★★★☆ | |

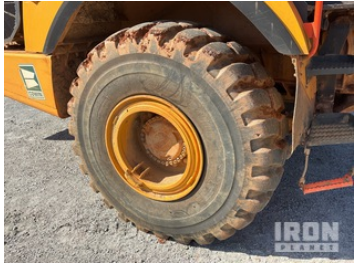
| Left Front Tire | ★★★★☆<br>Bridgestone VLTS 23.5R25 39/32"<br>Tread Depth | |

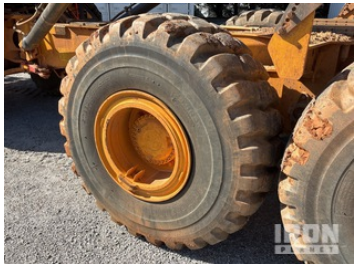
| Left Middle Tire | ★★★★☆<br>Bridgestone VLTS 23.5R25 40/32"<br>Tread Depth | |

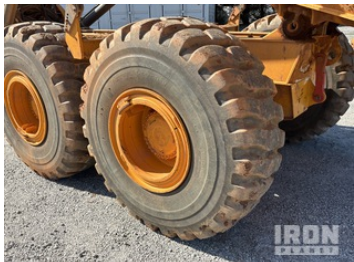
| Left Rear Tire | ★★★★☆<br>Bridgestone VLTS 23.5R25 39/32"<br>Tread Depth | |

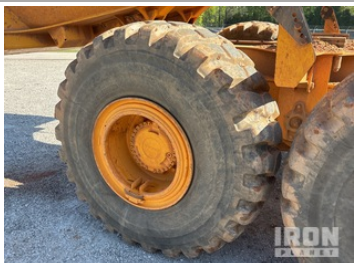
| Right Rear Tire | ★★★★☆<br>Bridgestone VLTS 23.5R25 39/32"<br>Tread Depth | |

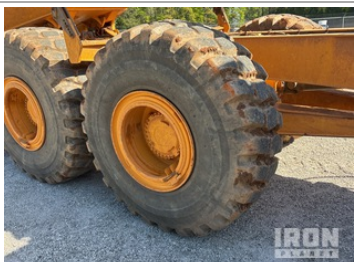
| Right Middle Tire | ★★★★☆<br>Bridgestone VLTS 23.5R25 39/32"<br>Tread Depth | |

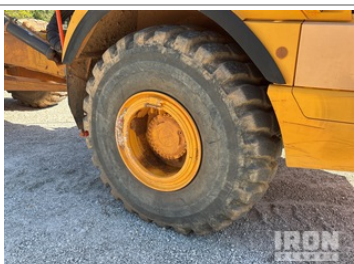
| Right Front Tire | ★★★★☆<br>Bridgestone VLTS 23.5R25 39/32"<br>Tread Depth | |

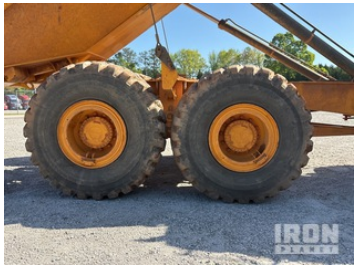
| Wheel Condition | No visible damage or missing components | |

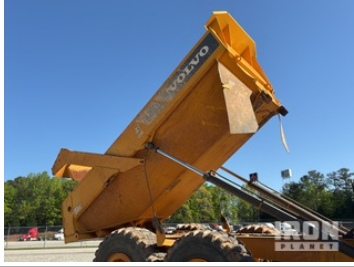
| Bed Body | ★★★★☆ | |

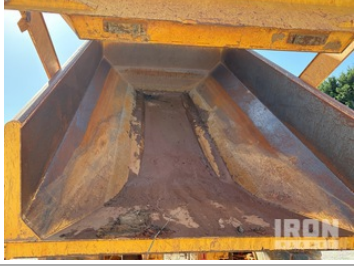
| Bed Liner | ★★★★☆ | |

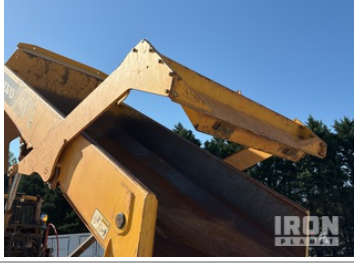
| Tail Gate | ★★★★☆ | |

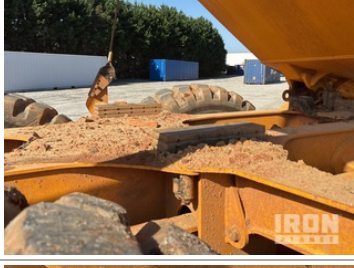
| Bed Pads | ★★★★☆ | |

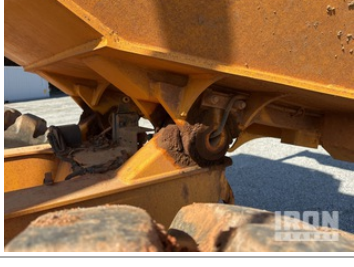
| Hinge Points | ★★★★☆ | |
