## Item #15746349 - 2022 Cat 150 Motor Grader

# Inspection Report

# 2022 CAT 150

UNIT: EB400550

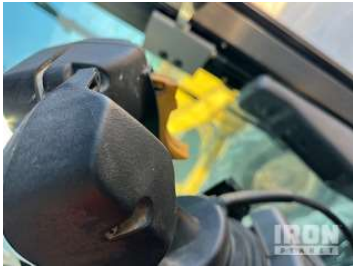
| Drivetrain Controls | ★★★★☆ | |

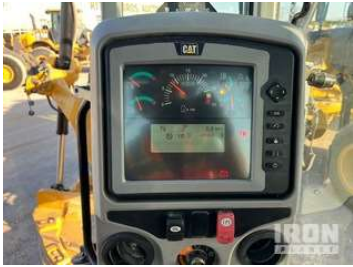
| Dash Console | ★★★★☆ | |

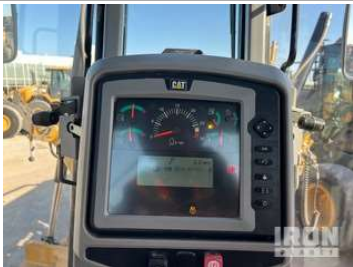
| Warning Lights | Operational, ! light stays on | |

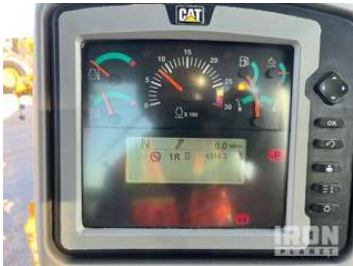
| Gauges | Operational | |

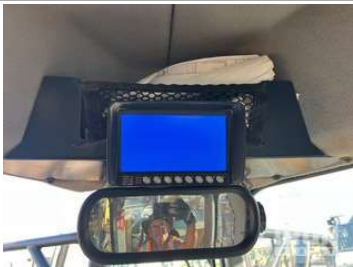
| Rear View Camera | Not working | |

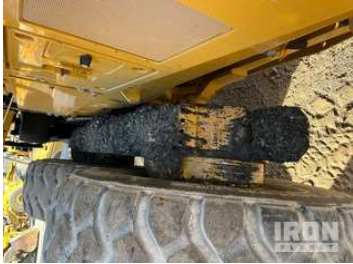
| Item | Assessment | Photo |
|---|---|---|
| Rear Tandems (Chain Drives) | ★★★★☆ | |

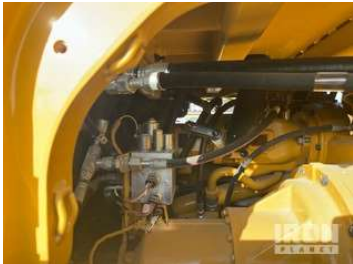
| Item | Assessment | Photo |
|---|---|---|
| Valves | ★★★★☆ | |

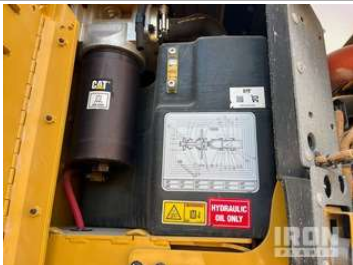
| Item | Assessment | Photo |
|---|---|---|
| Hydraulic Tank | ★★★★☆ | |

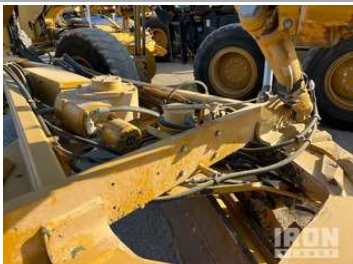
| Item | Assessment | Photo |
|---|---|---|
| Hoses (Hydraulics) | ★★★★☆ | |

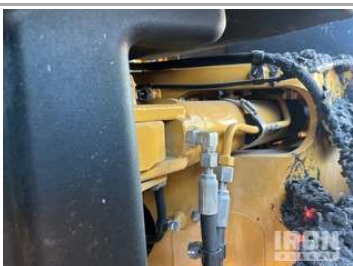
| Item | Assessment | Photo |
|---|---|---|
| Articulation Cylinders | ★★★★☆ | |

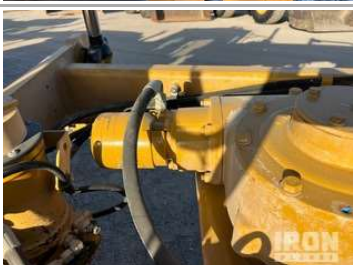
| Item | Assessment | Photo |
|---|---|---|
| Hydraulic Motors | ★★★★☆ | |

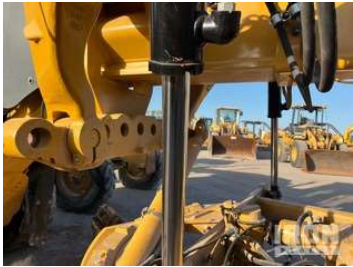
| Blade Lift Cylinders | ★★★★☆ | |

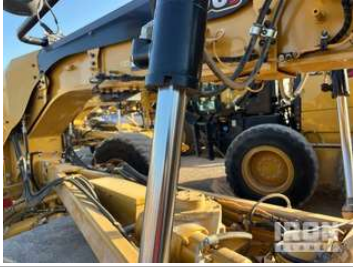
| Blade Angle Cylinders | ★★★★☆ | |

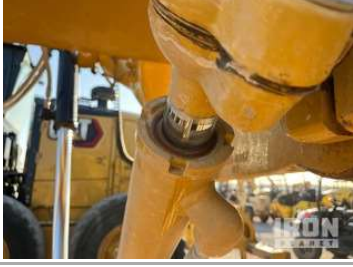
| Saddle Positioning Cylinder | ★★★★☆ | |

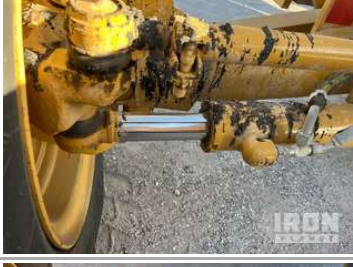
| Steering Cylinders | ★★★★☆ | |

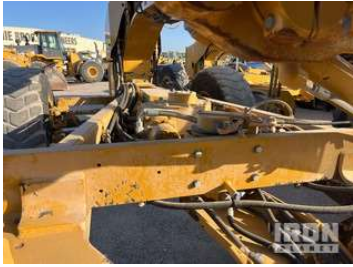
| Item | Assessment | Photo |
|---|---|---|
| Y-frame | ★★★★☆ | |

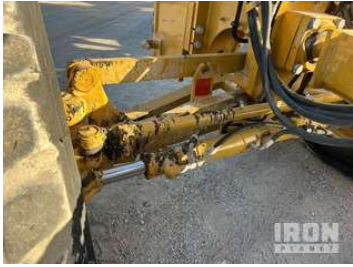
| Steering Linkage | ★★★★☆ | |

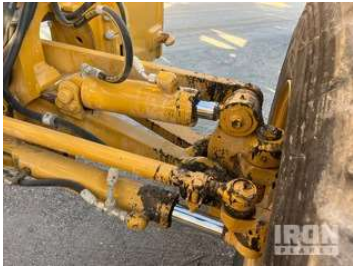
| Wheel Tilt Linkage | ★★★★☆ | |

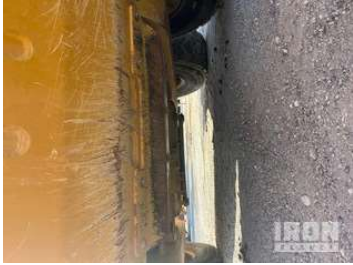
| Belly Pans | ★★★★☆ | |

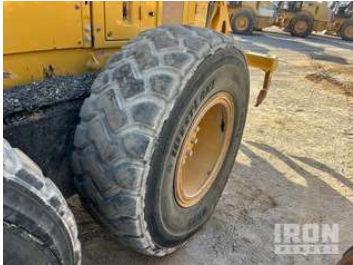
| Left Rear Tire | Size: 17.5R25 Brand: West Lake Model: WR03 Tread Depth: 18 /32 | |
