Item #15092790 - 2019 Hyundai HD 160D-9 36000 lb Forklift

Inspection Report

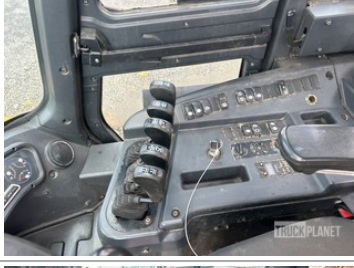
Hydraulic Controls	★★★★☆

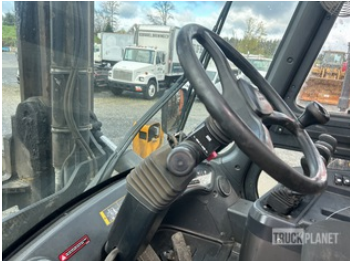
<p>Drivetrain Controls</p>	<p>★★★★☆</p>

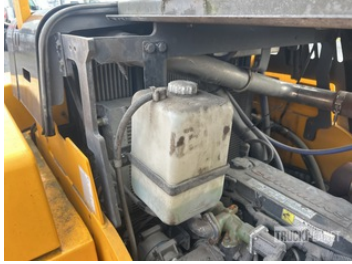
Radiator	★★★★☆

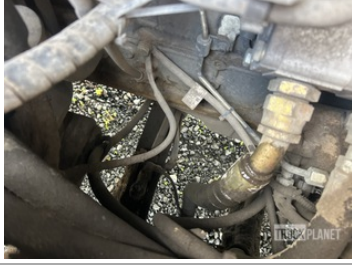
Oil Leaks	No dripping leaks

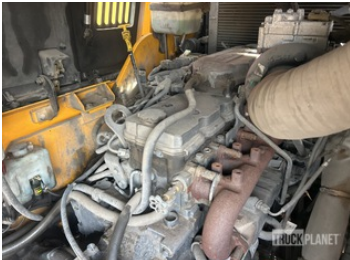
<p>Limited Function Check</p>	<p>After jump starting, the engine ran. The engine would not re-start after shutting down without jump starting.</p>	
<p>Engine #1</p>

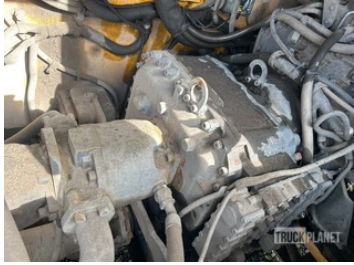
Drivetrain		
Operational test is limited to low speed in a confined flat area without load. Differential interlocks, full transmission shifting and functionality of all drive axles cannot be fully verified. Inspector listens for abnormal noises, observes leaks and notes physical damage.		
Item	Assessment	Photo
Transmission	★★★☆☆ Operational

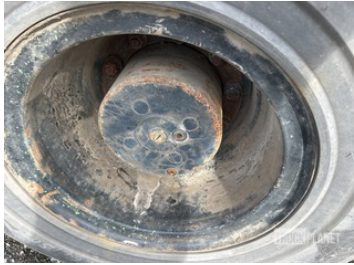
Final Drives	★★★☆☆

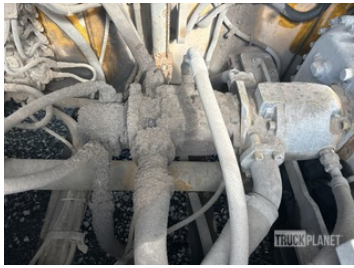
Hydraulics		
See photos for condition		
Item	Assessment	Photo
Pumps (Hydraulics)	★ ★ ★ ☆

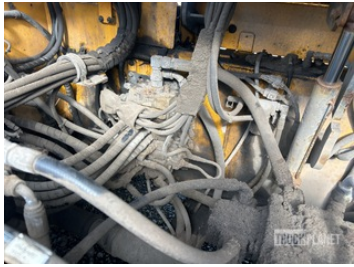
Valves	★ ★ ★ ☆

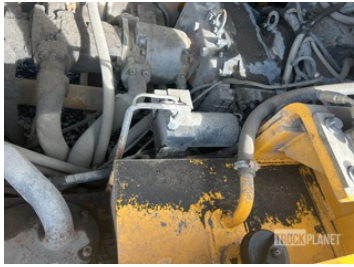
Hydraulic Tank	★ ★ ★ ☆

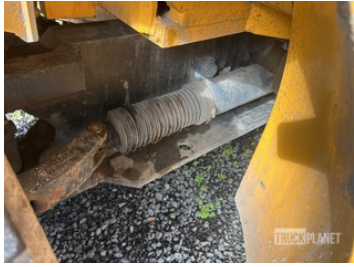
Steering Cylinders	★ ★ ★ ☆

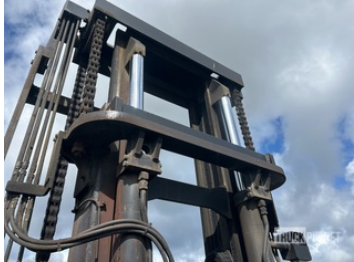
Mast Lift Cylinders	★ ★ ★ ☆

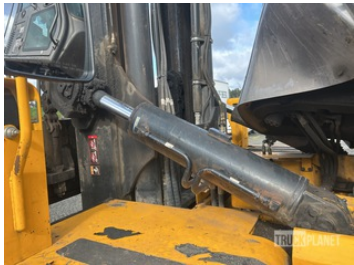
Mast Tilt Cylinders	★★★★☆

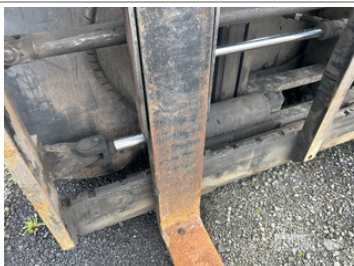
Side Shift Cylinder	★★★★☆

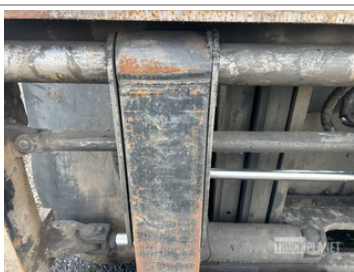
Fork Positioning Cylinder (on fork carriage)	★★★★☆

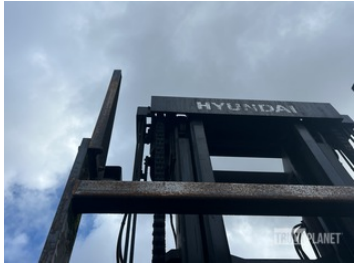
Carriage Rollers and Guides	★★☆☆

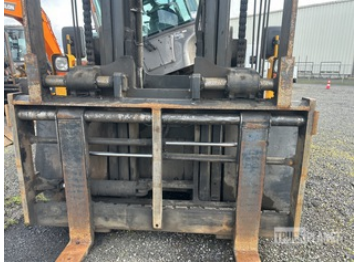
Load Back Rest	★★☆☆

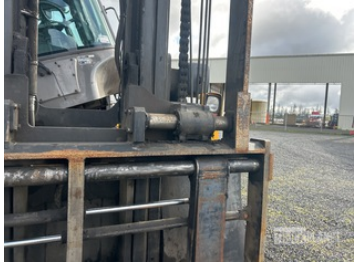
Side Shift	★★☆☆

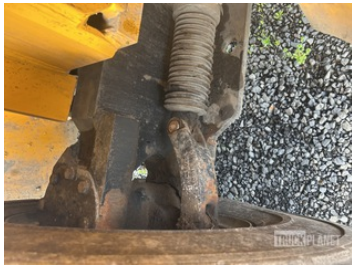
Steering Linkage	★★★★☆

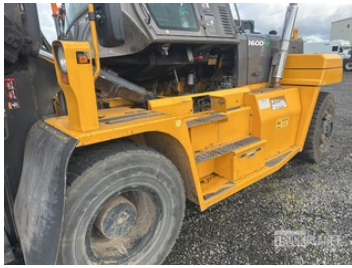
Frame Condition	★★★★☆

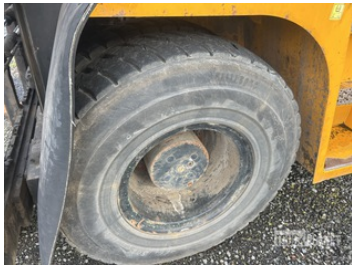
Park Brake	★★★★☆ Held against power	
Limited Function Check - Brakes	The brake system functioned, stopping and holding the machine.	
Left Front Tire	No visible defects

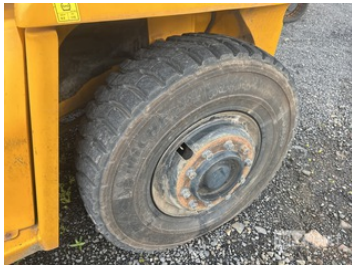
Left Rear Tire	No visible defects

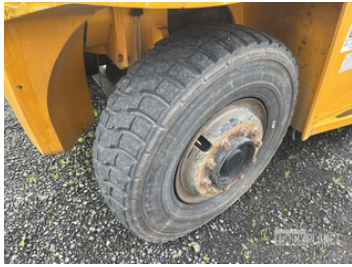
Right Rear Tire	No visible defects

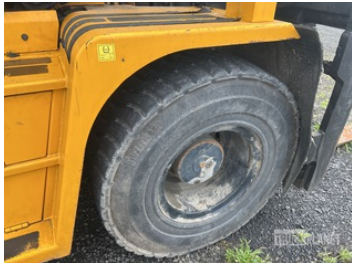
Right Front Tire	No visible defects
