## Item #14159141 - 2019 Volvo A25G Articulated Dump Truck

- Features: Air Conditioner, Rear View Camera, 2018 US EPA Label, Requires Diesel Exhaust Fluid, Steel Body Liner
- Meter Reading: 5,608 Hours
- Serial #: VCE0A25GJ00742299
- Inspection Completed: 4/14/25

# Inspection Report

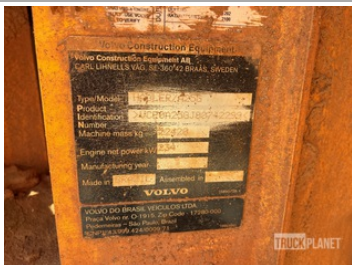
| Item | Assessment | Photo |
|---|---|---|
| Serial Number / VIN | VCE0A25GJ00742299 | |

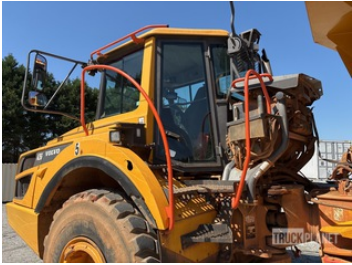
| Hand Rails | No visible damage or missing components | |

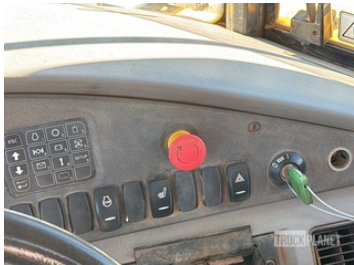
| Item | Assessment | Photo |
|---|---|---|
| Safety Lock Out/Stop | Operational | |

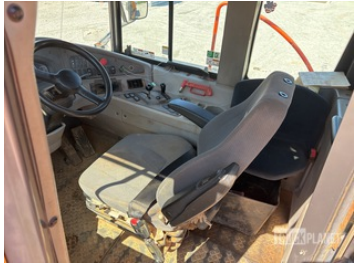
| Item | Assessment | Photo |
|---|---|---|
| Seat/Armrests | No visible damage or missing components | |

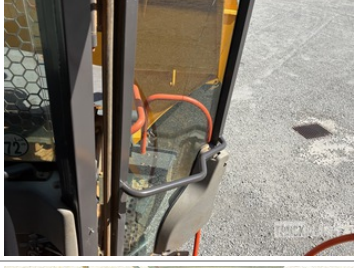
| Item | Assessment | Photo |
|---|---|---|
| Cab Doors | No visible damage or missing components | |

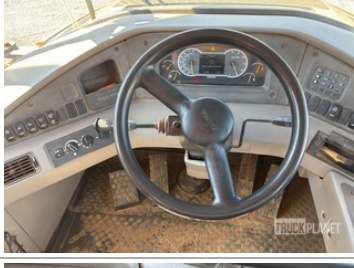
| Item | Assessment | Photo |
|---|---|---|
| Steering Controls | ★★★★☆ | |

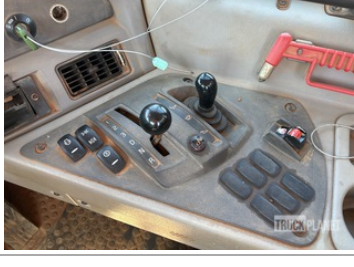
| Item | Assessment | Photo |
|---|---|---|
| Hydraulic Controls | ★★★★☆ | |

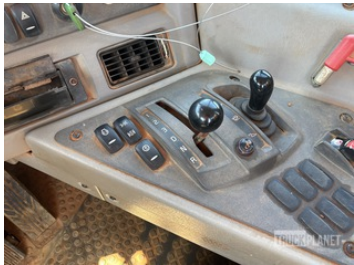
| Drivetrain Controls | ★★★★☆ | |

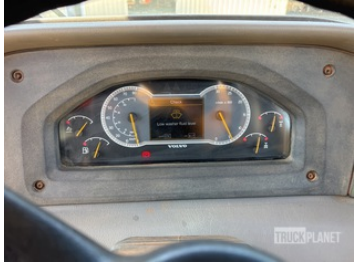
| Dash Console | ★★★★☆ | |

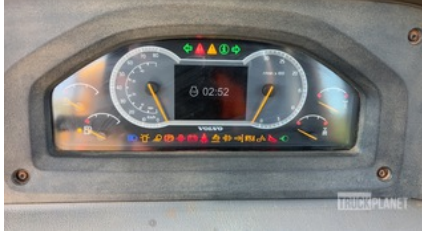
| Warning Lights | Operational | |

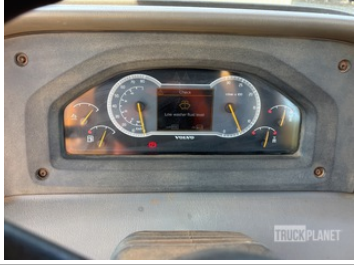
| Gauges | Operational | |

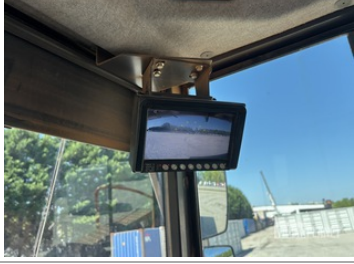
| Rear View Camera | Camera operates as intended | |

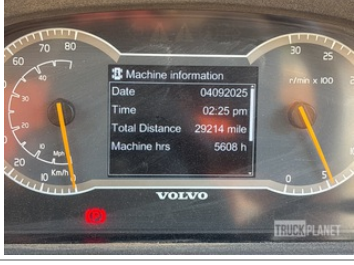
| Hour Meter / Odometer | 5608 hrs | |

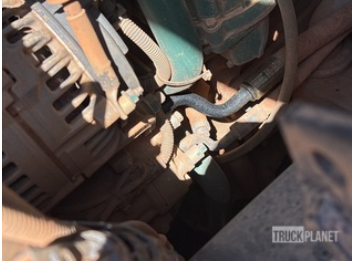
| Engine | | |
|---|---|---|
| A/C Compressor | Operational | |

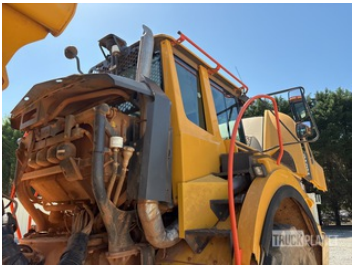
| Engine | | |
|---|---|---|
| Exhaust System | No visible damage or missing components | |

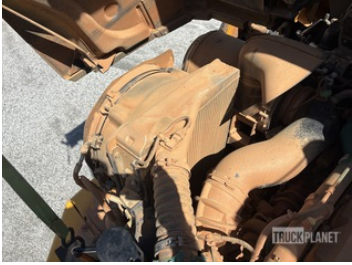
| Engine | | |
|---|---|---|
| Radiator | ★★★★☆ | |

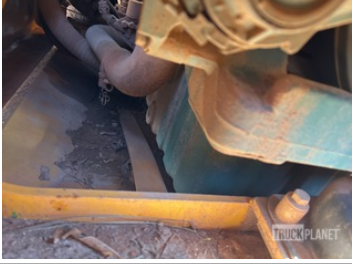
| Engine | | |
|---|---|---|
| Oil Leaks | No dripping leaks | |

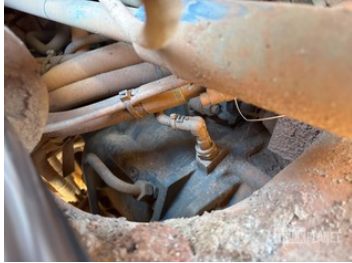
| Item | Assessment | Photo |
|---|---|---|
| Transmission | ★★★★☆ | |

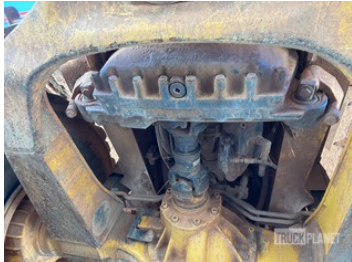
| Item | Assessment | Photo |
|---|---|---|
| Transfer Case / Drop Box | ★★★★☆ | |

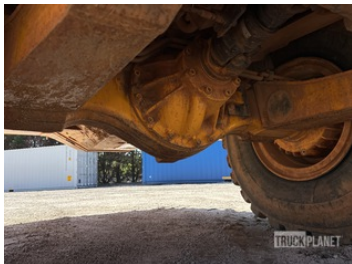
| Item | Assessment | Photo |
|---|---|---|
| Steer Axle | ★★★★☆ | |

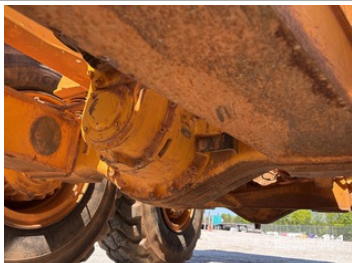
| Item | Assessment | Photo |
|---|---|---|
| Center Drive Axle | ★★★★☆ | |

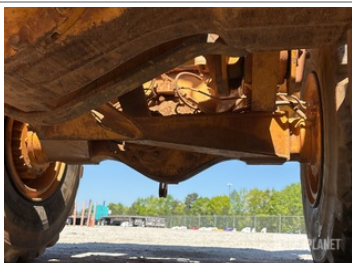
| Item | Assessment | Photo |
|---|---|---|
| Rear Drive Axle | ★★★★☆ | |

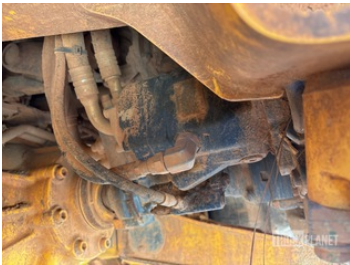
| Item | Assessment | Photo |
|---|---|---|
| Pumps (Hydraulics) | ★★★★☆ | |

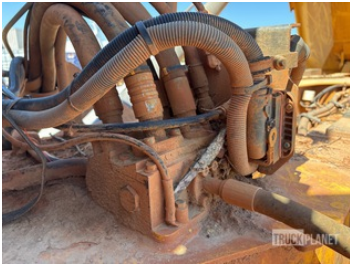
| Item | Assessment | Photo |
|---|---|---|
| Valves | ★★★★☆ | |

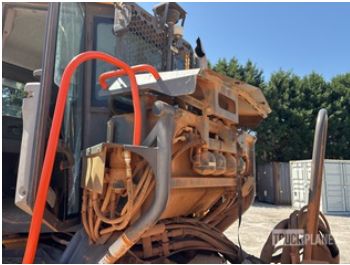
| Item | Assessment | Photo |
|---|---|---|
| Hydraulic Tank | ★★★★☆ | |

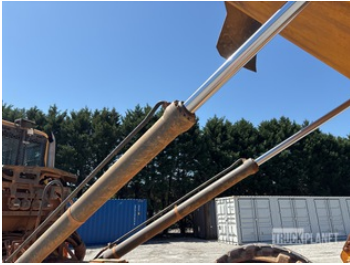
| Item | Assessment | Photo |
|---|---|---|
| Cylinders | ★★★★☆ | |

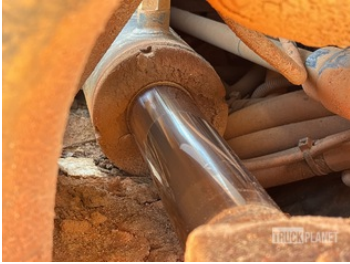
| Item | Assessment | Photo |
|---|---|---|
| Steering Cylinders | ★★★★☆ | |

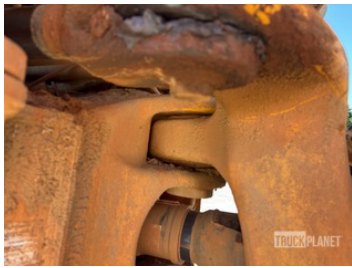
| Item | Assessment | Photo |
|---|---|---|
| Articulating Center Pins | ★★★★☆ | |

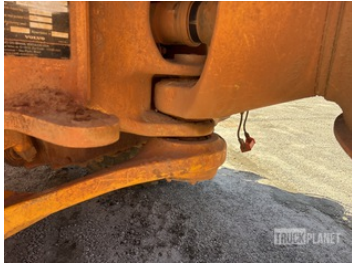
| Item | Assessment | Photo |
|---|---|---|
| Oscillating Hitch | ★★★★☆ | |

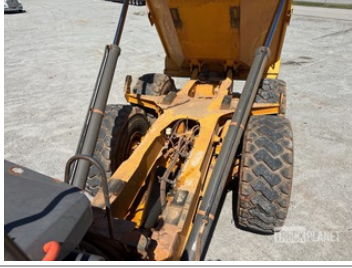
| Item | Assessment | Photo |
|---|---|---|
| Frame Condition | ★★★★☆ | |

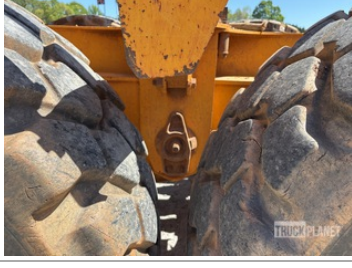
| Item | Assessment | Photo |
|---|---|---|
| Suspension Pivot Points | ★★★★☆ | |

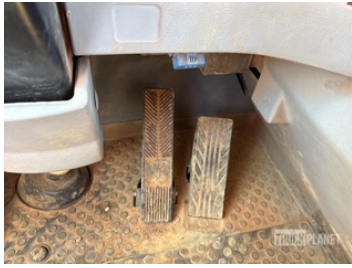
| Item | Assessment | Photo |
|---|---|---|
| Master Cylinder/Brake Control | ★★★★☆ | |

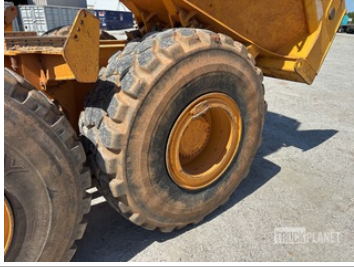
| Left Rear Tire | ★★★★☆<br>Michelin XADN+ 23.5R25 28/32" Tread Depth | A photograph showing the left rear tire of a yellow machine. The tire is a Michelin XADN+ 23.5R25 28/32" model. It shows significant wear, including cuts in the side wall and a visible tread pattern. |

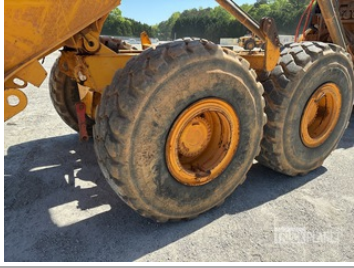
| Right Rear Tire | ★★★★☆<br>Michelin XADN+ 23.5R25 29/32" Tread Depth | A photograph showing the right rear tire of a yellow machine. The tire is a Michelin XADN+ 23.5R25 29/32" model. It shows significant wear, including cuts in the side wall and a visible tread pattern. |

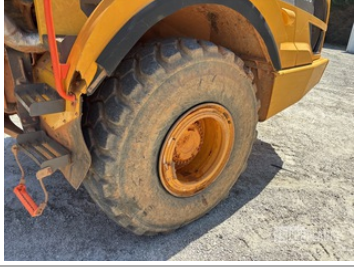
| Right Front Tire | ★★★★☆<br>Michelin XADN+ 23.5R25 28/32" Tread Depth | A photograph showing the right front tire of a yellow machine. The tire is a Michelin XADN+ 23.5R25 28/32" model. It shows significant wear, including cuts in the side wall and a visible tread pattern. |

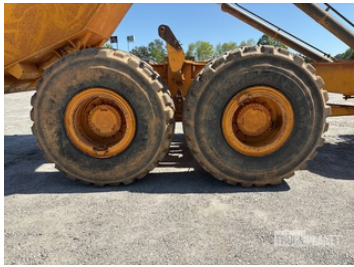
| Wheel Condition | No visible damage or missing components | |

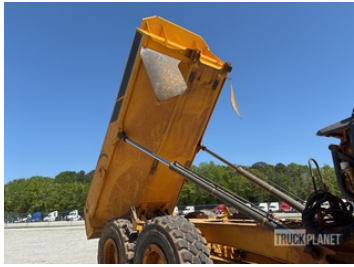
| Bed Body | ★★★★☆ | |

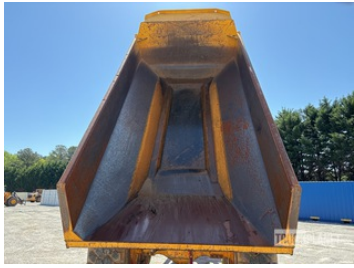
| Bed Liner | ★★★★☆ | |

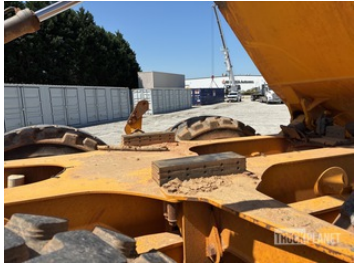
| Bed Pads | ★★★★☆ | |

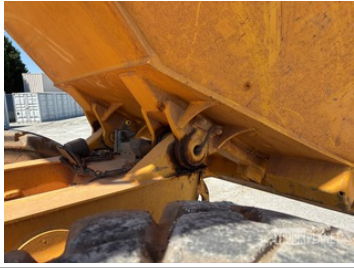
| Hinge Points | ★★★★☆ | |
