Item #7251498 - 2014 Apache AS720 90 ft 4x2 High Clearance Self-Propelled Sprayer

Inspection Report

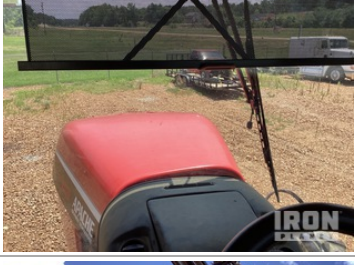
<p>Glass</p>	<p>No visible damage</p>

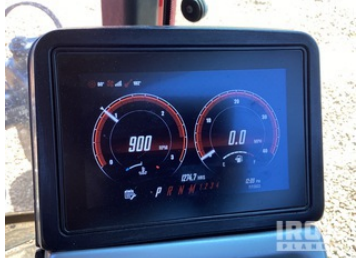
Oil Pressure	No oil pressure indicator

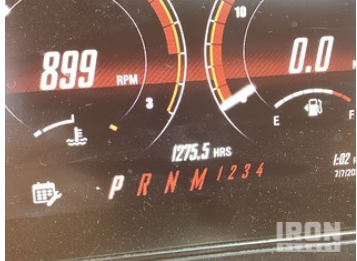
Hour Meter	1275.5 hrs, Operational hour meter

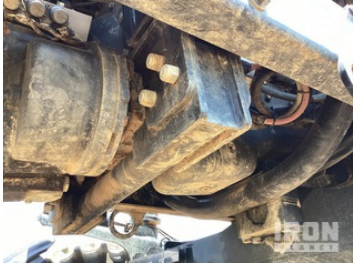
Oil Leaks	No dripping leaks

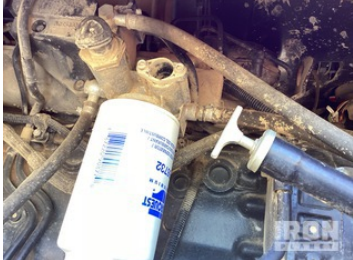
Fuel Leaks	No dripping leaks

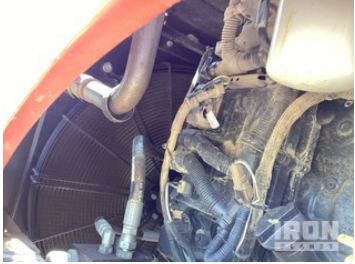
Cooling System Leaks	No dripping leaks

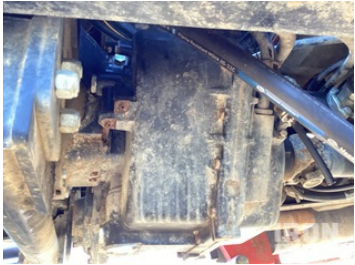
Drivetrain		
Operational test is limited to low speed in a confined flat area without load. Differential interlocks, full transmission shifting and functionality of all drive axles cannot be fully verified. Inspector listens for abnormal noises, observes leaks and notes physical damage.		
Item	Assessment	Photo
Transmission	★★☆☆ Operational

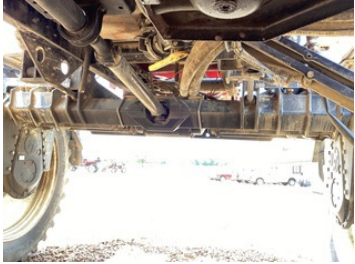
Rear Drive Axle	★★☆☆

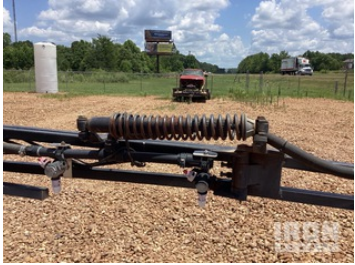
Boom Shocks	★★☆☆

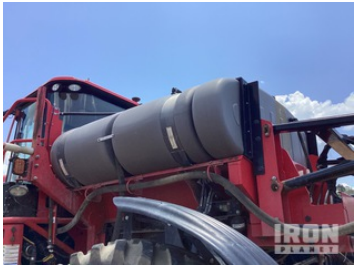
Tank	★★☆☆

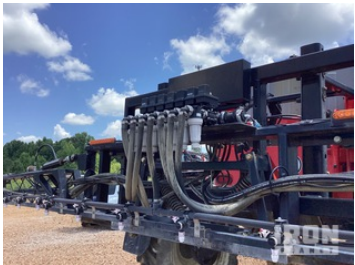
Plumbing	★★☆☆ Not operationally tested

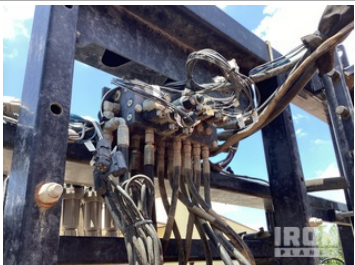
Electrical	★★☆☆ Not operationally tested

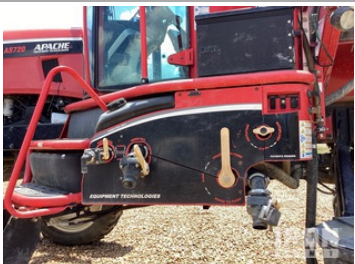
Fluid Flush System	★★☆☆ Not operationally tested

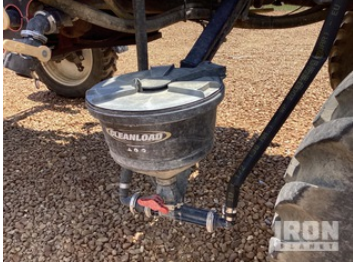
Granular Bins	★★★★☆ Number of Bins 1, Could not check sensors
