### Item #15307646 - 2024 Komatsu PC210LC-11 Tracked Excavator

- Features: Air Conditioner, 2023 US EPA Label, 10 ft Stick, Auxiliary Hydraulic Plumbing, 48 in Digging Bucket
- Meter Reading: 1,447 Hours
- Serial # : KMTPC257LPTC82469
- Inspection Completed: 7/8/26

# Inspection Report

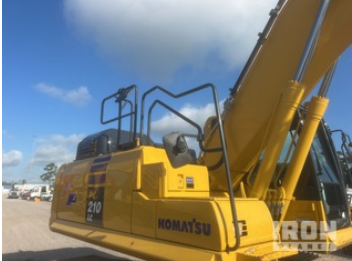
Hand Rails	No visible damage or missing components

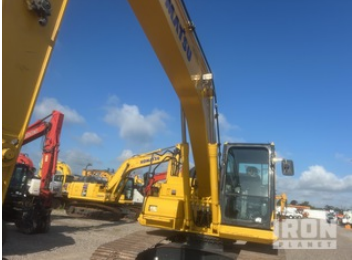
Exterior Lights	All lights operational

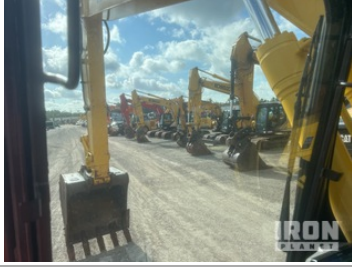
Glass	No visible damage or missing components

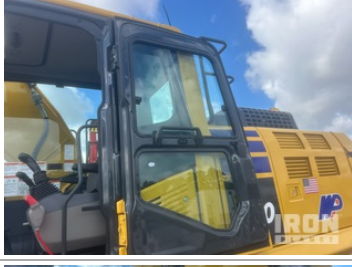
Cab Door	No visible damage or missing components

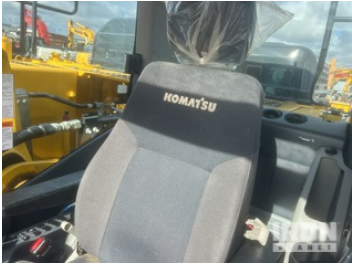
Heater	Operational	
Limited Function Check	The main components are in place and operational as noted. Cable to the front glass is broken and cannot get the front glass to sit down in the frame properly	
Excavator* # 1

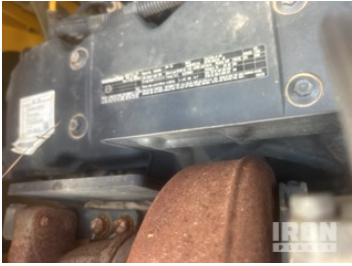
<b>Engine</b>		
<b>Item</b>	<b>Assessment</b>	<b>Photo</b>
Engine	2023 US EPA Label	
Emission Label

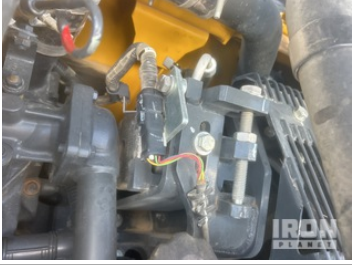
A/C Compressor	Operational

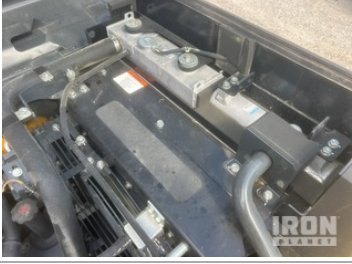
Blow-by (subjective visual observation)	No noticeable vapor or pressure	
Starter	Operational	
Exhaust System	No visible damage or missing components	 
Radiator	★★★★☆

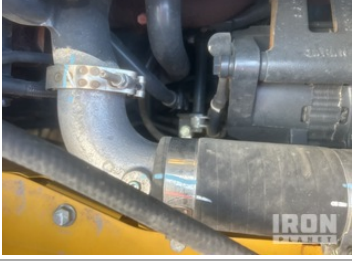
Oil Leaks	No dripping leaks

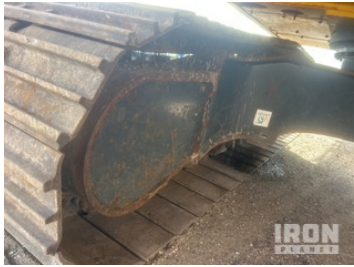
<b>Drivetrain</b>		
Operational test is limited to low speed in a confined flat area without load. Differential interlocks, full transmission shifting and functionality of all drive axles cannot be fully verified. Inspector listens for abnormal noises, observes leaks and notes physical damage.		
<b>Item</b>	<b>Assessment</b>	<b>Photo</b>
Left Drive Motor	★★★★☆

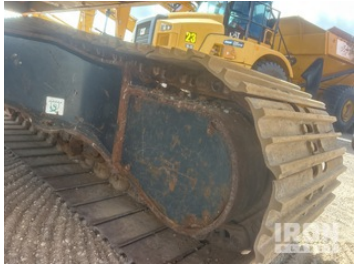
Right Drive Motor	★★★★☆

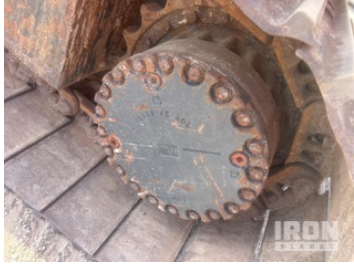
Left Final Drive	★★★★☆

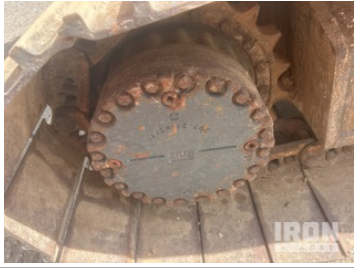
Right Final Drive	★★★★☆

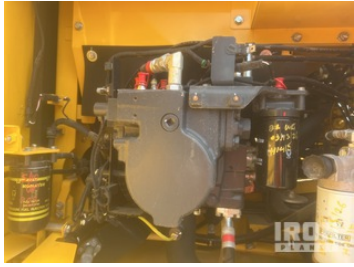
Hydraulics		
Item	Assessment	Photo
Pumps (Hydraulics)	★★★★☆

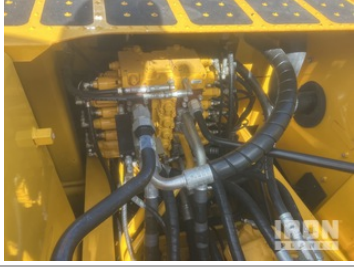
Valves	★★★★☆

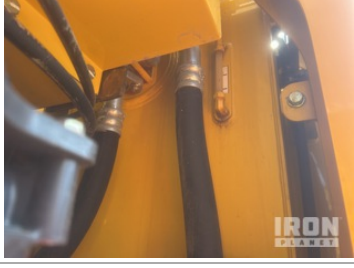
Hydraulic Tank	★★★★☆

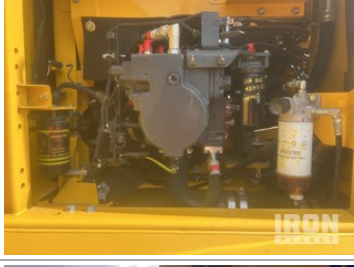
Hoses (Hydraulics)	★★★★☆

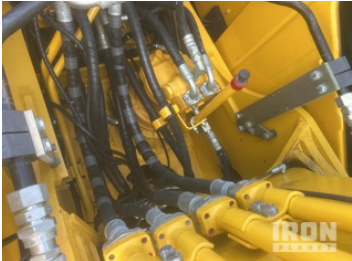
Hydraulic Center Swivel	★★★★☆

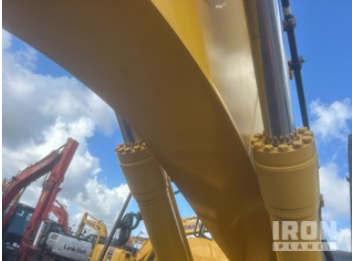
Boom Lift Cylinder(s)	★★★★☆

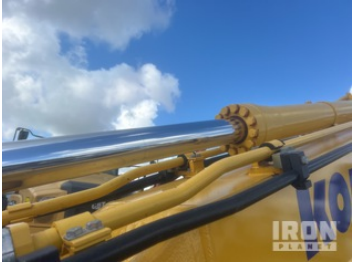
Stick Cylinder	★★★★☆

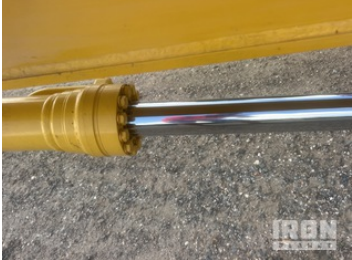
Bucket Cylinder	★★★★☆

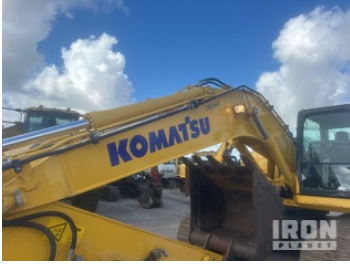
Chassis		
IronPlanet pin connection pivot point wear inspections are limited to sound, sight and feel observations. Dial indicator testing is not performed.		
Item	Assessment	Photo
Boom Condition	★★★★☆

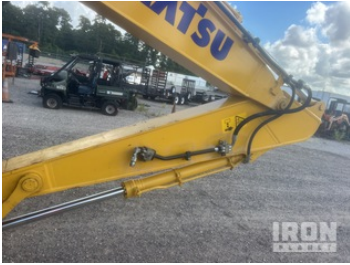
Stick Condition	★★★★☆

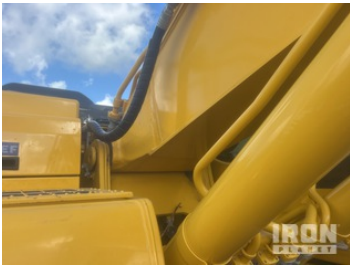
Boom Base Pin and Bushings	★★★★☆

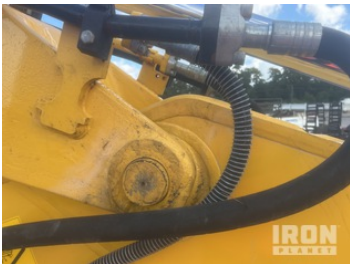
Pin and Bushings Boom to Stick	★★★★☆

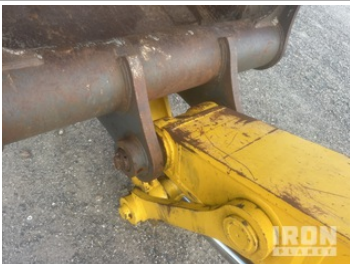
Pin and Bushings Stick to Bucket	★★★★☆

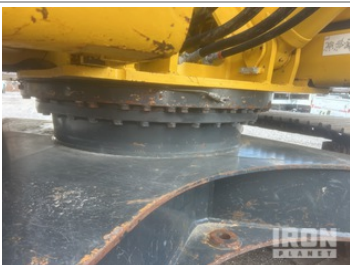
Turntable Bearing	★★★★☆

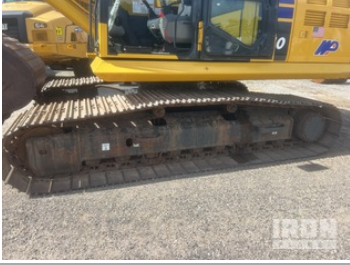
Item	Assessment	Photo
Left Roller Frame	★★★★☆

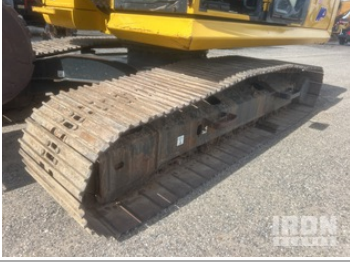
Left Track Tensioner	★★★★☆

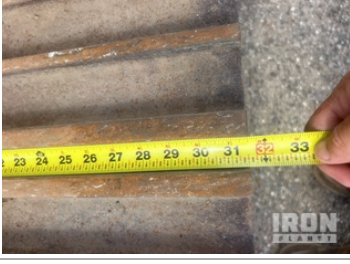
Left Track Pads	★★★★☆ 31.5 in Wide

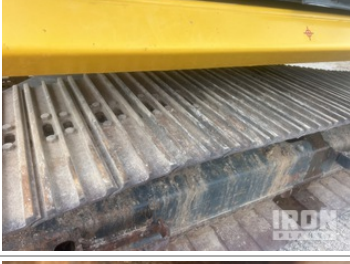
Left Grouser Height	25 mm

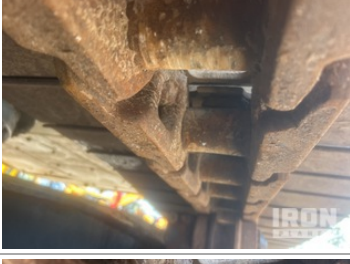
Left Track Links	105 mm

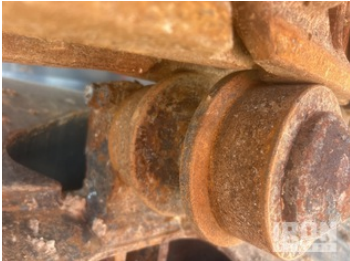
<p>Left Carrier Rollers</p>	<p>2 carrier rollers #1 118 mm #2 118 mm</p>

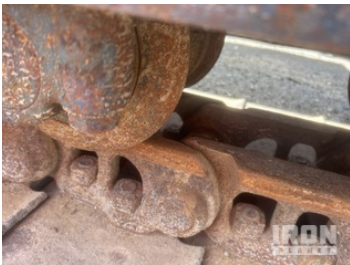
<p>Left Bottom Rollers</p>	<p>9 Bottom Rollers #1 154 mm #2 154 mm #3 Rock guard mm #4 154 mm #5 154 mm #6 154 mm #7 Rock guar mm #8 154 mm #9 154 mm</p>

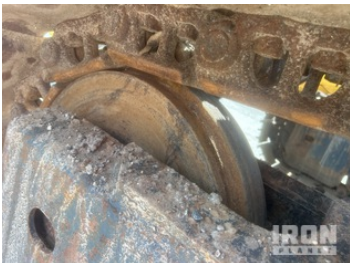
<p>Left Idler</p>	<p>21 mm</p>

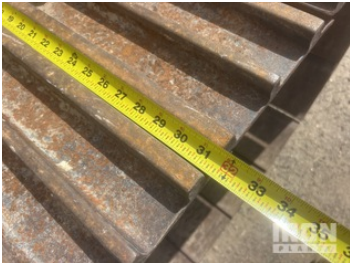
<p>Right Track Pads</p>	<p>★★★★☆ 31.5 in Wide</p>

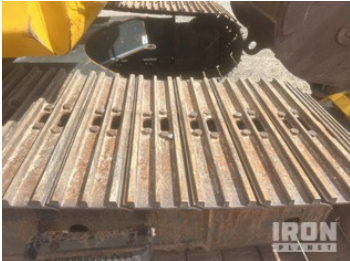
<p>Right Grouser Height</p>	<p>25 mm</p>

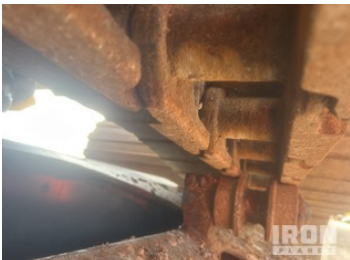
<p>Right Track Links</p>	<p>105 mm</p>

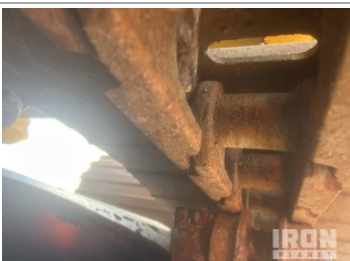
<p>Right Track Bushings</p>	<p>59 mm</p>

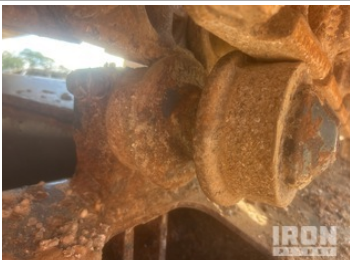
<p>Right Carrier Rollers</p>	<p>2 Carrier Rollers #1 119 mm #2 119 mm</p>

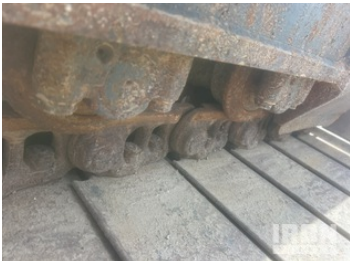
<p>Right Bottom Rollers</p>	<p>9 Bottom Rollers: #1 155 mm #2 155 mm #3 Rock guard mm #4 155 mm #5 155 mm #6 155 mm #7 Rock guard mm #8 155 mm #9 155 mm</p>
