## Item #15396135 - 2024 Tigercat 620H 4x4 Skidder

# Inspection Report

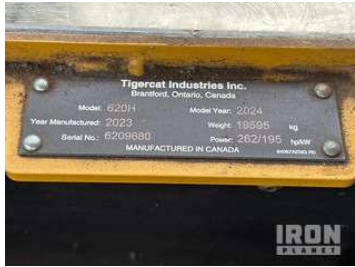
| Serial Number / VIN | 6209680 | |

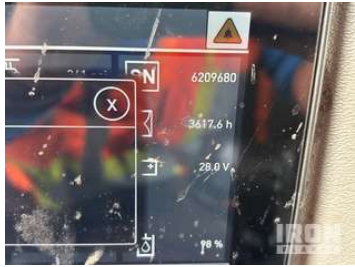
| Hour Meter / Odometer | 3617 hrs | |

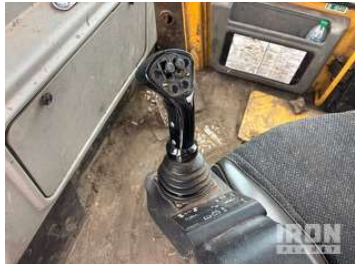
| Item | Assessment | Photo |
|---|---|---|
| Steering Controls | ★★★★☆ | |

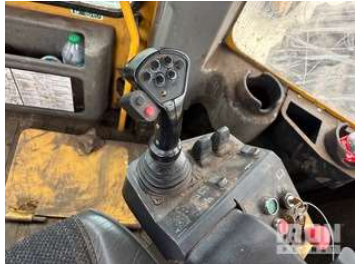
| Item | Assessment | Photo |
|---|---|---|
| Hydraulic Controls | ★★★★☆ | |

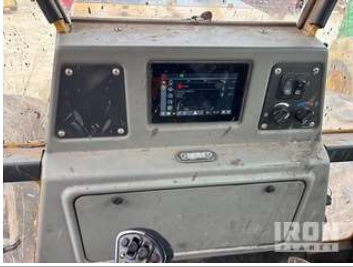
| Dash Console | <p>★★★★</p> | |

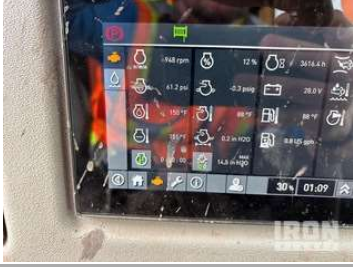
| Engine Oil Pressure | <p>The gauge registers in the operating range.</p> | |

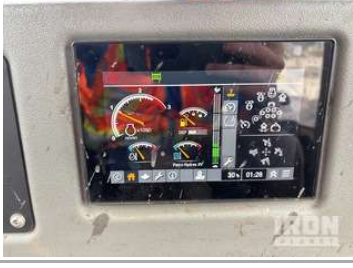
| Gauges | <p>Operational</p> | |

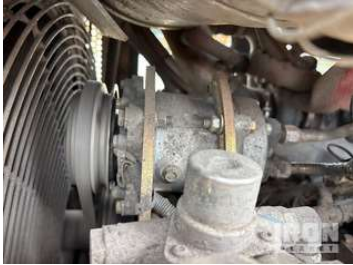
| Engine | | |
|---|---|---|
| A/C Compressor | Operational | |

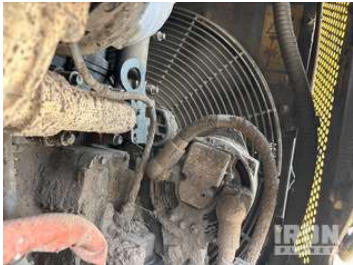
| Engine | | |
|---|---|---|
| Radiator | ★★★★☆ | |

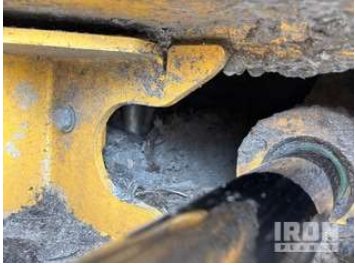
| Item | Assessment | Photo |
|---|---|---|
| Transmission | ☆☆☆☆<br>Operational, Not visible | |

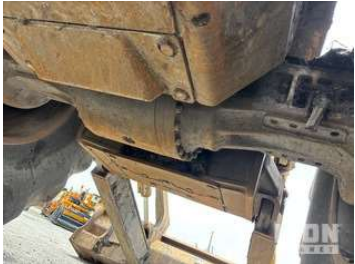
| Item | Assessment | Photo |
|---|---|---|
| Front Drive Axle | ☆☆☆☆ | |

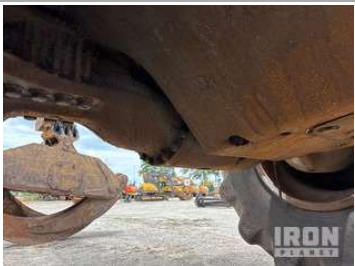
| Item | Assessment | Photo |
|---|---|---|
| Rear Drive Axle | ☆☆☆☆ | |

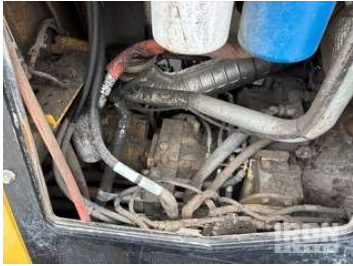
| Item | Assessment | Photo |
|---|---|---|
| Pumps (Hydraulics) | ★★★★☆ | |

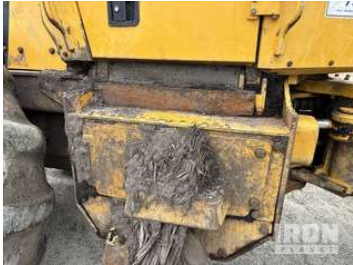
| Item | Assessment | Photo |
|---|---|---|
| Hydraulic Tank | ★★★★☆ | |

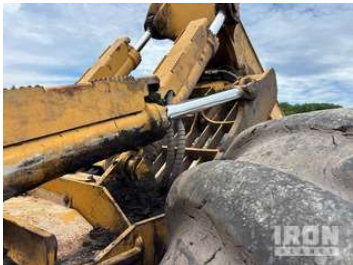
| Item | Assessment | Photo |
|---|---|---|
| Hoses/Lines - Skidder | ★★★★☆ | |

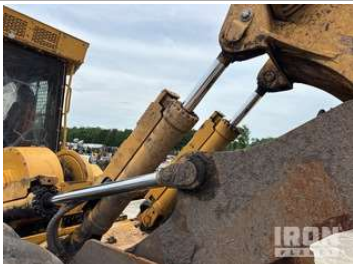
| Item | Assessment | Photo |
|---|---|---|
| Boom Lift Cylinder(s) | ★★★★☆ | |

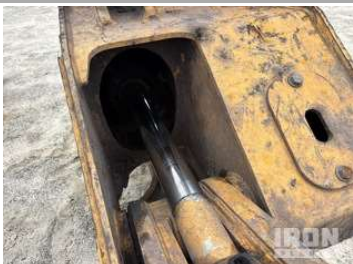
| Item | Assessment | Photo |
|---|---|---|
| Grapple Cylinders | ★★★★☆ | |

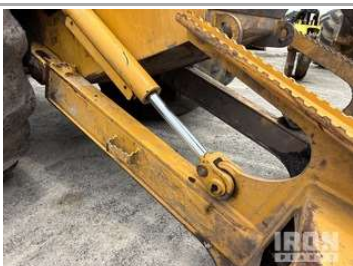
| Item | Assessment | Photo |
|---|---|---|
| Blade Lift Cylinders | ★★★★☆ | |

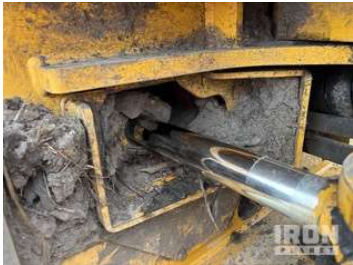
| Steering Cylinders | ★ ★ ★ ☆ | |

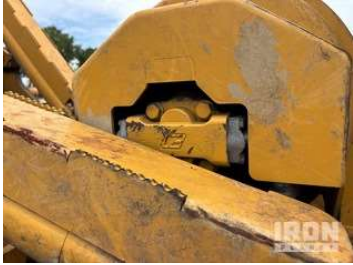
| Hydraulic Motors | ★ ★ ★ ☆ | |

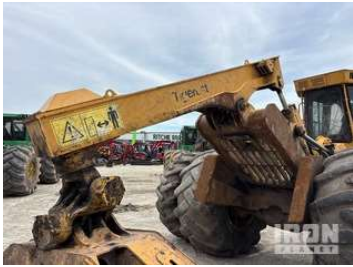
| Grapple Boom Condition | ★★★★☆ | |

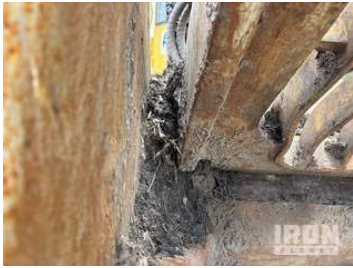
| Chassis to Arm Pins | ★★★★☆ | |

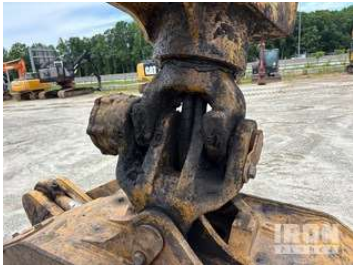
| Boom to Grapple Pins and Bushings | ★★★★☆ | |

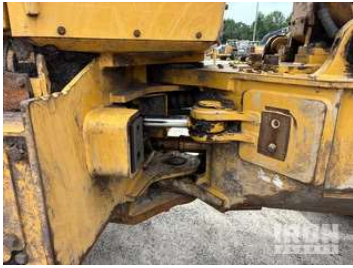
| Item | Assessment | Photo |
|---|---|---|
| Articulating Center Pins | ★★★★☆ | |

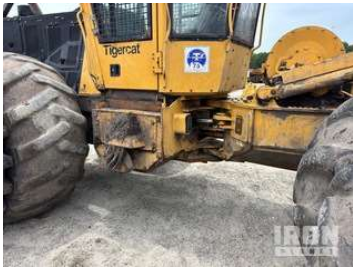
| Item | Assessment | Photo |
|---|---|---|
| Frame Condition | ★★★★☆ | |

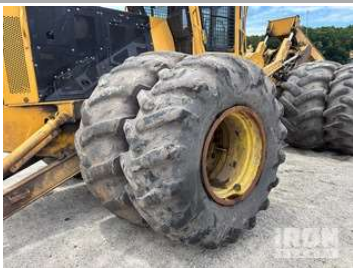
| Item | Assessment | Photo |
|---|---|---|
| Left Front Tire | | |

| Item | Assessment | Photo |
|---|---|---|
| Left Rear Tire | All tires have damage | |

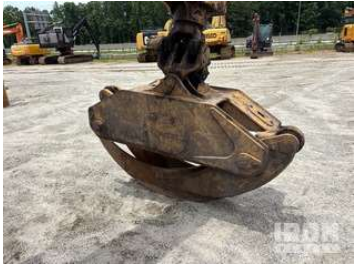
| Specialty | | |
|---|---|---|
| Grapple | ★★☆☆ | |
