## Item #13748190 - 2021 Volvo EC750EL Tracked Excavator

# Inspection Report

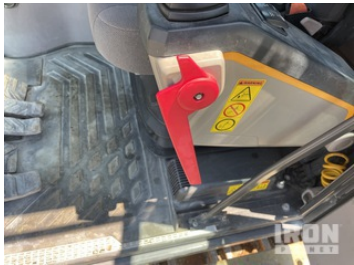
| Item | Assessment | Photo |
|---|---|---|
| Safety Lock Out/Stop | Operational | |

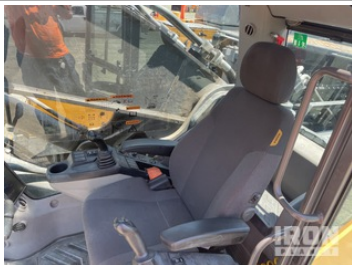
| Item | Assessment | Photo |
|---|---|---|
| Seat/Armrests | No visible damage or missing components | |

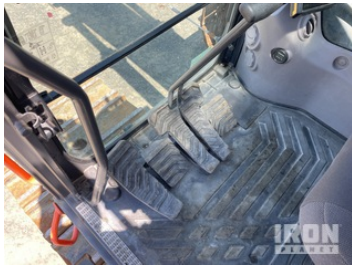
| Item | Assessment | Photo |
|---|---|---|
| Steering Controls | ★★★★☆ | |

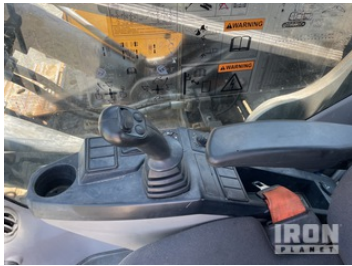
| Item | Assessment | Photo |
|---|---|---|
| Hydraulic Controls | ★★★★☆ | |

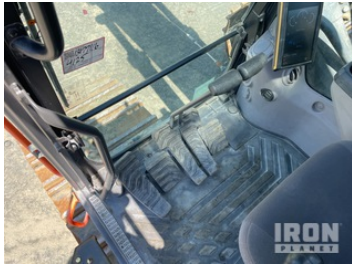
| Item | Assessment | Photo |
|---|---|---|
| Drivetrain Controls | ★★★★☆ | |

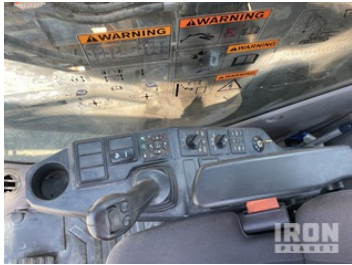
| Item | Assessment | Photo |
|---|---|---|
| Dash Console | ★★★★☆ | |

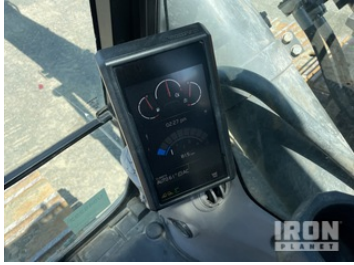
| Warning Lights | Operational | |

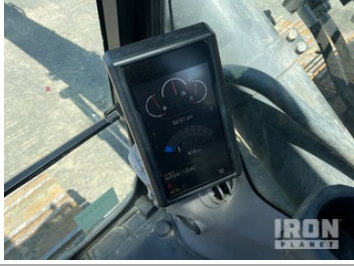
| Gauges | Operational | |

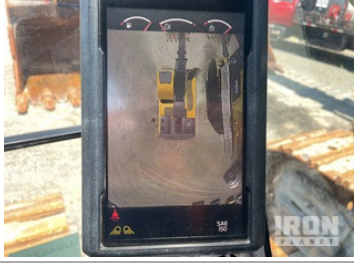
| Rear View Camera | Camera operates as intended | |

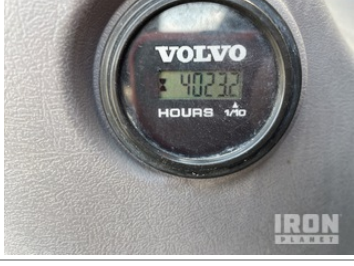
| Hour Meter / Odometer | 4023 hrs | |

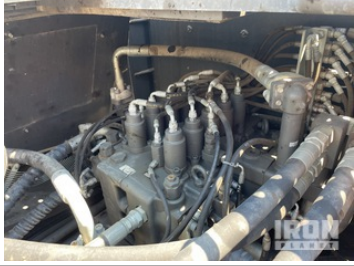
| Item | Assessment | Photo |
|---|---|---|
| Valves | <p>★ ★ ★ ☆</p> | |

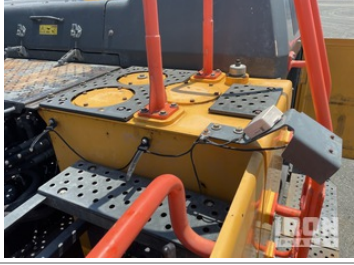
| Item | Assessment | Photo |
|---|---|---|
| Hydraulic Tank | <p>★ ★ ★ ☆</p> | |

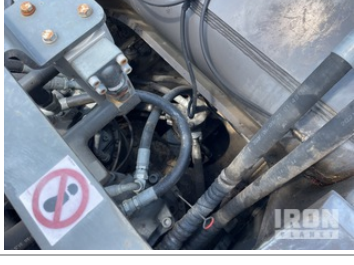
| Item | Assessment | Photo |
|---|---|---|
| Hydraulic Center Swivel | <p>★ ★ ★ ☆</p> | |

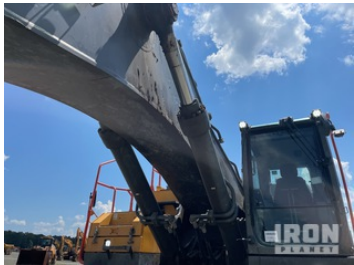
| Boom Lift Cylinder(s) | ★ ★ ★ ☆ | |

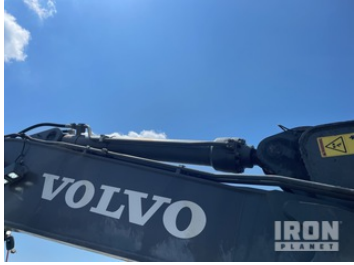
| Stick Cylinder | ★ ★ ★ ☆ | |

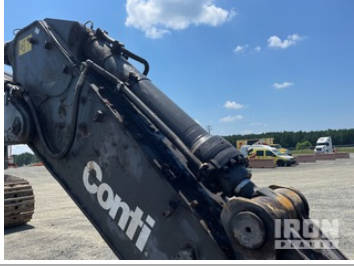
| Bucket Cylinder | ★ ★ ★ ☆ | |

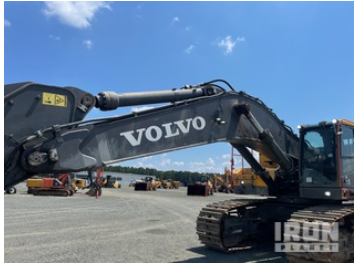
| Item | Assessment | Photo |
|---|---|---|
| Boom Condition | ★★★★☆ | |

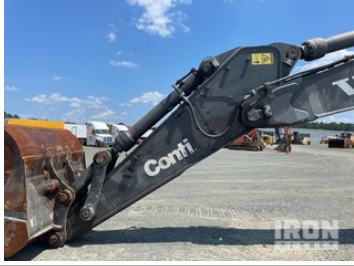
| Item | Assessment | Photo |
|---|---|---|
| Stick Condition | ★★★★☆ | |

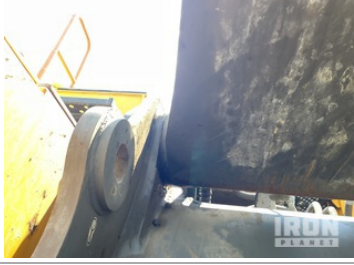
| Item | Assessment | Photo |
|---|---|---|
| Boom Base Pin and Bushings | ★★★★☆ | |

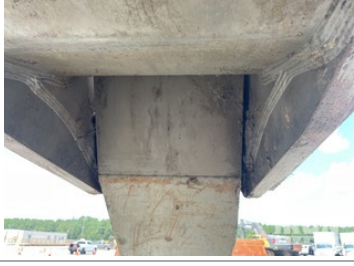
| Item | Assessment | Photo |
|---|---|---|
| Pin and Bushings Boom to Stick | ★★★★☆ | |

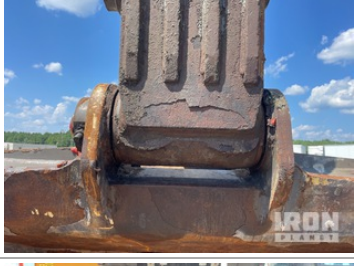
| Item | Assessment | Photo |
|---|---|---|
| Pin and Bushings Stick to Bucket | ★★★★☆ | |

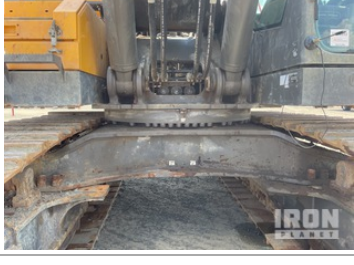
| Item | Assessment | Photo |
|---|---|---|
| Turntable Bearing | ★★★★☆ | |

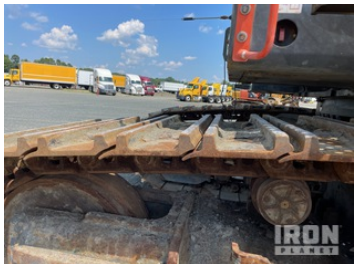
| Item | Assessment | Photo |
|---|---|---|
| Left Grouser Height | 48 mm | |

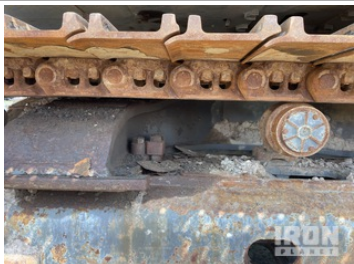
| Item | Assessment | Photo |
|---|---|---|
| Left Track Links | 36 mm | |

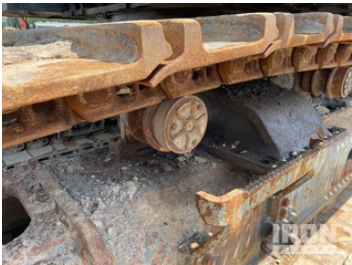
| Left Carrier Rollers | 3 carrier rollers #1 195 mm #2 196 mm #3 196 mm | |

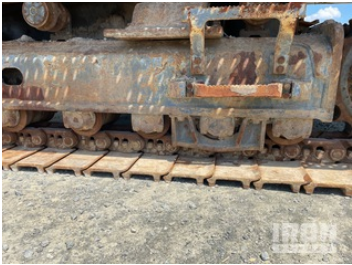
| Left Bottom Rollers | 8 Bottom Rollers #5 236 mm Can only access number five roller | |

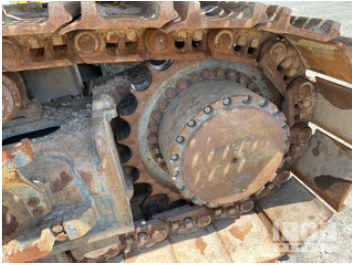
| Left Sprocket | ★★★★☆ | |

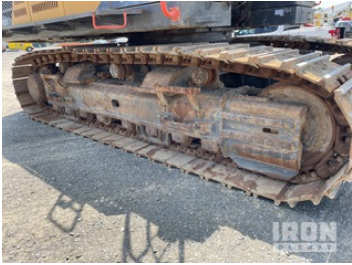
| Right Roller Frame | ★★★★☆ | |

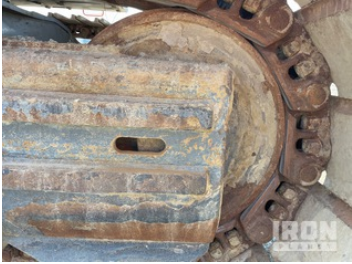
| Right Track Tensioner | ★★★★☆ | |

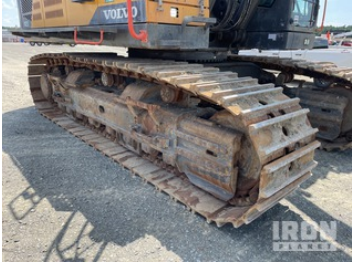
| Right Track Pads | ★★★★☆<br>36 in Wide | |

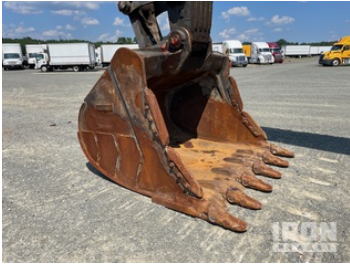
| Item | Assessment | Photo |
|---|---|---|
| Excavator Bucket Condition | ★★★★☆ | |

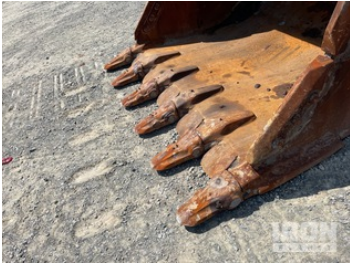
| Item | Assessment | Photo |
|---|---|---|
| Bucket Cutting<br>Edge/Shanks/Teeth | ★★★★☆<br>No visible damage or missing<br>components | |
