## Item #15681455 - 2022 CMI C-175 TwisterII Tracked Mulcher Tractor

- Features: Enclosed Cab, Air Conditioner, Joystick Steering, Rear View Camera, 2022 US EPA Label, Requires Diesel Exhaust Fluid, 22 in Track Belts, Denis Cimaf 6 ft 3 in, Forestry mower, Winch
- Meter Reading: 1,928 Hours
- Serial # : CMI175CUD204504
- Inspection Completed: 8/3/26

# Inspection Report

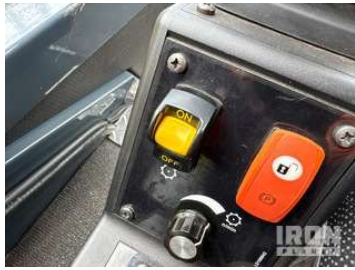
| Item | Assessment | Photo |
|---|---|---|
| Safety Lock Out/Stop | Operational | |

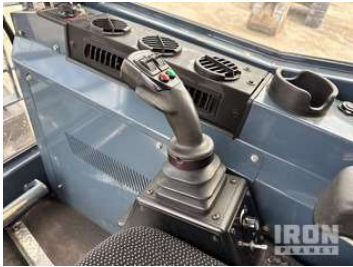
| Steering Controls | ★★★★☆ | |

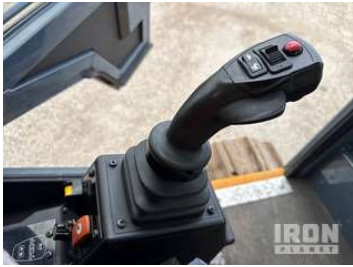
| Hydraulic Controls | ★★★★☆ | |

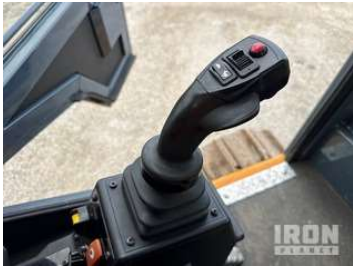
| Drivetrain Controls | ★★★★☆ | |

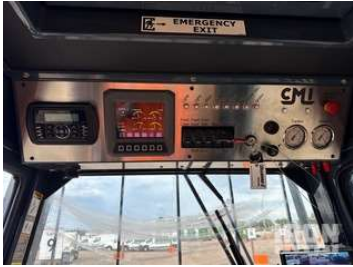
| Dash Console | ★★★★☆ | |

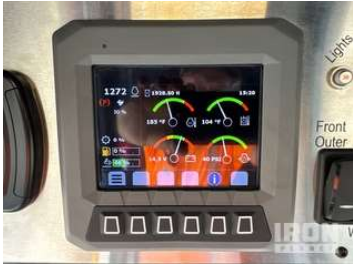
| Warning Lights | Operational | |

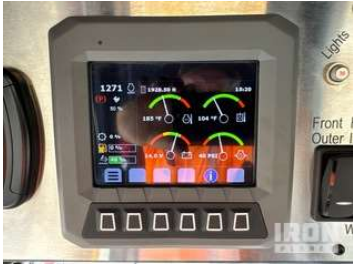
| Gauges | Operational | |

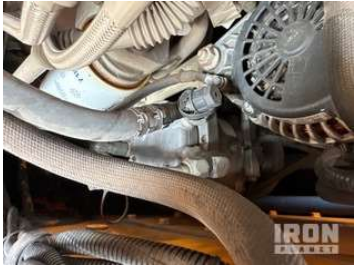
| Engine | | |
|---|---|---|
| A/C Compressor | Operational | |

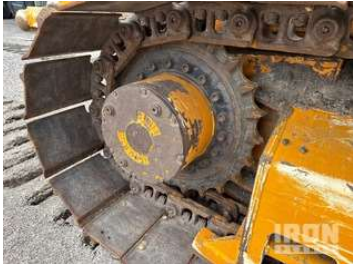
| Item | Assessment | Photo |
|---|---|---|
| Final Drives | ★★★☆☆ | |

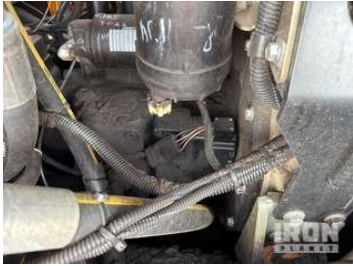
| Item | Assessment | Photo |
|---|---|---|
| Pumps (Hydraulics) | ★★★★☆ | |

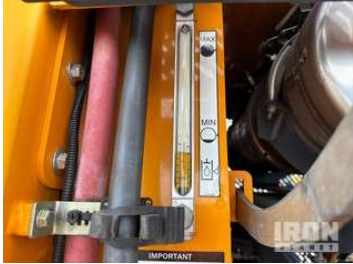
| Item | Assessment | Photo |
|---|---|---|
| Hydraulic Tank | ★★★★☆ | |

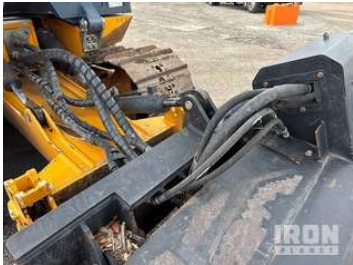
| Item | Assessment | Photo |
|---|---|---|
| Hoses (Hydraulics) | ★★★★☆ | |

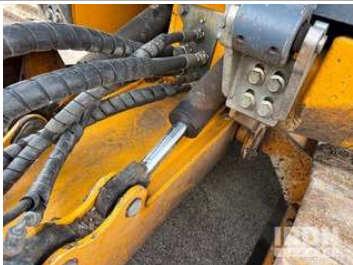
| Item | Assessment | Photo |
|---|---|---|
| Loader Lift Cylinders | ★★★★★ | |

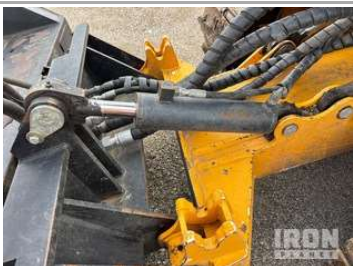
| Item | Assessment | Photo |
|---|---|---|
| Bucket Tilt Cylinders | ★★★★☆ | |

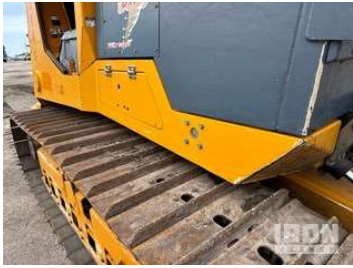
| Item | Assessment | Photo |
|---|---|---|
| Frame Condition | ★★★★☆ | |

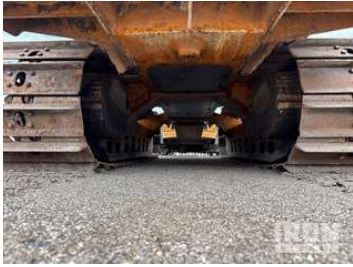
| Item | Assessment | Photo |
|---|---|---|
| Belly Pans | ★★★★☆ | |

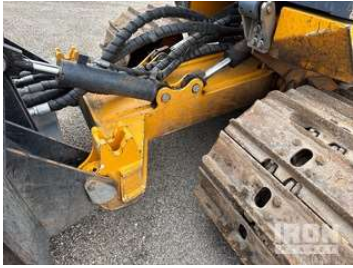
| Item | Assessment | Photo |
|---|---|---|
| Lift Arm Condition | ★★★★☆ | |
