## Item #12984395 - 2021 Hamm H10i Smooth Drum Compactor

## Inspection Report

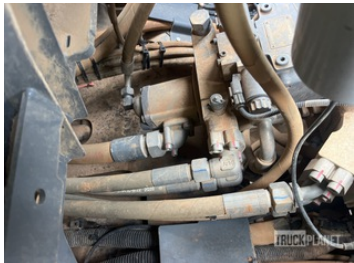
| Hydraulics | | |
|---|---|---|
| Pumps (Hydraulics) | ★★★★ | |

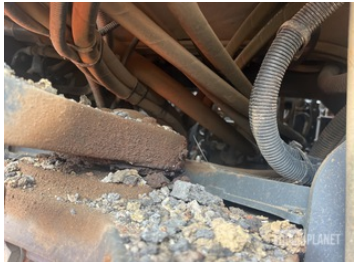
| Hydraulics | | |
|---|---|---|
| Valves | ★★★★ | |

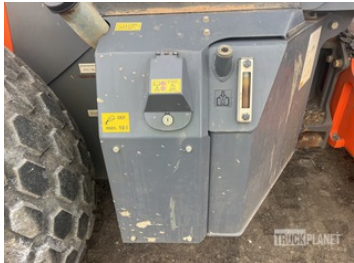
| Hydraulics | | |
|---|---|---|
| Hydraulic Tank | ★★★★ | |

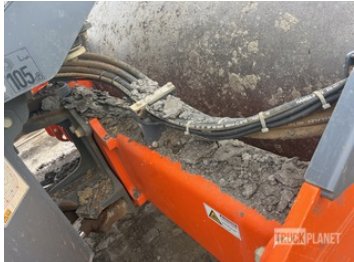
| Hydraulics | | |
|---|---|---|
| Hoses | ★★★★ | |

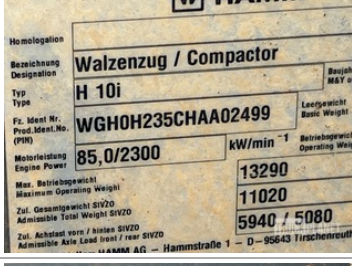
| Item | Assessment | Photo |
|---|---|---|
| Serial Number / VIN | WGH0H235CHAA02499 | |

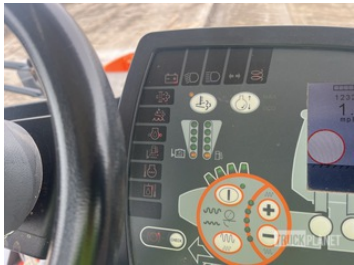
| Warning Lights | Operational | |

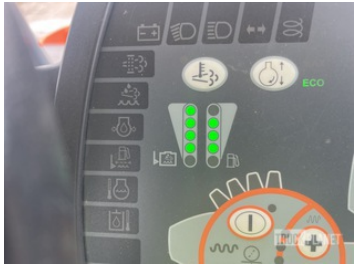
| Gauges | Operational | |

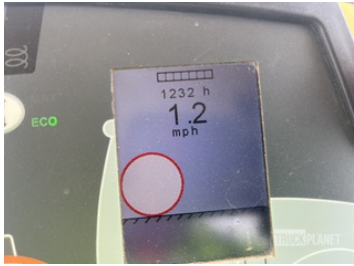
| Hour Meter / Odometer | 1232 mi | |

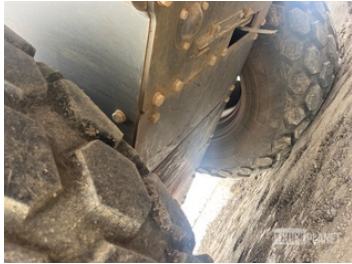
| Item | Assessment | Photo |
|---|---|---|
| Rear Center Drive Motor | ★★★★☆ | |

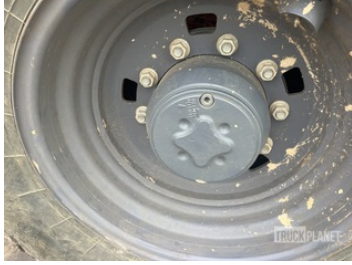
| Item | Assessment | Photo |
|---|---|---|
| Final Drives | ★★★★☆ | |
