**Item #15936905 - 2024 Kobelco SK210LC Tracked Excavator**

# Inspection Report

# 2024 KOBELCO SK210LC-11

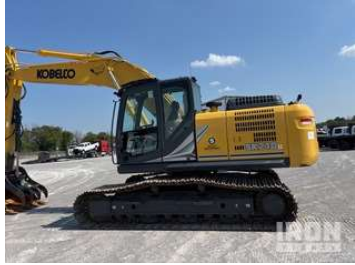
| Paint | No visible damage | |

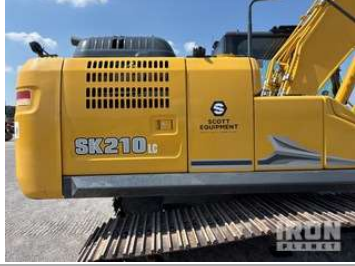
| Body Panels | No visible damage or missing components | |

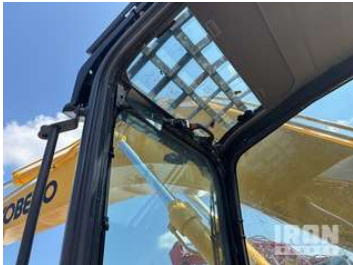
| Item | Assessment | Photo |
|---|---|---|
| Mirrors | | |

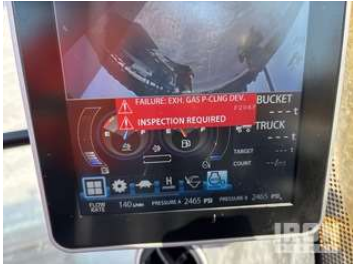
| Warning Lights | Operational, Check engine light stays on | |

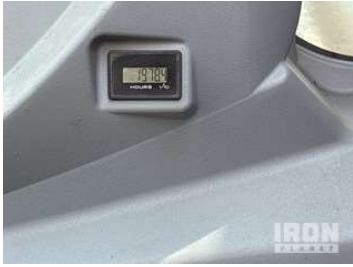
| Hour Meter / Odometer | 1978 mi | |

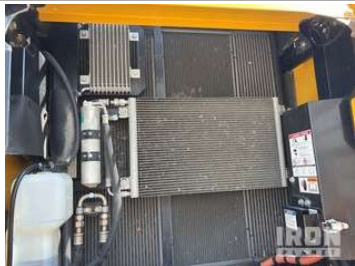
| Item | Assessment | Photo |
|---|---|---|
| Radiator | ★★★★☆ | |

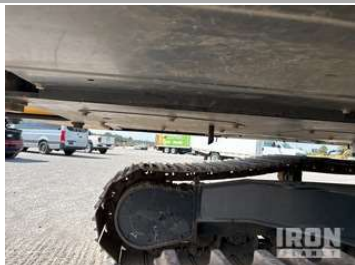
| Item | Assessment | Photo |
|---|---|---|
| Oil Leaks | No dripping leaks | |

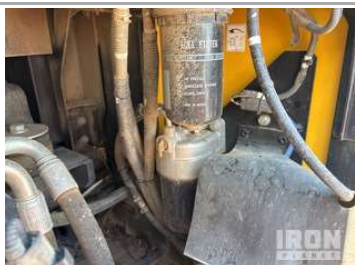
| Item | Assessment | Photo |
|---|---|---|
| Fuel Leaks | No dripping leaks | |

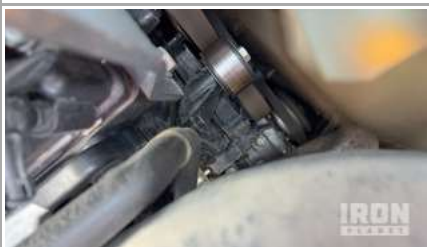
| Item | Assessment | Photo |
|---|---|---|
| Cooling System Leaks | No dripping leaks | |

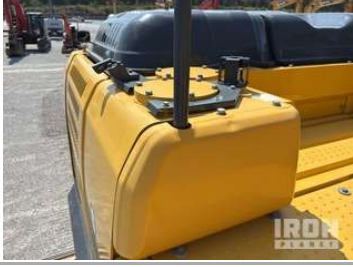
| Item | Assessment | Photo |
|---|---|---|
| Hydraulic Tank | ★★★★☆<br>Low fluid level | |

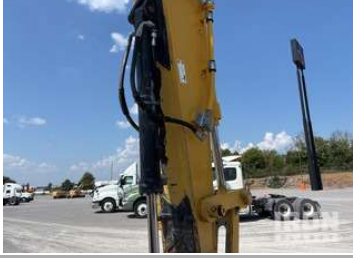
| Item | Assessment | Photo |
|---|---|---|
| Auxiliary Hydraulic Plumbing | Operational, End of stick | |

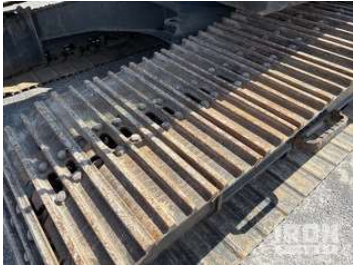
| Item | Assessment | Photo |
|---|---|---|
| Left Track Pads | ★★★★☆<br>31 in Wide Triple Grouser | |

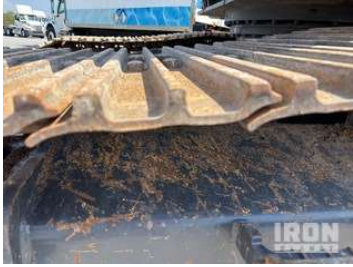
| Item | Assessment | Photo |
|---|---|---|
| Left Grouser Height | 25 mm | |

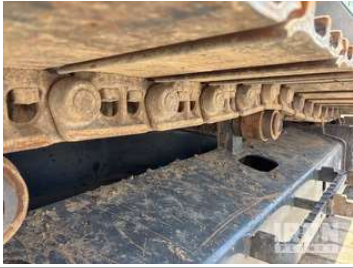
| Item | Assessment | Photo |
|---|---|---|
| Left Track Links | 106 mm | |

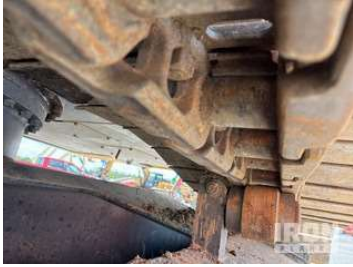
| Item | Assessment | Photo |
|---|---|---|
| Left Track Bushings | 40 mm | |

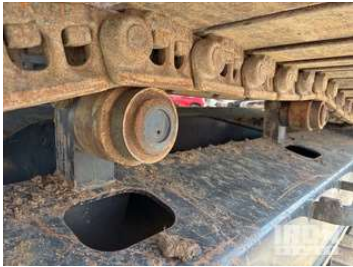
| Left Carrier Rollers | 2 carrier rollers #1 98 mm #2 98 mm | |

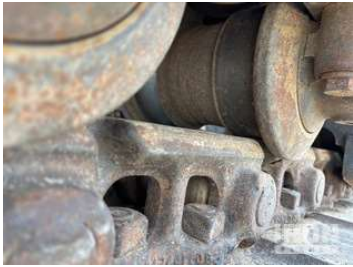
| Left Bottom Rollers | 8 Bottom Rollers #1 131 mm #2 131 mm #3 131 mm #4 131 mm #5 131 mm #6 131 mm #7 131 mm #8 131 mm | |

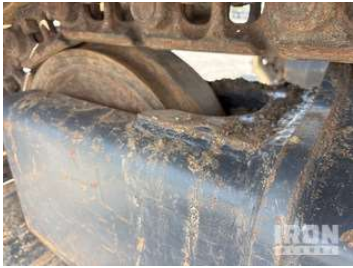
| Left Idler | 20 mm | |

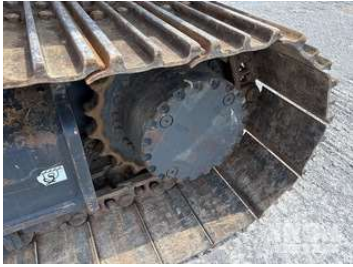
| Left Sprocket | ★★★★☆ | |

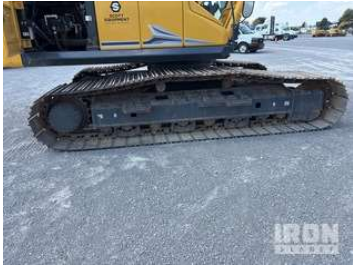
| Right Roller Frame | ★★★★☆ | |

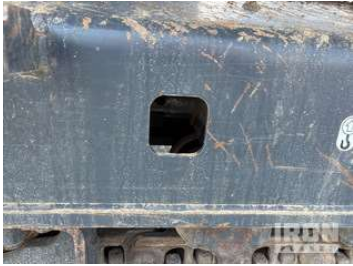
| Right Track Tensioner | ★★★★☆ | |

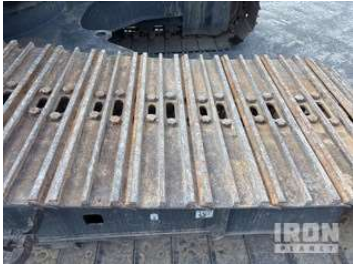
| Right Track Pads | ★★★★☆<br>31 in Wide Triple Grouser | |

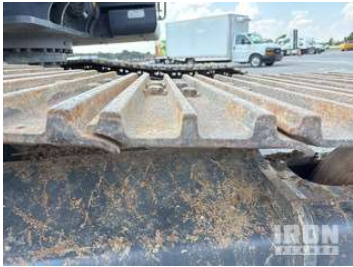
| Right Grouser Height | 26 mm | |

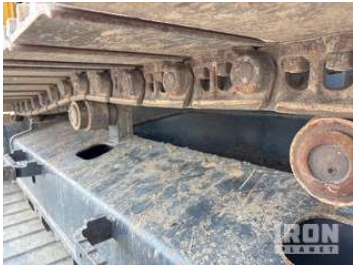
| Right Track Links | 107 mm | |

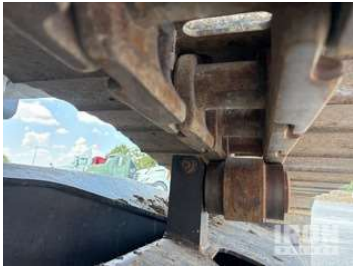
| Right Track Bushings | 39 mm | |

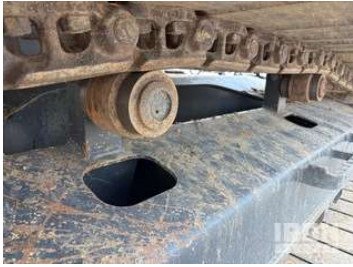
| Right Carrier Rollers | 2 Carrier Rollers #1 108 mm #2 108 mm | |

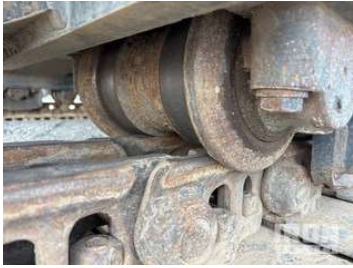
| Right Bottom Rollers | 8 Bottom Rollers: #1 130 mm #2 130 mm #3 130 mm #4 130 mm #5 130 mm #6 130 mm #7 130 mm #8 130 mm | |

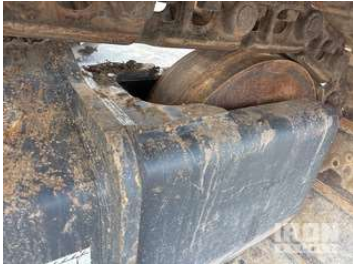
| Right Idler | 19 mm | |

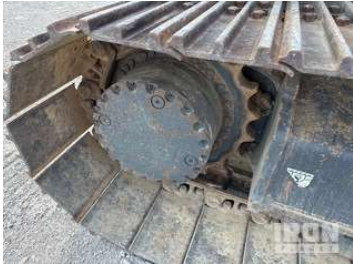
| Right Sprocket | ★★★★☆ | |
