## Item #15092789 - 2021 Hyundai 110D-9 25000 lb Forklift

# Inspection Report

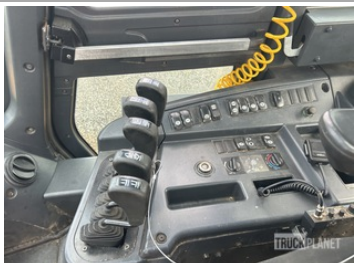
Hydraulic Controls	★★★★☆

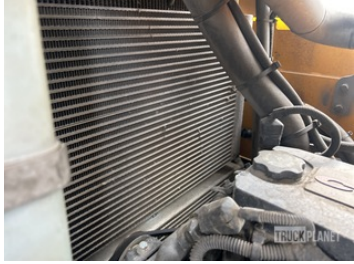
Radiator	☆☆☆☆

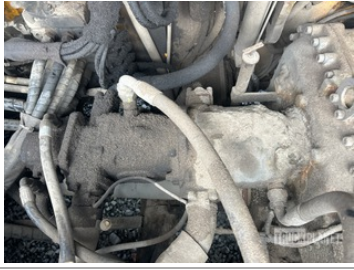
<h2>Hydraulics</h2>		
<p>See photos for condition</p>		
Item	Assessment	Photo
Pumps (Hydraulics)	★ ★ ★ ☆

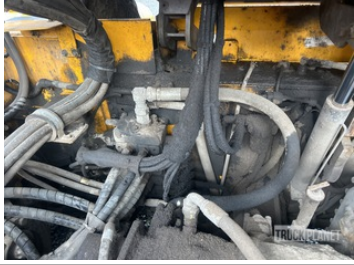
Valves	★ ★ ★ ☆

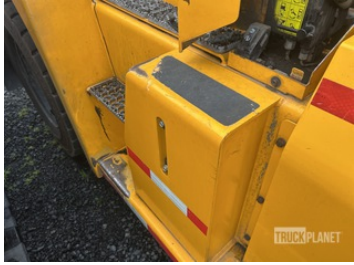
Hydraulic Tank	★ ★ ★ ☆

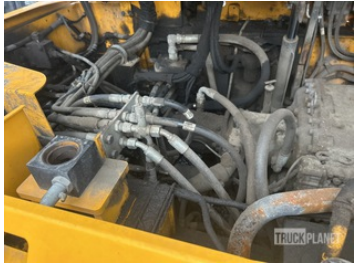
Hoses (Hydraulics)	★ ★ ★ ☆

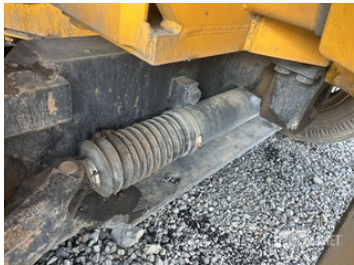
Steering Cylinders	★ ★ ★ ☆

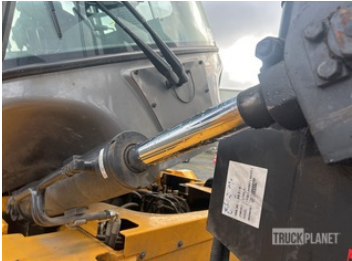
Mast Tilt Cylinders	★★★★☆

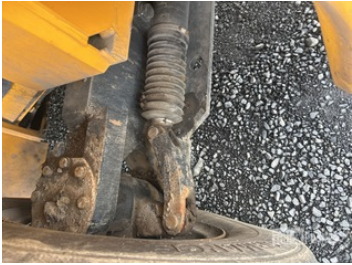
Steering Linkage	★★★★☆

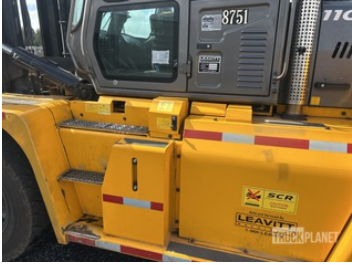
Frame Condition	★★★★☆

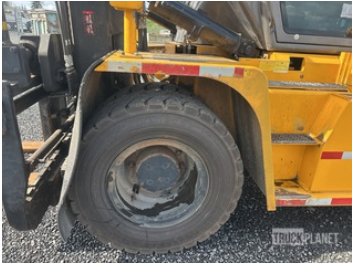
Park Brake	★★★★☆ Held against power	
Limited Function Check - Brakes	The brake system functioned, stopping and holding the machine.	
Left Front Tire	No visible defects

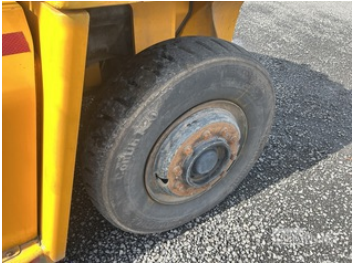
Left Rear Tire	No visible defects

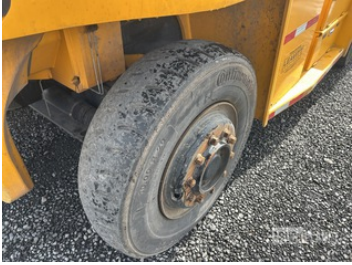
Right Rear Tire	No visible defects

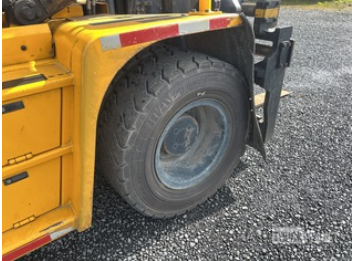
Right Front Tire	No visible defects

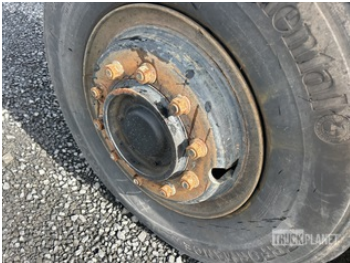
Wheel Condition	No visible damage or missing components
